Front Passenger Interior Door Assist Grip Cover Loose

Service Category Vehicle Interior

Section Interior Panels/Trim

YEAR(S)	MODEL(S)	ADDITIONAL INFORMATION
2011 – 2015	CT200H

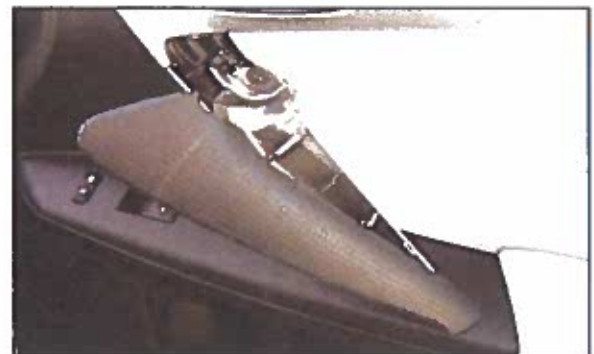
Figure 1.

1. Confirm that the front passenger interior door assist grip cover is loose.
 - A. If the door assist grip cover is loose, proceed to step 2 for door assist cover replacement.
 - B. If the door assist grip cover is not loose, this bulletin does not apply.
