**TECHNICAL INSTRUCTIONS
FOR
LIMITED SERVICE CAMPAIGN D0N
REAR DRIVESHAFT ASSEMBLY REPLACEMENT
CERTAIN 2011-2012 MODEL YEAR HIGHLANDER HV**

Due to an assembly error during manufacturing, the Rear Driveshaft in certain 2011-2012 Model Year Highlander Hybrid vehicles can disengage from its inboard joint assembly. If this occurs, the driveshaft could vibrate and rattle inside the inboard joint, causing a loud noise from the rear of the vehicle while driving. Continuing to drive the vehicle can damage the housing of the Rear Differential Motor. If the housing is damaged, the entire differential motor would also require replacement.

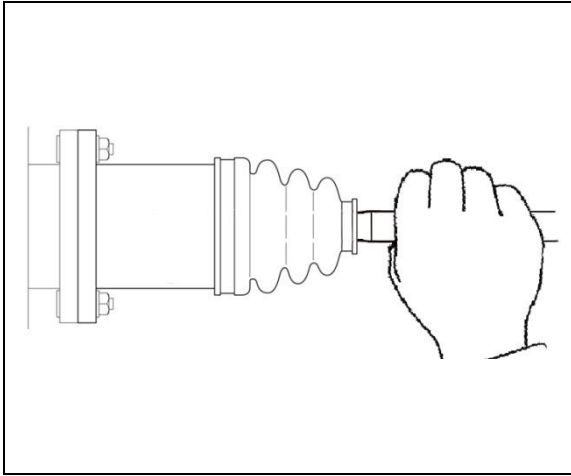
1. INSPECT THE REAR DRIVESHAFT ASSEMBLY FOR DISENGAGEMENT

- a) Approximately one inch from the inner rubber boot, firmly grab the metal portion of the driveshaft.
- b) Move the driveshaft assembly from side to side and up-and-down. If the driveshaft moves excessively, the inner bearing has disengaged from the shaft.

Note: The driveshaft has some slight backlash by design.

- c) Check both driveshafts in the same manner.

NOTE: Disengagement of the driveshaft may cause damage to the inside of the rear differential motor. If either driveshaft is found to be disengaged, replacement of the rear differential motor is required.

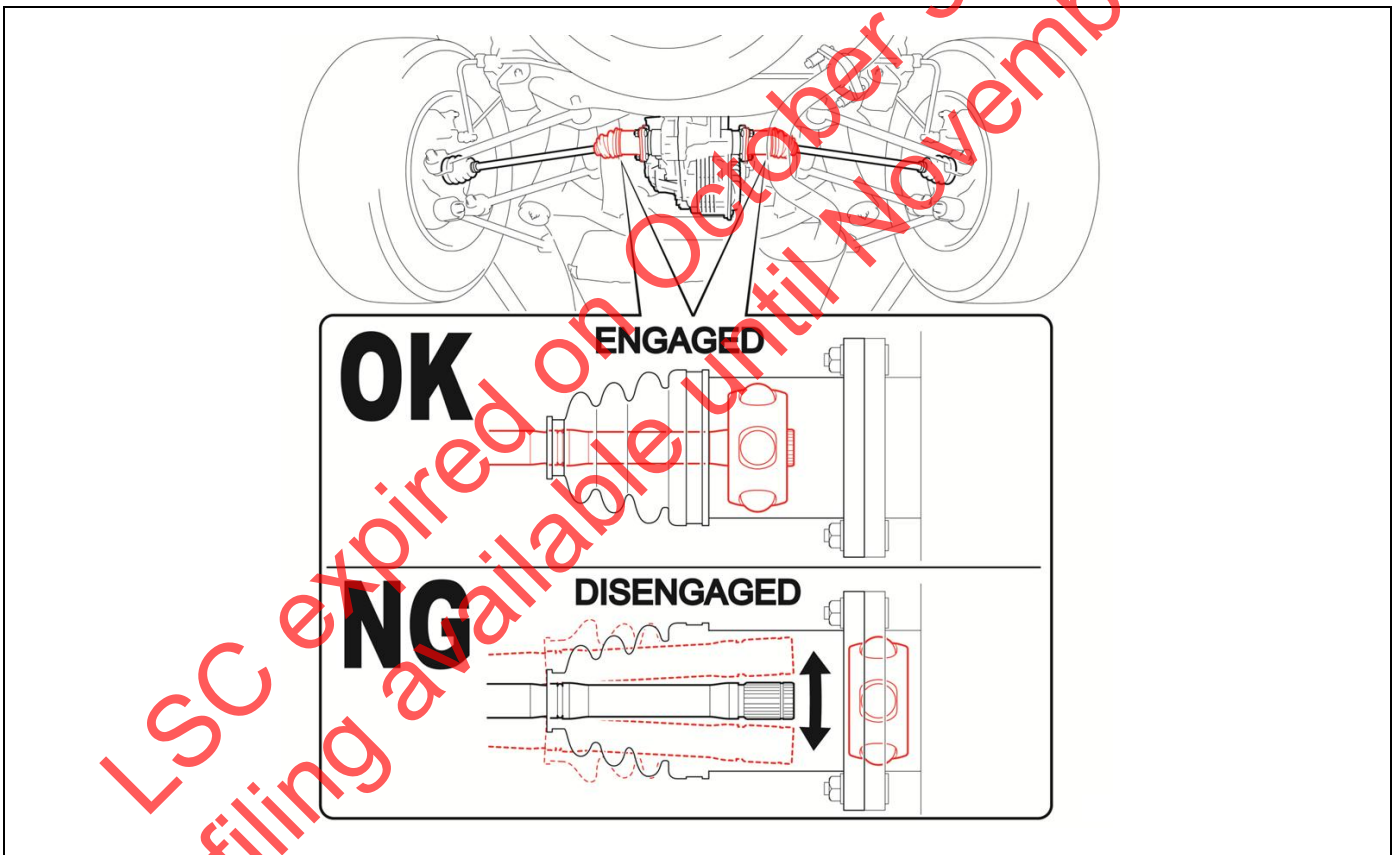
Results	ACTION REQUIRED
BOTH Driveshafts Engaged OK	REPLACE THE REAR DRIVESHAFT ASSEMBLY Both drive shafts must be replaced. Proceed to section VII
One or both shafts disengaged NG	REPLACE THE REAR DIFFERENTIAL MOTOR ASSEMBLY AND REAR DRIVESHAFT ASSEMBLY. The rear differential motor assembly AND both driveshafts must be replaced. Proceed to Section VIII

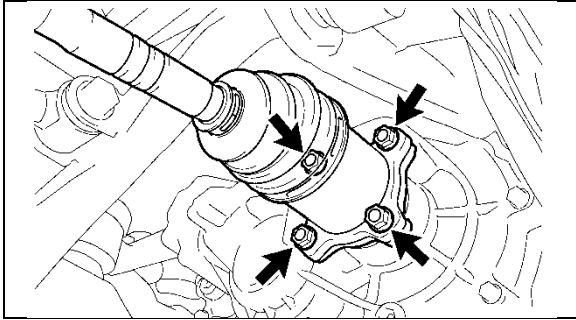
1. LOOSEN THE 4 DRIVE SHAFT NUTS

- Loosen the 4 nuts. DO NOT remove them at this time.

NOTE: If the nuts cannot be loosened due to the driveshaft spinning, apply the parking brake to hold the rear tire.

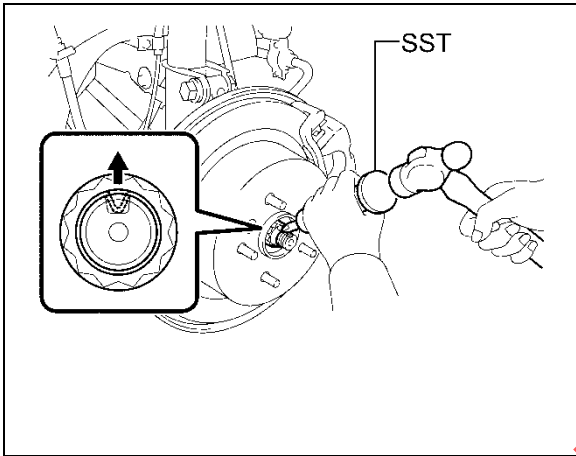
2. REMOVE THE AXLE NUT

- Remove the rear wheels.
- Using the SST and a hammer, release the staked part of the rear axle shaft nut.

SST 09930-00010

- While applying the brakes, remove the rear axle shaft nut.
- Put a mark on the removed nut to identify it cannot be reused.

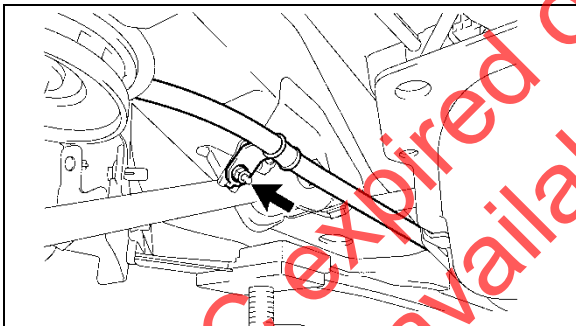
3. REMOVE PARKING BRAKE CABLE AND SUSPENSION COMPONENTS

- Remove the nut and separate the No.3 parking brake cable assembly.

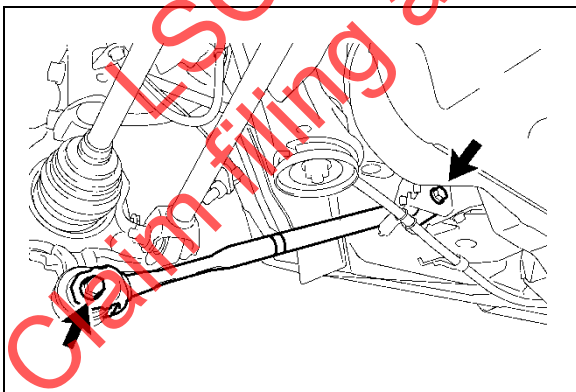
- Remove the 2 bolts, the 2 nuts, and the rear strut rod assembly.

- Since lock nuts are used, loosen the bolts.
- If difficult to remove the bolts, use a wooden block and a jack to slightly lift up the axle carrier and remove the bolts.

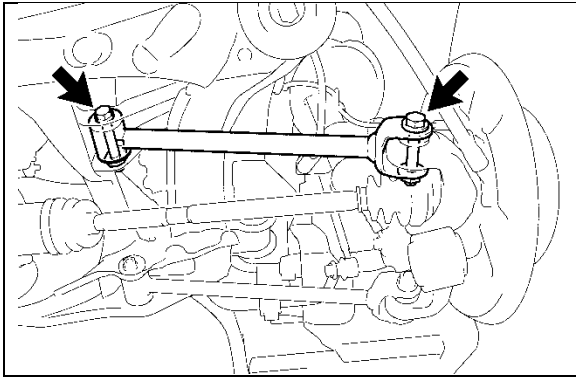
- c) Remove the 2 bolts, the 2 nuts, and the rear No.1 suspension arm assembly.

- Since lock nuts are used, loosen the bolts.
- Before removing the driveshaft, be sure to remove the rear No.1 suspension arm assembly, otherwise it may be damaged by interference with the boot of the axle carrier.

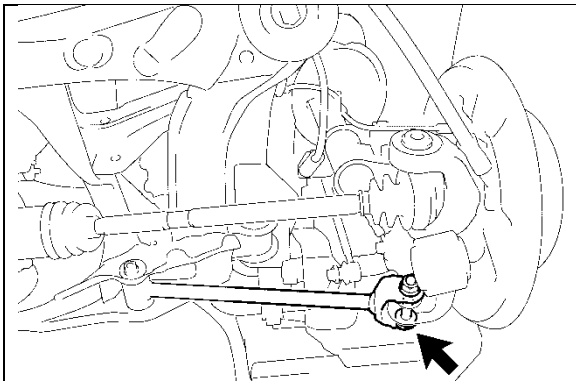
- d) Remove the bolt and the nut, and separate the rear No.2 suspension arm assembly.

NOTE: Since lock nuts are used, loosen the bolts.

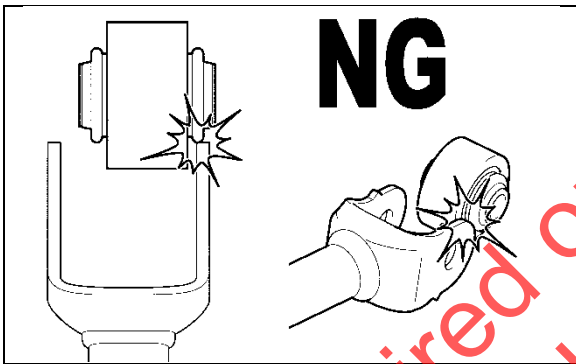
STOP DO NOT allow the rear No.2 suspension arm assembly to strike the boot of the wheel hub assembly as it will damage it.

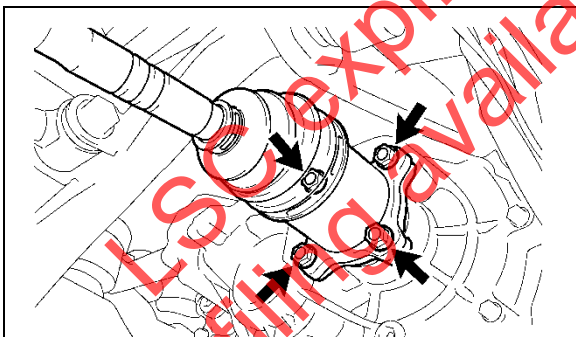
4. REMOVE THE REAR DRIVESHAFT

- a) Remove the 4 nuts and washers.

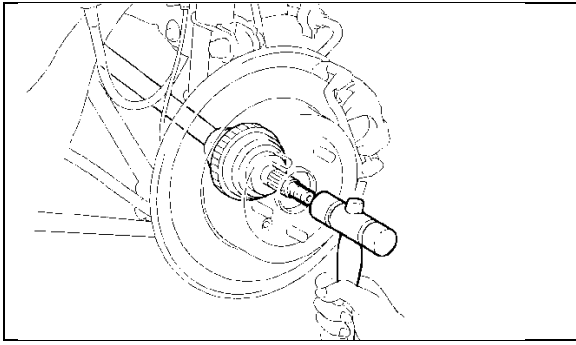
- b) Using the plastic hammer, disengage the driveshaft.

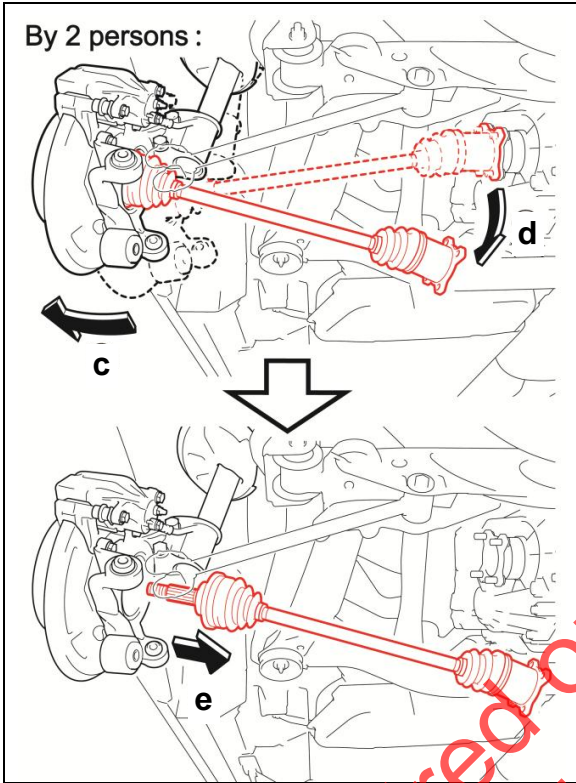
- c) Move the wheel hub assembly towards the outside of the vehicle and hold it in place.

- Move the wheel hub assembly only far enough to allow the inboard side of the axle shaft to be cleanly removed from the motor side flange.
- DO NOT excessively move the wheel hub assembly, as it may stress the upper support of the suspension strut.

- d) Separate the inboard side of the driveshaft, and remove the driveshaft from the wheel hub assembly.

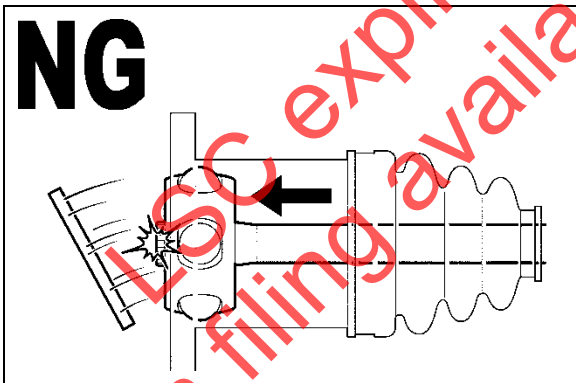
5. **INSTALL THE NEW REAR DRIVESHAFT**

DO NOT apply excessive force to the rear driveshaft to prevent the end cover from being removed.

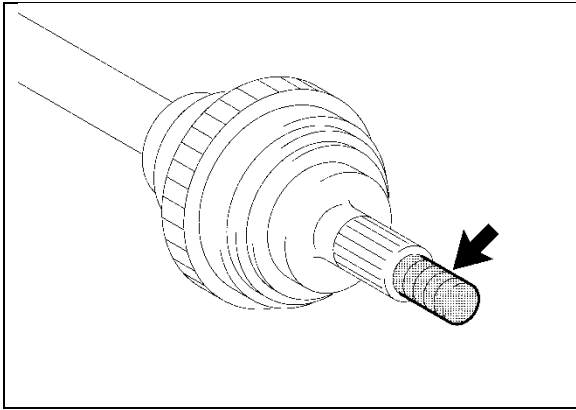
- a) Using brake cleaner, remove the corrosion inhibitor on the tip of the **NEW** driveshaft.

- The corrosion inhibitor is colorless and transparent.
- If the rear driveshaft is installed without removal of the corrosion inhibitor, it may cause an over-torqued rear axle shaft nut and damage the driveshaft.
- **DO NOT** apply oils or fats after cleaning of the tip.

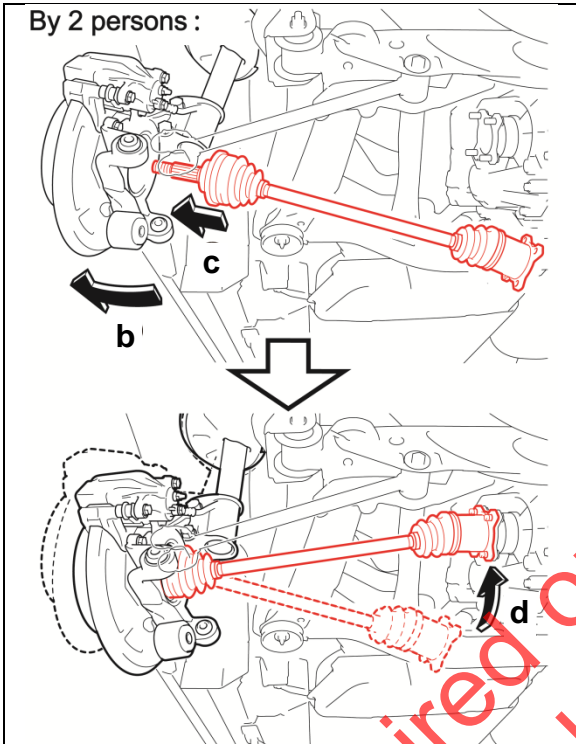
- b) Move the axle carrier towards the outside of the vehicle and hold it in place.
- c) Insert the **NEW** driveshaft into the wheel hub assembly.

Move the rear wheel hub assembly until the inner driveshaft flange does not interfere with the motor side mounting flange.

- d) Install the inboard side of the driveshaft.

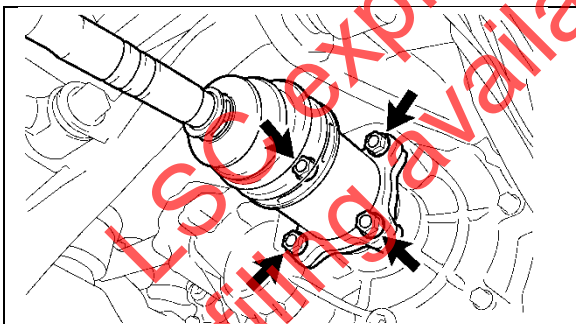
- e) Loosely install the 4 nuts and the 4 washers.

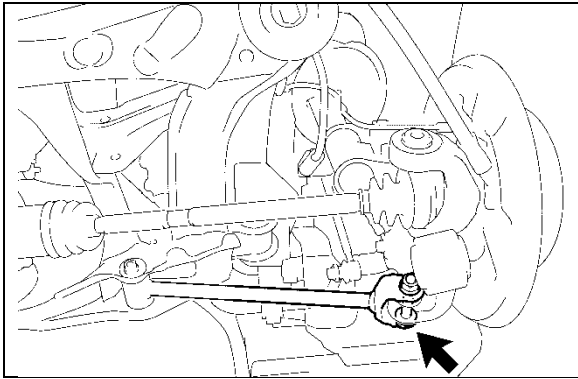
6. INSTALL THE SUSPENSION COMPONENTS AND THE PARKING BRAKE CABLE

- a) Temporarily install the rear No.2 suspension arm assembly with the bolt and nut.

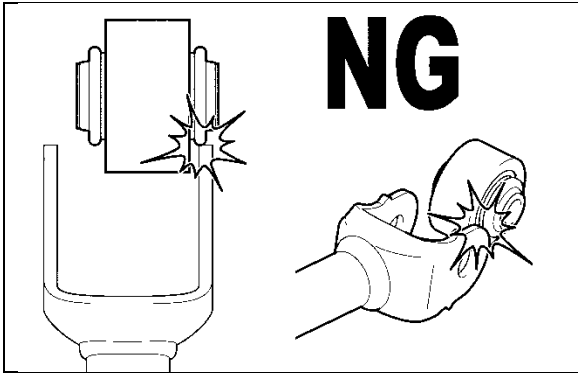
STOP DO NOT allow the rear No.2 suspension arm assembly to strike the boot of the wheel hub assembly as it will damage it.

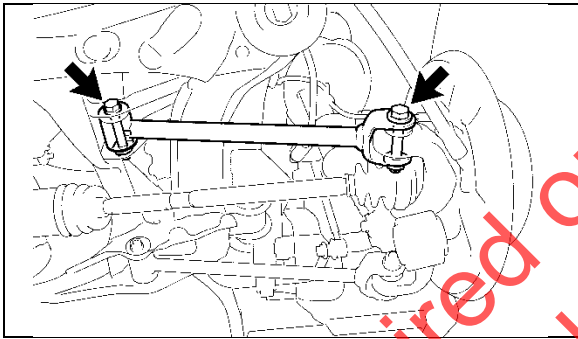
- b) Loosely install the rear No.1 suspension arm assembly with the 2 bolts and the 2 nuts.

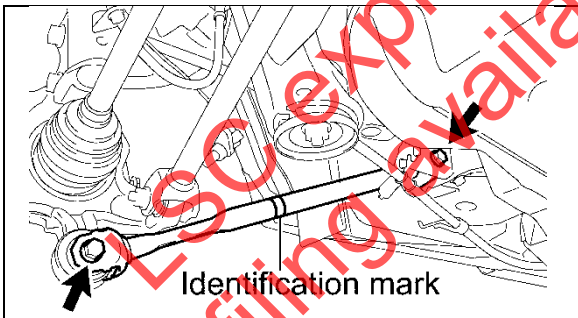
- c) Check that the identification mark of the rear strut rod assembly is positioned on the inner side of the vehicle.
- d) Loosely install the rear strut rod assembly with the 2 bolts and the 2 nuts.

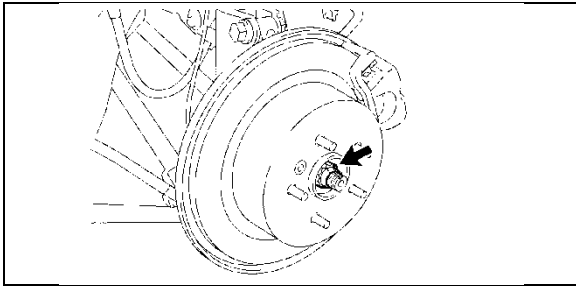
7. LOOSELY INSTALL A NEW REAR AXLE SHAFT NUT.

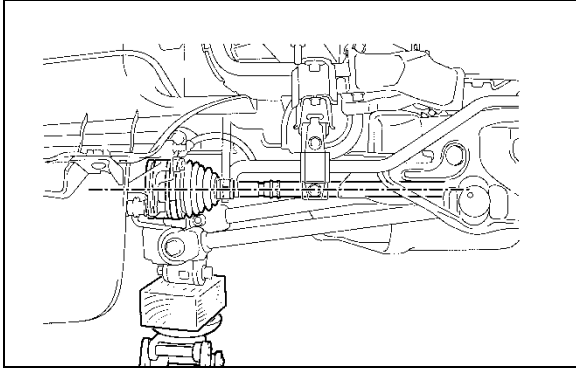
8. JACK UP THE REAR AXLE SUB-ASSEMBLY

- a) Jack up the rear axle sub-assembly, placing a wooden block underneath to avoid damage. Apply load to the suspension so that the rear driveshaft assembly is positioned horizontally.

- DO NOT jack up the rear axle sub-assembly too high as the vehicle may fall off of the lift.
- DO NOT bend the brake dust cover.

- If the rear driveshaft assembly cannot be positioned horizontally as shown in the illustration even when the rear wheel hub assembly is jacked up, apply additional load to the vehicle such as by having a person sit in the rear seat.
- Use the same procedure for the RH and LH side.

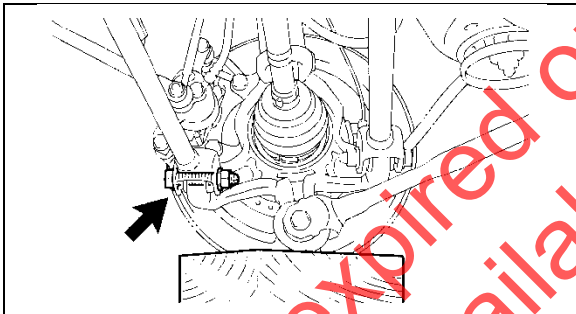
9. TORQUE THE REAR NO. 2 SUSPENSION ARM ASSEMBLY BOLT AND NUT.

Torque: 82 ft. lbf (112 N m)

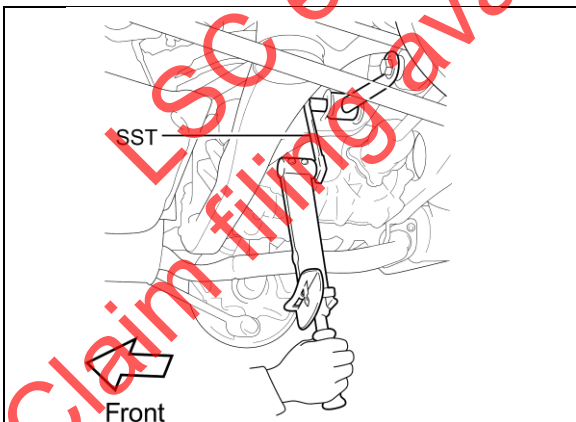
10. TORQUE THE NO. 1 SUSPENSION ARM ASSEMBLY

- a) Using a torque wrench that is 14.96 in (380mm) long with SST 09961-00950, torque the bolt and nut on the inside of the No.1 suspension arm assembly.

Torque:
with SST: 42 ft lbf (57 N m)

- If you are not using the exact tools described in step b) you must refer to the repair manual for torque specifications. (Link)
- Since a lock nut is used, torque the bolt.
- The final torque must be applied under standard vehicle height conditions.

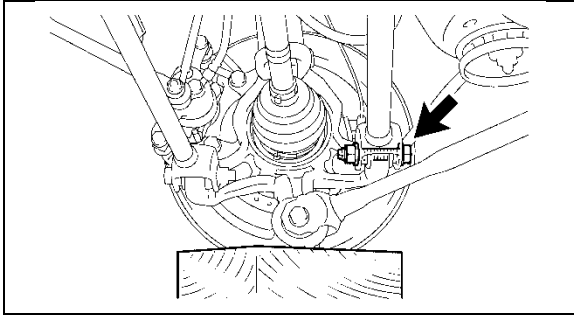
11. Torque the bolt and nut on the outside of the No.1 suspension arm assembly.

Torque: 82 ft lbf(112 N m)

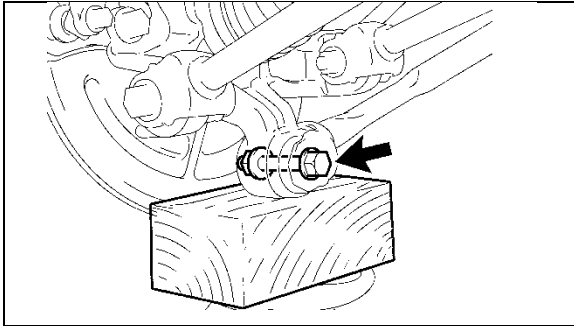
12. Torque the bolt and the rear strut rod assembly.

Torque: 59 ft lbf (80 N m)

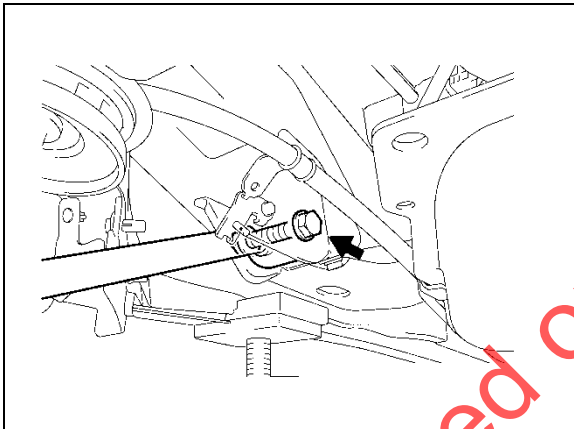
13. TORQUE THE BOLT AND THE REAR STRUT ROD ASSEMBLY.

Torque: 59 ft lbf (80 N m)

- Since a lock nut is used, tighten the bolt.
- The final torque must be applied under standard vehicle height conditions.

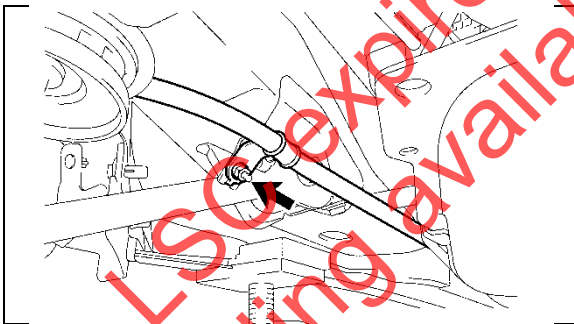
14. REINSTALL THE NO. 3 PARKING BRAKE CABLE ASSEMBLY WITH THE NUT.

Torque: 53 in lbf (6.0 N m)

STOP DO NOT twist the No. 3 parking brake cable assembly when installing it.

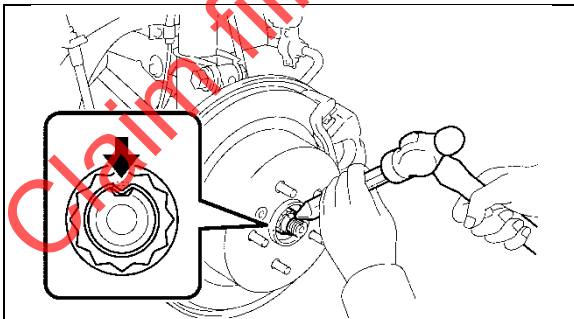
15. TORQUE THE NEW AXLE SHAFT NUT.

Torque: 216 ft lbf (294 N m)

a) Using a chisel and a hammer, stake the rear axle shaft nut.

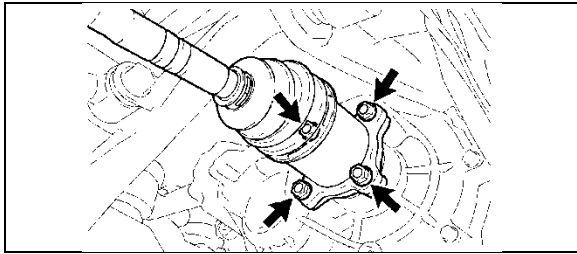
16. TORQUE THE NEW REAR DRIVESHAFT ASSEMBLY WITH THE 4 NUTS AND 4 WASHERS.

Torque: 41 ft lbf (56 N m)

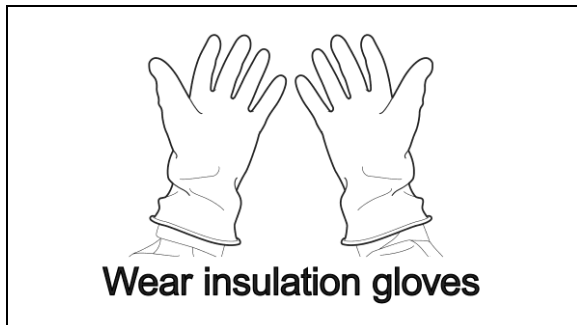
3. USE INSULATED TOOLS OR INSULATE TOOLS

- a) To prevent shock and short circuits use insulated tools. If insulated tools are not available insulate the tools being used with tape.

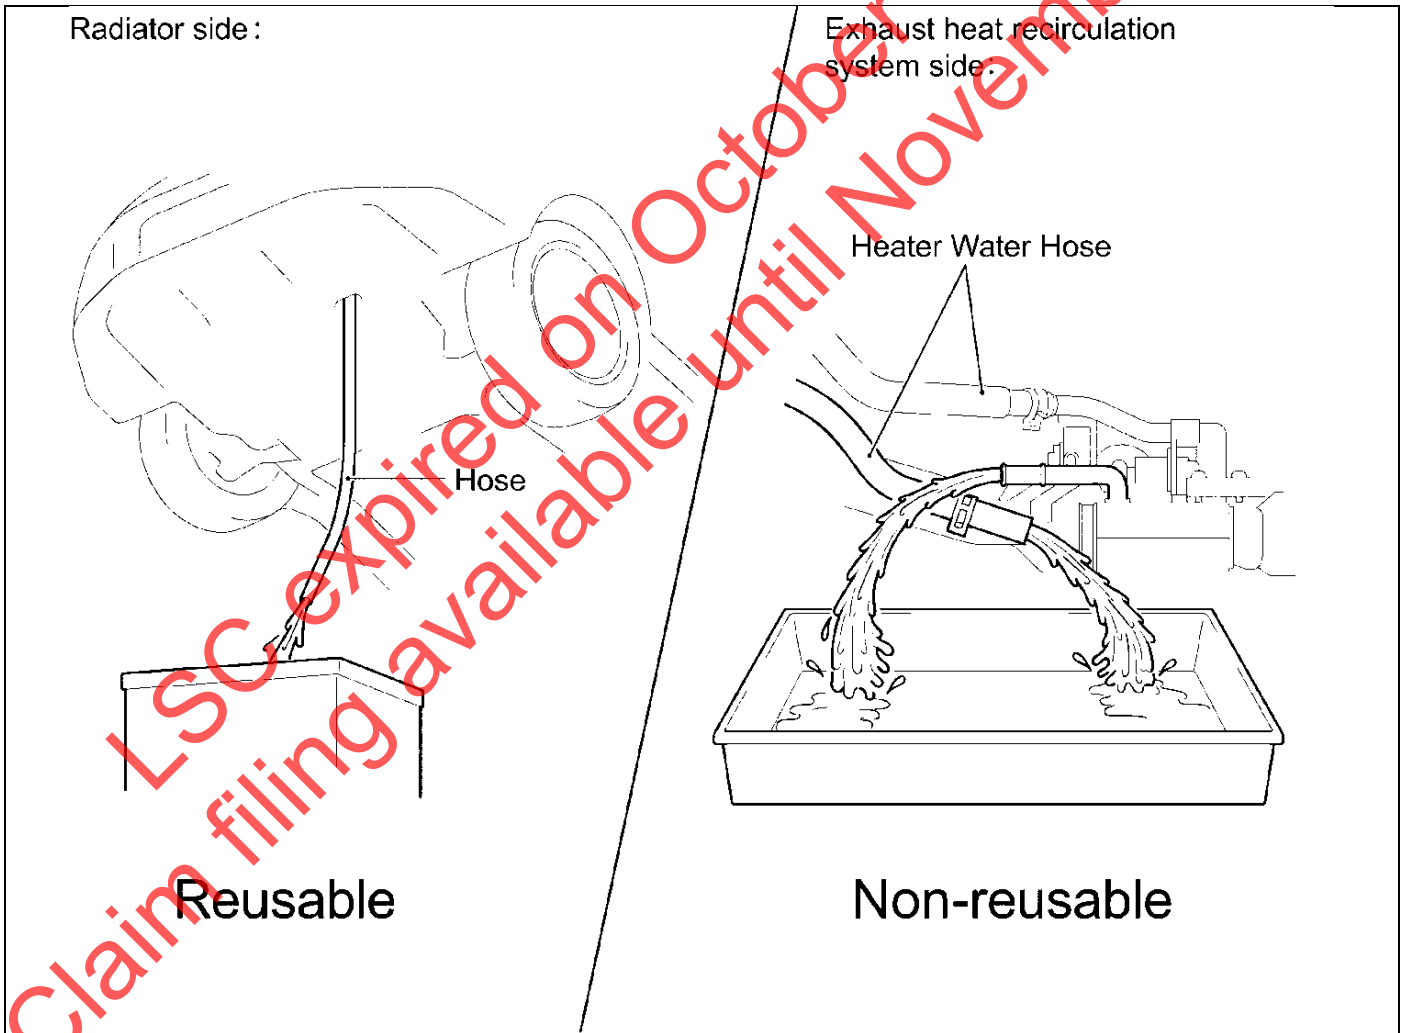
- Confirm the coolant is not hot before beginning any work.
- The coolant drained from the radiator must be reused, confirm that a clean container is used when draining the coolant.
- DO NOT reuse any coolant that is drained when disconnecting the coolant hoses by the exhaust gas control actuator, this coolant may be contaminated when drained.
- DO NOT mix the coolant drained from the radiator with the coolant drained from the hoses.

- a) Remove the rear differential motor assembly and rear driveshaft assembly.
[Refer to TIS for instructions on rear differential motor assembly removal.](#)
