Technical Service Bulletin

94 Ambient light in outer door handle does not work and/or water ingress into light housing

94 18 97 2050363/1 February 14, 2018.

Model(s)	Year	VIN Range	Vehicle-Specific Equipment
A4, A5, and Q5	2017 - 2018	All	Not Applicable

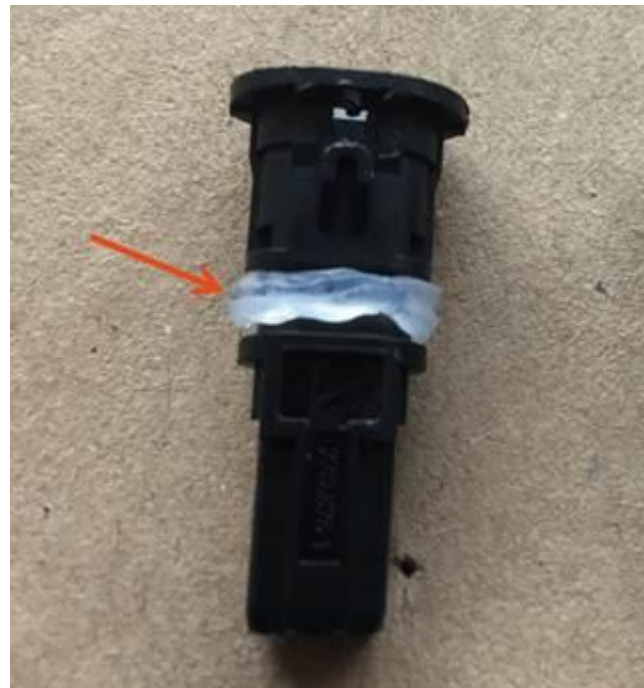
There is a damaged seal (Figure 1) in the wiring harness connector for surround lighting in the outer door handle. Water seeps into the light in the outer door handle through the connector. This leads to the failure of the ambient light.

Figure 1. Damaged seal in wiring harness connector.

1. Check the wiring harness connector for the ambient light in the outer door handle for correct fit and its wiring for other irregularities.
2. If the wiring harness connector and its wiring for the ambient light in the outer door handle are damaged or have the white seal, the faulty ambient light in the outer door handle can be replaced (Figure 2).

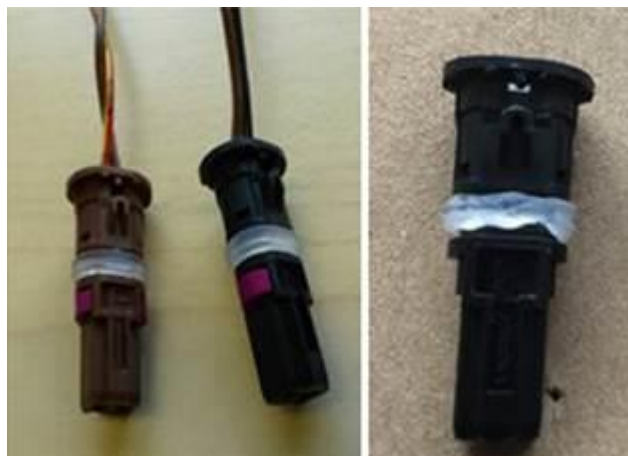
Figure 2. Damaged or white seal connector.

Start by inspecting one door handle light. If it is the old part, then replace all four (unless the A5 Cabriolet which would only replace two).

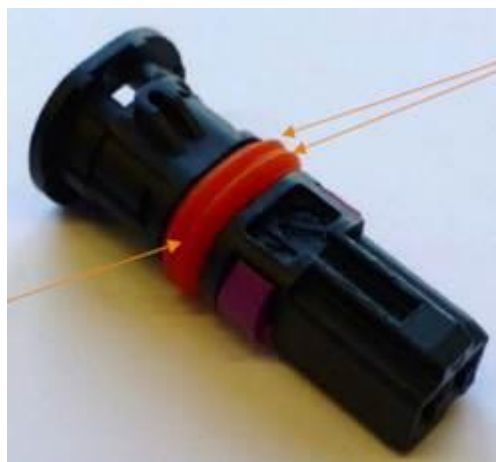
3. If the wiring harness has an orange seal, this is the updated connector (Figure 3) and will not need to be replaced.

Figure 3. Updated connector.
