Emissions Recall

Code: 23V4

Subject	3.0L TDI Engine – Emissions System Modification
Release Date	February 08, 2018
Affected Vehicles	U.S.A.: 2014-2016 MY Audi Q5, A6, A7 A8/A8L 3.0L TDI Generation 2 PC <i>Check Campaigns/Actions screen in Elsa on the day of repair to verify that a VIN qualifies for repair under this action. Elsa is the <u>only</u> valid campaign inquiry & verification source.</i> <ul style="list-style-type: none">✓ Campaign status must show “open.”✓ If Elsa shows other open action(s), inform your customer so that the work can also be completed at the same time the vehicle is in the workshop for this campaign.
Problem Description	3.0 TDI vehicles were equipped with undisclosed Auxiliary Emission Control Devices which are not permitted by emissions regulations.
Corrective Action	Install updated engine control module (ECM) software, transmission control module (TCM) software and hardware to bring affected vehicles into regulatory compliance.

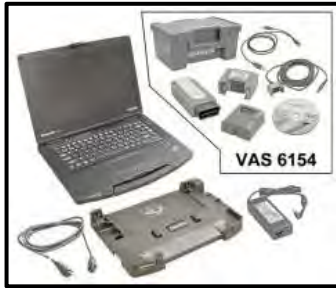
VAS6150D - Diagnostic Tester (or equivalent)
 VAS6154 - Vehicle Communication Interface (or equivalent)

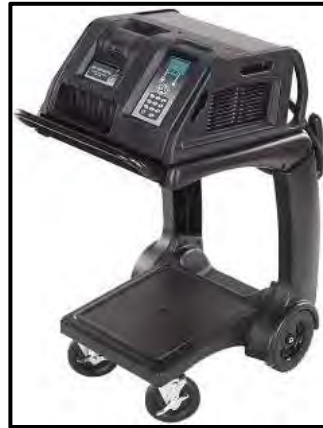
GRX3000VAS – Battery Tester/Charger (or equivalent)

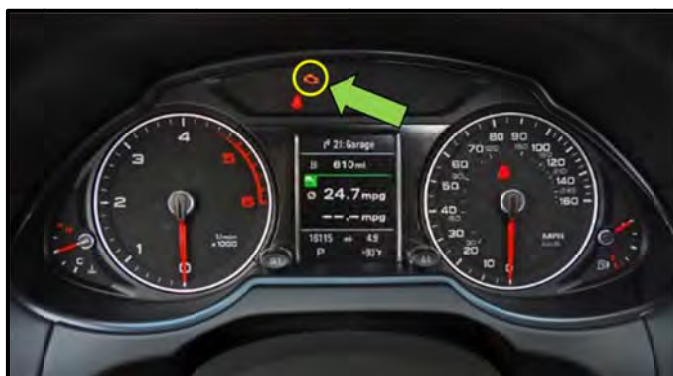
- If vehicle modifications from original equipment related to emissions components are not found, continue the work procedure.
- Check for illumination of the MIL <arrow>.

- If MIL is illuminated, **STOP**, create an ATA ticket and contact the Audi Technicians Helpline.
 - If MIL is not illuminated, continue the work procedure.

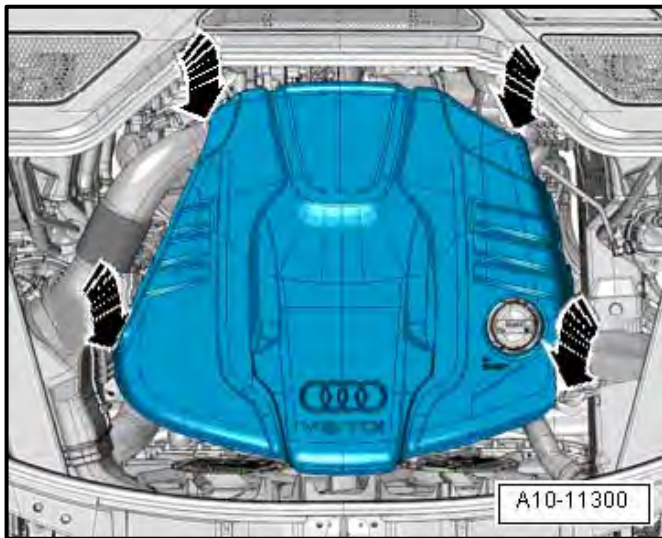
All Vehicles

- In order to prevent causing damage, do not hit the engine cover with your fist or tool.
- Be sure not to place the engine cover on the oil filler tube.
- If removed, press on the engine cover with both hands first on the pins in the rear, and then with both hands on the pins in the front.
- Fill AdBlue tank to maximum fill line. Refer to the **Parts Required** chart at the beginning of this procedure for maximum fill quantities.

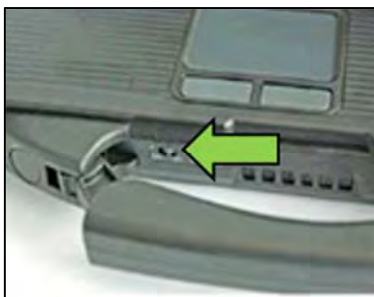
VAS 6150 & VAS 6150A
(Front panel behind handle)

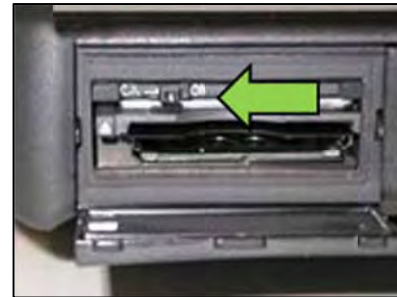
VAS 6150C
(Left side behind SC/EX door)

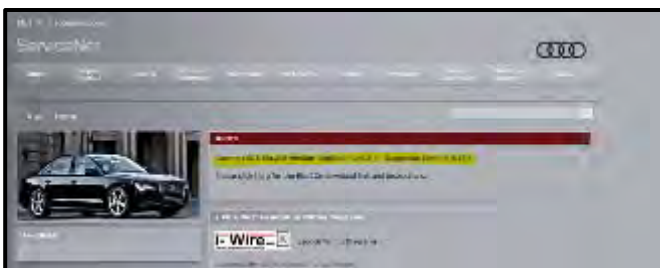
- At this time, refer to the "Alerts" section of ServiceNet <arrow> to verify that the most recent version of ODIS Software is loaded to the VAS6150X Diagnostic Tester (or equivalent). Failure to flash the vehicle using the most recent version of ODIS Diagnostic Software will cause faults in certain features of the flash operation.
- Failure to validate the ODIS Diagnostic version before flashing the vehicle may result in flash failure, and may delay if not negate the payment of the emissions modification.

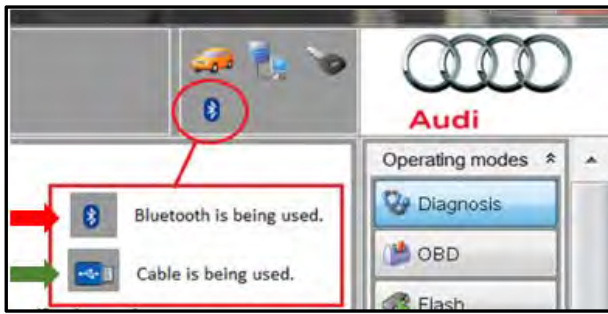
- Confirm that scan tool is communicating with the diagnostic head by USB <Green Arrow>.
 - If the Bluetooth symbol is shown <Red Arrow> then disconnect the diagnostic head from the vehicle and reconnect the USB cable to the diagnostic head and then reattach to the vehicle.

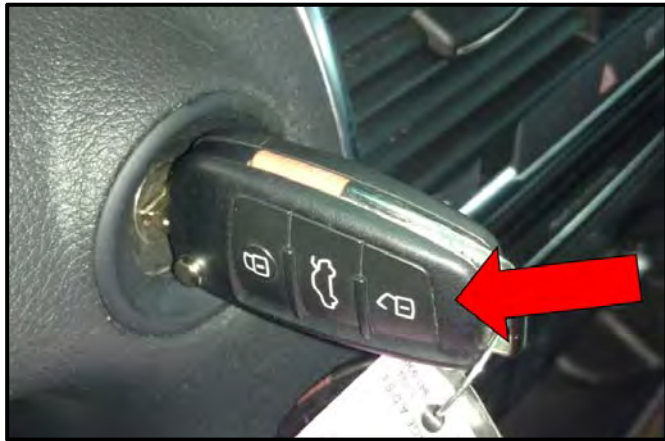
It is **REQUIRED** to insert the key into the reader coil <arrow>, or place the key in the closest proximity possible to the reader coil throughout the flash process.
