Emissions Recall Code: 23V5

3.0L TDI Engine – Emissions System Modification – Customer Only (Retail Sold) TDI Vehicles USA ONLY

U.S.A.: 2013-2015 MY Audi Q7 3.0L TDI Generation 2.1

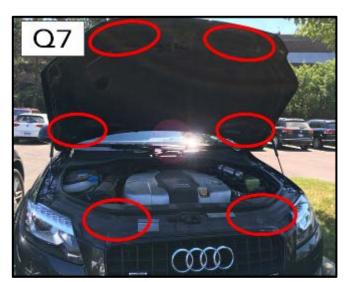
Install TDI Recall Proof of Completion label

- The surface where the label is to be installed must be clean, dry, and free from oil residue prior to installing the label.
- Label must NOT cover any existing label(s).
- Photo documentation of label installed is required.
- Clean the surface next to the Vehicle Emission Control Information Label where the TDI Recall Proof of Completion label is to be installed.
- Fill out completely the Recall Code, Dealer Code, and Repair Date.
- Affix the TDI Recall Proof of Completion label and verify that the correct part number is being installed according to chart below onto the underside of the hood or onto the core support. The TDI Recall Proof of Completion label and Supplemental Vehicle Emissions Control Information (VECI) label should be placed next to each other so that a single photograph can capture both labels.
