Subject: IMPORTANT UPDATE -- 3.0L AEM Touareg TDI

Important Reminder #1:

Important Reminder #2:

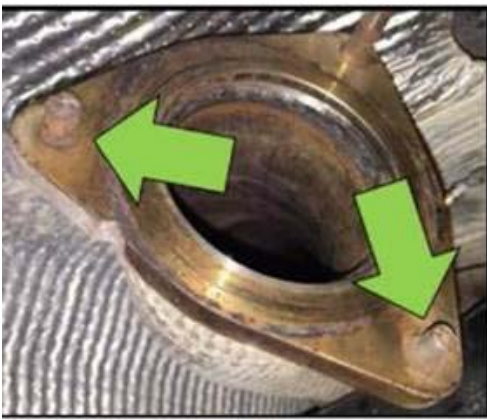
NOTE
 Due to corrosion, one or more of the mounting studs may break <arrows> when removing the SCR catalytic converter from the Diesel Particulate Filter (DPF) flange. Follow the steps below if one or more studs are broken or damaged.

If you have reviewed the 3.0L repair instructions you know that special care must be taken if you have a broken stud at the DPF or SCR Cat flange. **DO NOT USE a hammer, punch, torch, air chisel, air hammer, or any tool other than the recommended press tool in this area of the exhaust system. It is highly likely that the EGT sensor will be damaged by heat, impact, and vibration. Also the DEF line can easily be damaged if using a torch in this situation.**

STOP! STOP!

DO NOT use a hammer and punch, heat, air hammer, or other method to remove the studs from the DPF. Consequential damage to the DPF or ancillary components **will NOT be covered** under this action due to damage from heat, impact, or vibration.

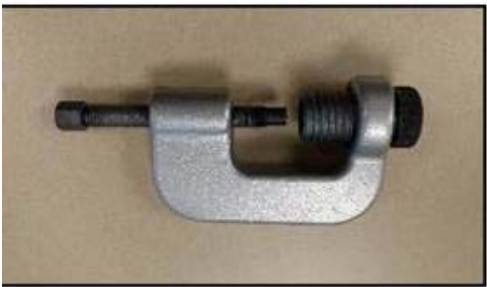
- If stud replacement is necessary, use a commercially available clevis pin press, such as an OTC 5057 (shown) or equivalent to press any broken or damaged studs out of the DPF flange.
 - It is advised if one stud breaks that all three studs are pressed out and replaced with the bolts/nuts included in the parts kit.
- Install the replacement bolts and corresponding nuts into the rear DPF flange.

Part Number	Description	Quantity
N 01024713	Replacement Exhaust Bolt	3
N 91130802	Shouldered Hex Nut	3
