S-SB-0012-14

April 29, 2014

# HVAC Evaporator Drain Hose Clogged Due to Insect Intrusion

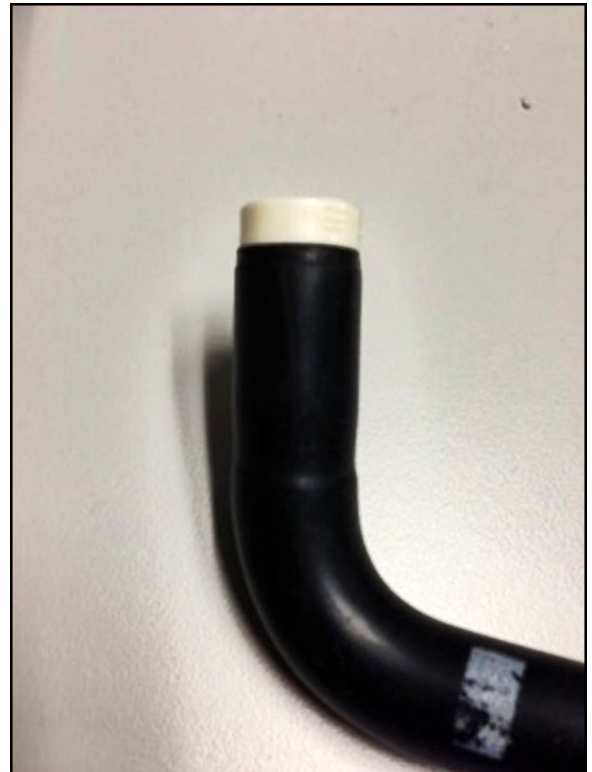
Some vehicles in particular geographic areas may exhibit a condition where the HVAC Evaporator Drain Hose has become obstructed with an insect nest. An insect repellent drain hose tip (ARINIX<sup>®</sup> Tip) is now available to help minimize future occurrences of this environmental condition. For some models, a new drain hose is required to properly fit the ARINIX<sup>®</sup> Tip. Follow the procedures in this bulletin for proper handling and installation of this optional service part.

1. Follow the instructions provided in the Safety Requirements for Handling the ARINIX® Tip (Connector, Water Hose) section of this bulletin.
2. Locate the HVAC Evaporator Drain Hose.
3. Following the vehicle specific Repair Manual, remove the HVAC Evaporator Drain Hose.
4. Put on all necessary PPE and install the ARINIX® Tip (Connector, Water Hose) into the NEW HVAC Evaporator Drain Hose listed in the Parts Information section of this bulletin.
5. When installing the ARINIX® Tip, verify it is fully seated in the HVAC Evaporator Drain Hose as shown in Figure 1.
6. Following the vehicle specific Repair Manual, install the HVAC Evaporator Drain Hose.

1. Follow the instructions provided in the Safety Requirements for Handling the ARINIX® Tip (Connector, Water Hose) section of this bulletin.
2. Locate the HVAC Evaporator Drain Hose.
3. Following the vehicle specific Repair Manual, remove the HVAC Evaporator Drain Hose.
4. Put on all necessary PPE and install the ARINIX® Tip into the original HVAC Evaporator Drain Hose listed in the Parts Information section of this bulletin.
5. When installing the ARINIX® Tip, verify it is fully seated in the HVAC Evaporator Drain Hose as shown in Figure 1.
6. Following the vehicle specific Repair Manual, install the HVAC Evaporator Drain Hose.
