GX460 Front Seatback Cover Service

2010-2014 GX460

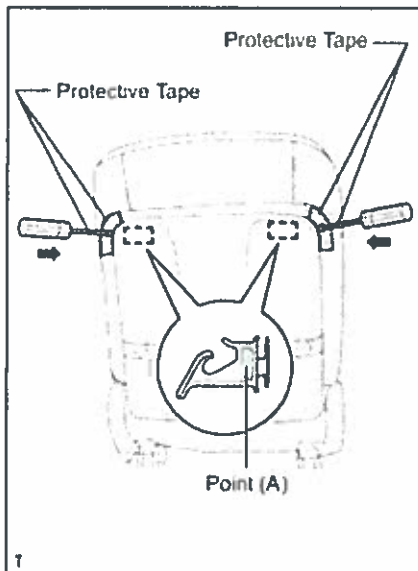
Use a screwdriver to apply force to clips at point A one side at a time.

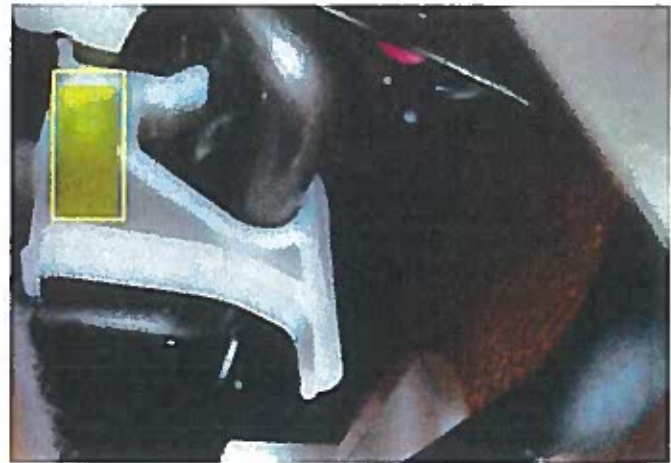
Point A from the RM highlighted

Driver Side Seatback cover with the clip engaged. View is from the center of the vehicle looking towards the door.

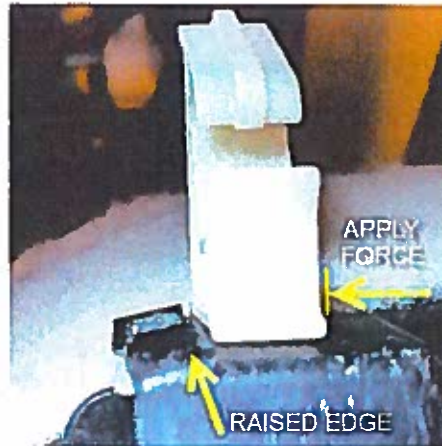
1. Apply force at point A towards the center of the seatback cover to dismount the clip.
2. The clip must overcome the raised edge on the seatback cover that is used keep the clip in place.

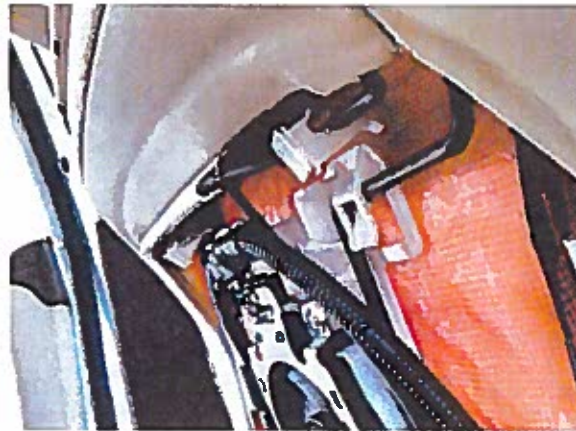
View of the clip once it has been
successfully detached from the seatback cover

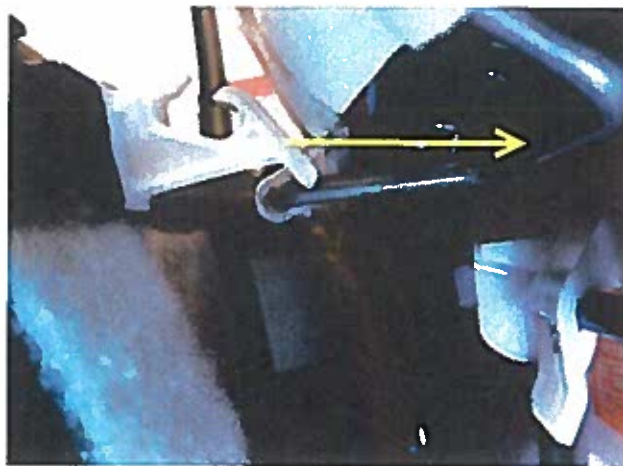
There is potential for the clip to become damaged during the installation of the seatback cover

Use caution when reinstalling the seat back cover to ensure that the clip is not damaged.
