# Windshield Dam Is Loose/Visible

YEAR(S)	MODEL(S)	ADDITIONAL INFORMATION
2010 – 2013	Tundra	Plant Code(s): X WMI(s): 5TF

Some 2010 – 2013 model year Tundra vehicles may exhibit a condition where a deformed windshield dam, or some weatherstrip may be loose between the A-pillar garnish and windshield glass. Normally, the windshield dam is not visible and is only necessary for production. Over time, the dam adhesive may lose adhesion and deform. There is no functional concern with the windshield sealing and there is no need to replace or reseal the windshield if there are no complaints of water/air leaks. Please follow the process below to remove the exposed portion of the windshield dam.

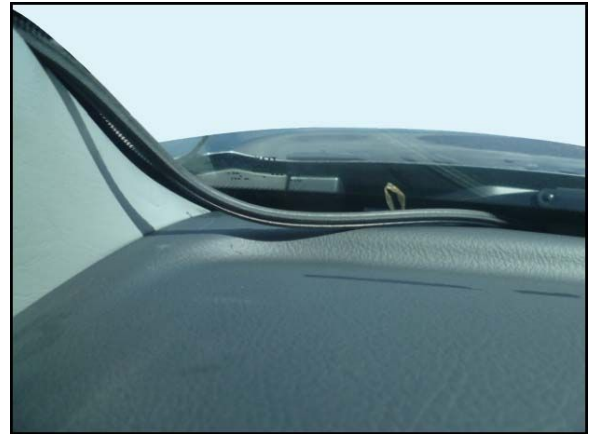
Figure 1.

1. Confirm that the windshield dam is loose.

**NOTE**  
The condition may present itself on either lower corner of the windshield.
