Back Door Garnish Loose or Broken

Service Category Vehicle Exterior

Section Exterior Panels/Trim

| YEAR(S) | MODEL(S) | ADDITIONAL INFORMATION |
|---|---|---|
| 2004 – 2006 | xB | |

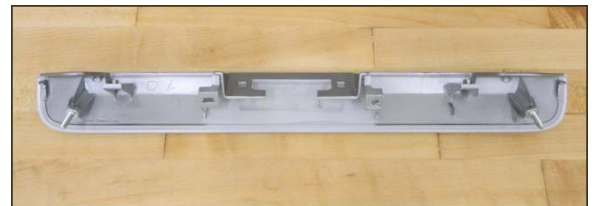
Figure 4.

5. Assemble the NEW back door garnish.
 - A. Lay the NEW back door garnish (P/N 76811-52122-##) down on a clean protected work surface to prevent scratching of the painted surface.

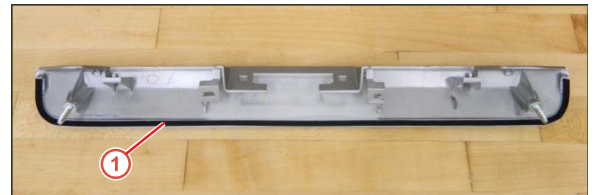
Figure 5.

- B. Remove the protective backing and install the foam strip (P/N 76821-52030, Back Door Garnish Protector) around the outer portion of the garnish as shown.

| 1 | Foam Strip |

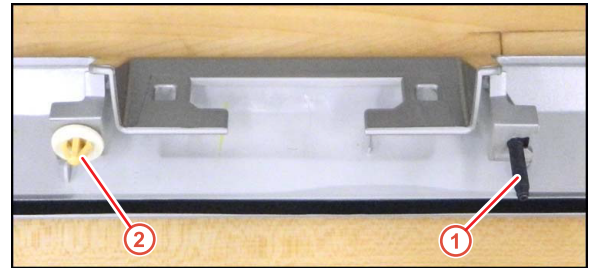
- C. Transfer the mounting stud that was removed in step 4B to the NEW garnish.

| 1 | Mounting Stud |
| 2 | Clip |

- D. Install the new mounting clip (P/N 90467-10077, Clip), as shown in Figure 6.
- E. Install the 3 foam washers (P/N 90562-04007, Ring) onto each of the 3 mounting studs.

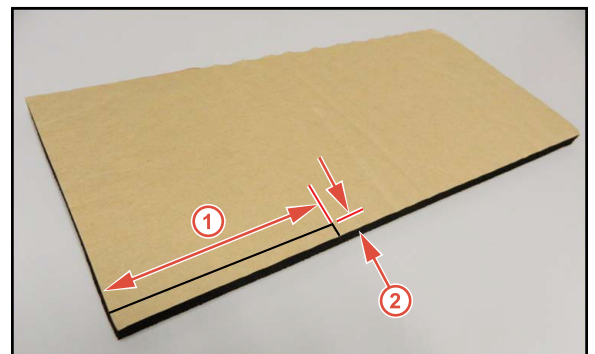
Figure 8.

- F. Once the foam washers have been installed, a strip of foam must be cut and placed on the NEW garnish to isolate the rear lamp wire harness.

Cut a foam strip from the Wind Noise Kit (P/N 08231-00813).

Foam Strip Dimensions: 95 mm x 7 mm
(3.74 in. x 0.28 in.)

Cut foam from sheet as shown to get the most strips from the sheet.

| 1 | 95 mm |
| 2 | 7 mm |

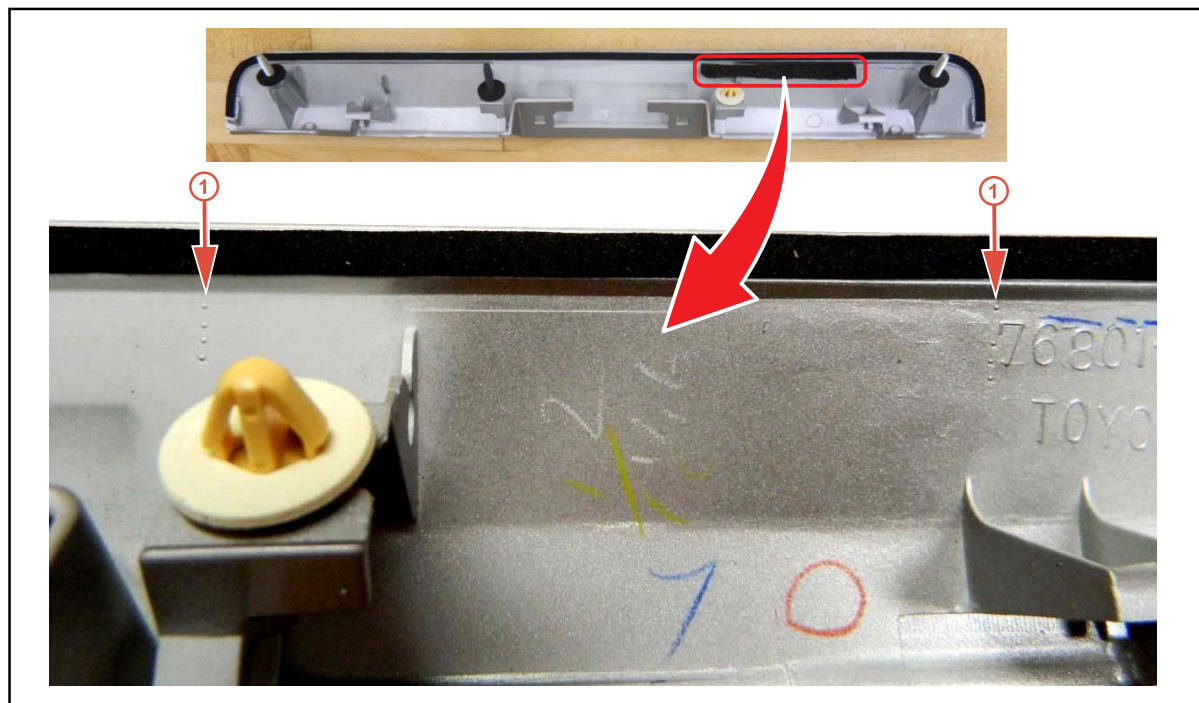
Figure 9.

G. Place foam strip between the dotted alignment marks on the NEW garnish.

| 1 | Dotted Alignment Marks |

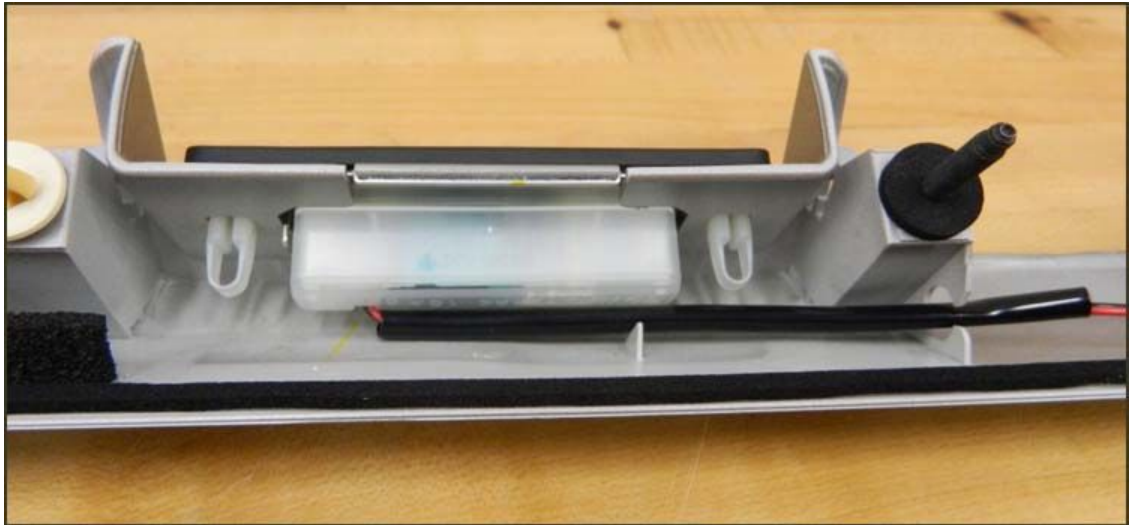
Figure 10.

H. Transfer back door opener switch assembly over to the NEW garnish.

- (1) Install switch, and fasten with the 2 black screws previously removed from the OLD garnish in step 4A.
- (2) Be sure the black wire harness protector is positioned as shown to protect the wires.

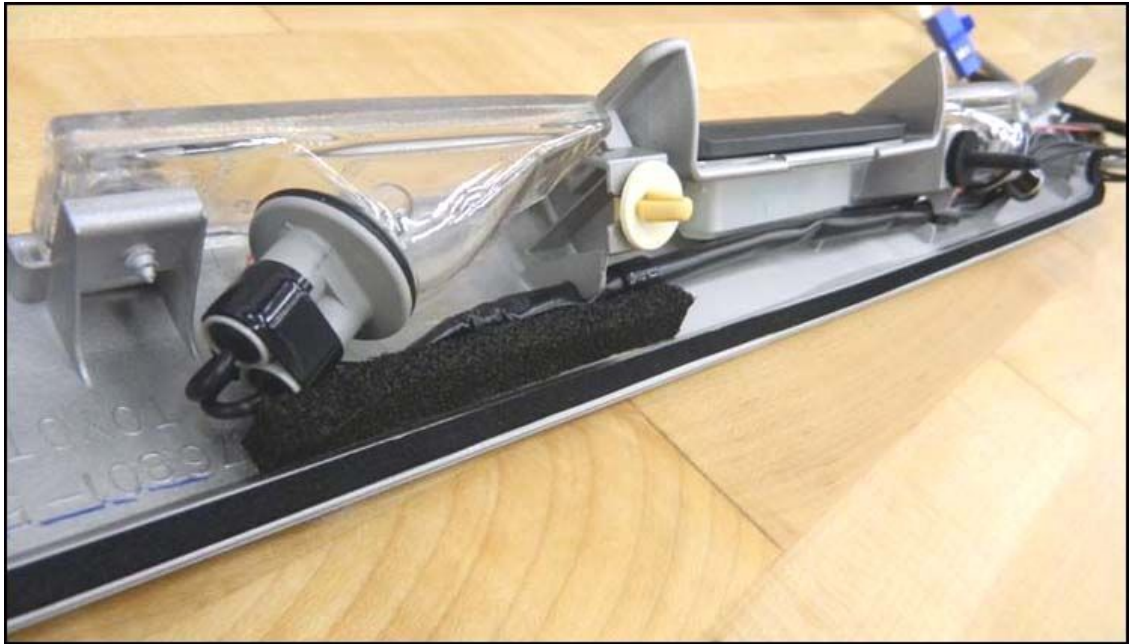
Figure 11.

- I. Transfer the rear lamp set to the NEW garnish. Use the silver screws previously removed from the OLD garnish in step 4A.
 - (1) Route wire harness as shown, and make sure the wire harness is secured behind the previously installed foam strip.

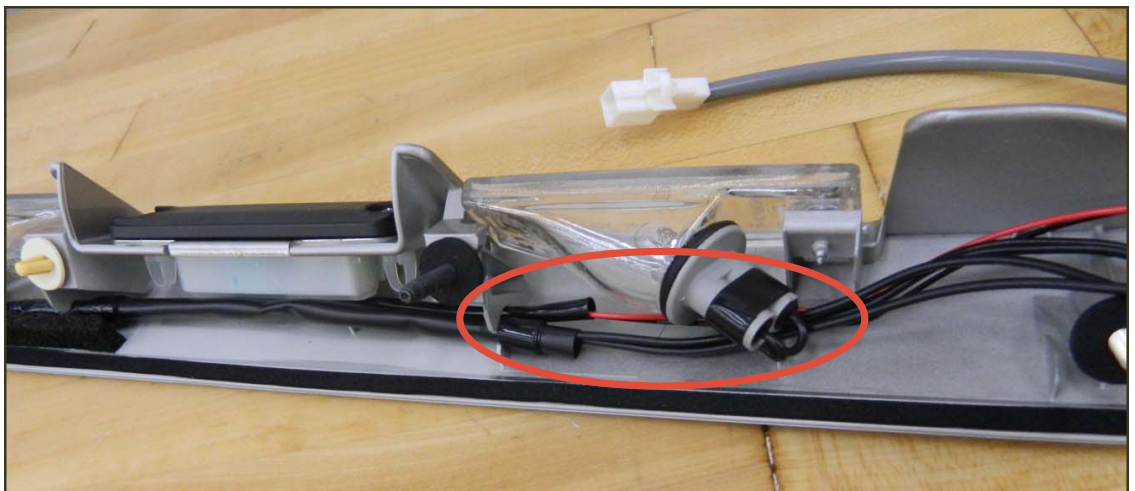
Figure 12.

- (2) Secure the switch wire harness under the rear lamp set wire harness, and route both wire harnesses under the light bulb housing as circled below.
