08711 Version 5

## Product Update: 2016 Pilot 9-Speed Transmission Warmer

Supersedes 17-009, dated August 25, 2017, to revise the information highlighted in **yellow**

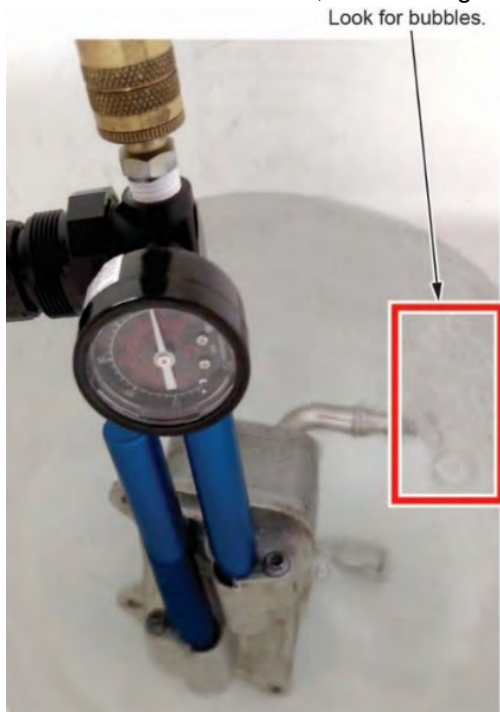
14. Check the transmission warmer for leaks by submerging the warmer completely under the water and watching for bubbles.

NOTE: Some bubbles are normal when the transmission warmer is first submerged and will come to a stop. If there is a leak, there will be a steady stream of bubbles coming from the transmission warmer.

- If there are no bubbles coming from the warmer, continue with the warmer replacement. Go to step 15.
- If there are bubbles, take photos (see Photos) and check to see if the vehicle also overheated by checking the customer responses on the RO.
  - If the transmission warmer leaks, but the engine **did not overheat**, go to [REPAIR PROCEDURE B](#).
  - If the transmission warmer leaks, and the engine **overheated**, go to [REPAIR PROCEDURE C](#).

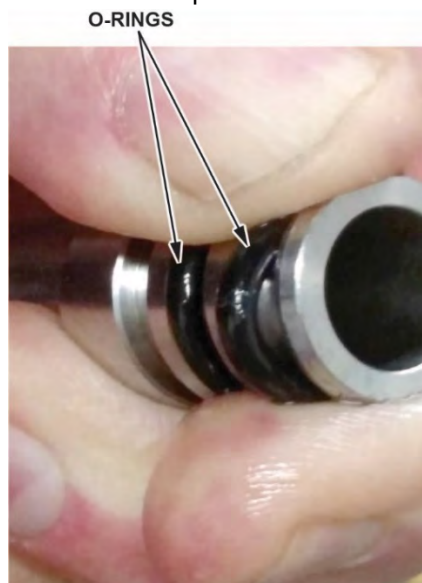
15. Remove the two ATF lines from the transmission warmer, then remove the 4 O-rings on the pipes by gently pushing the O-rings off with your fingers.

- Do not use picks or screwdrivers to remove the O-rings as you may damage the sealing surface.

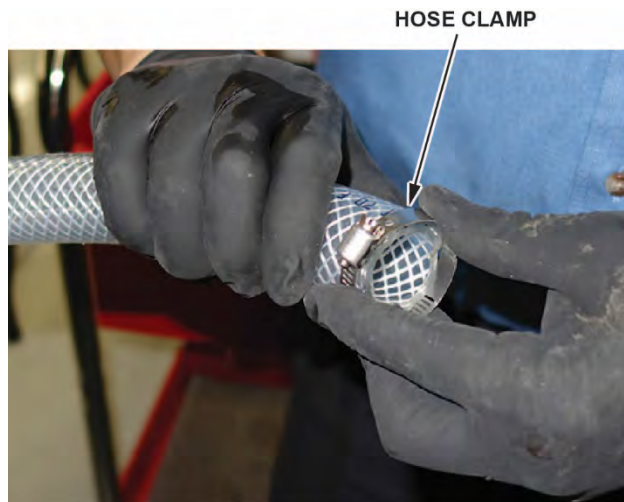
14. Install the return hose to the water passage as shown, then fill the bucket with 4.5 gallons of fresh water, and install the lid.

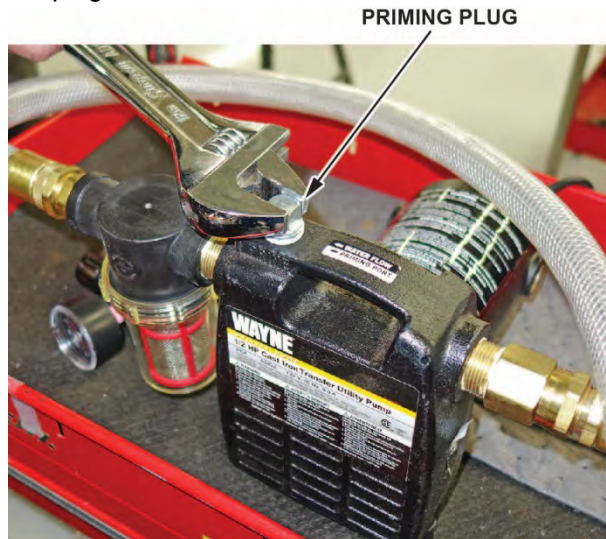
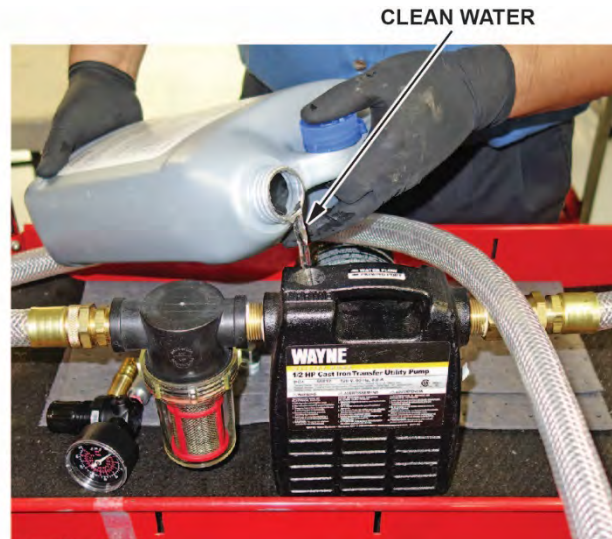
NOTE: If this is the first time using the pump, remove the priming plug, fill the pump with clean water, then reinstall the plug.

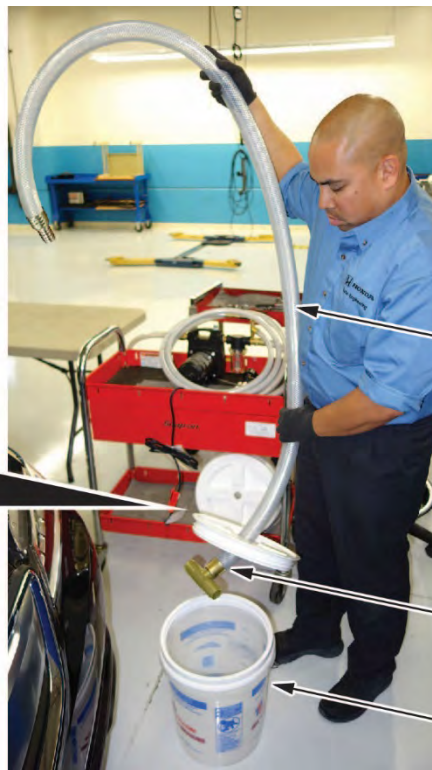
23. Install the heater core return hose through the DUMP bucket lid.

HEATER CORE RETURN HOSE

T-FITTING
