April 7, 2018

08699 Version 6

## Product Update: TLX 9-Speed Transmission Warmer

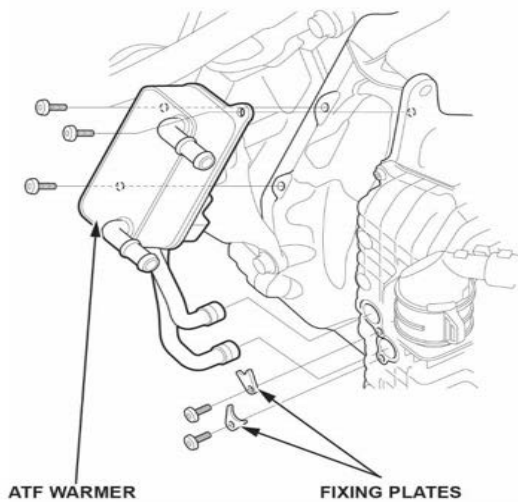
11. Remove the 3 hold down bolts and 2 fixing plate bolts to remove the transmission warmer. Place the warmer on a clean surface.

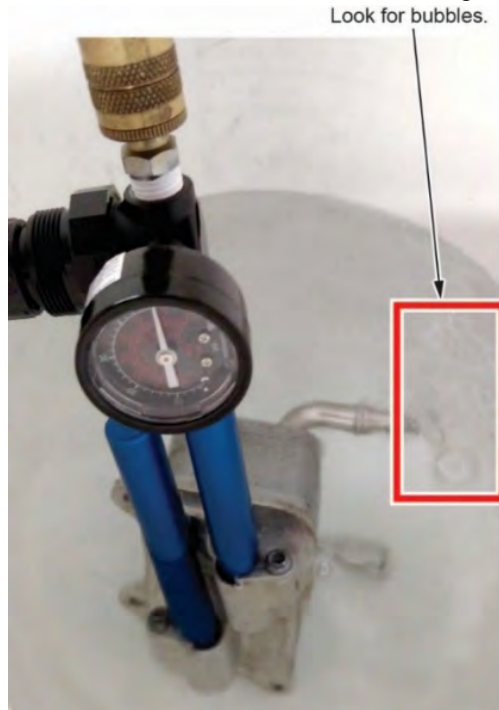
13. Check the transmission warmer for leaks by submerging the warmer completely under the water and watching for bubbles.

NOTE: Some bubbles are normal when the transmission warmer is first submerged and will come to a stop. If there is a leak, there will be a steady stream of bubbles coming from the transmission warmer.

- If there are no bubbles coming from the warmer, continue with the warmer replacement. Go to step 14.
- If there are bubbles, take photos (see Photos) and check to see if the vehicle also overheated by checking the customer responses on the RO.
  - If the transmission warmer leaks, but the engine **did not overheat**, go to [REPAIR PROCEDURE B](#).
  - If the transmission warmer leaks, and the engine **overheated**, go to [REPAIR PROCEDURE C](#).

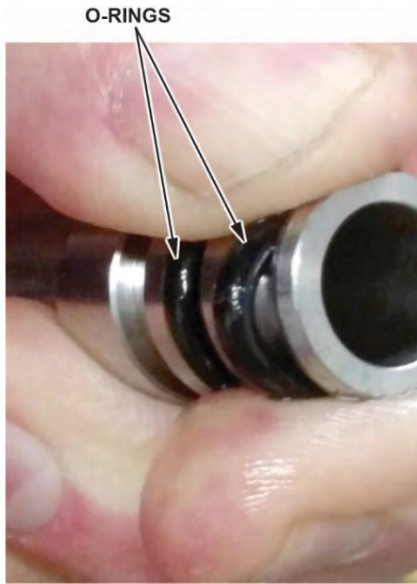
14. Remove the two ATF lines from the transmission warmer, then remove the 8 O-rings on the pipes by gently pushing the O-rings off with your fingers.

- Do not use picks or screwdrivers to remove the O-rings as you may damage the sealing surface.

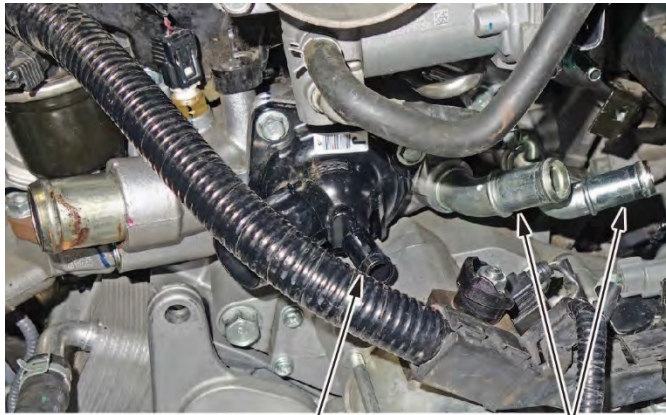
9. Using the three colored plugs from the flush kit, cap off both heater hoses and the ATF transmission warmer line as shown.

ATF TRANSMISSION  
WARMER LINE

HEATER HOSES

YELLOW PLUG  
(ATF WARMER LINE)

RED PLUG  
(HEATER  
HOSE)

SILVER PLUG  
(HEATER  
HOSE)

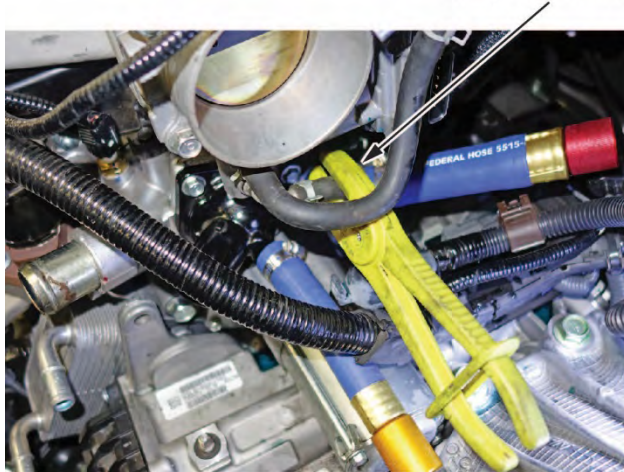
10. Using commercially-available clamps, clamp the throttle body coolant lines as shown.

Clamp both of the throttle body coolant lines.

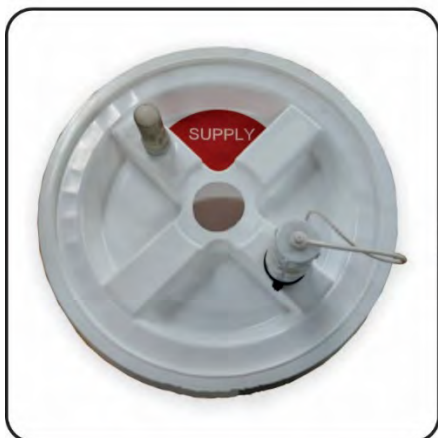
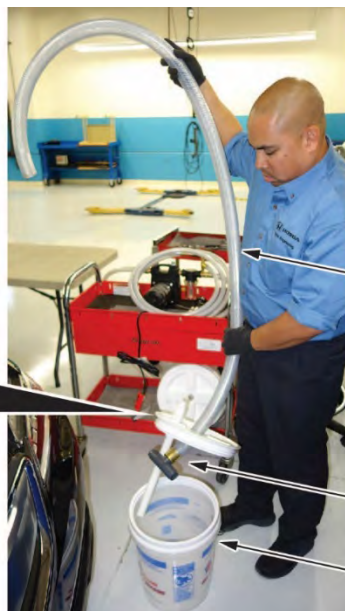
11. Remove the lid from the SUPPLY bucket, and install the large (1.5 in.) return hose with the T-fitting through the hole in the lid as shown.

ENGINE RETURN HOSE

T-FITTING

SUPPLY BUCKET

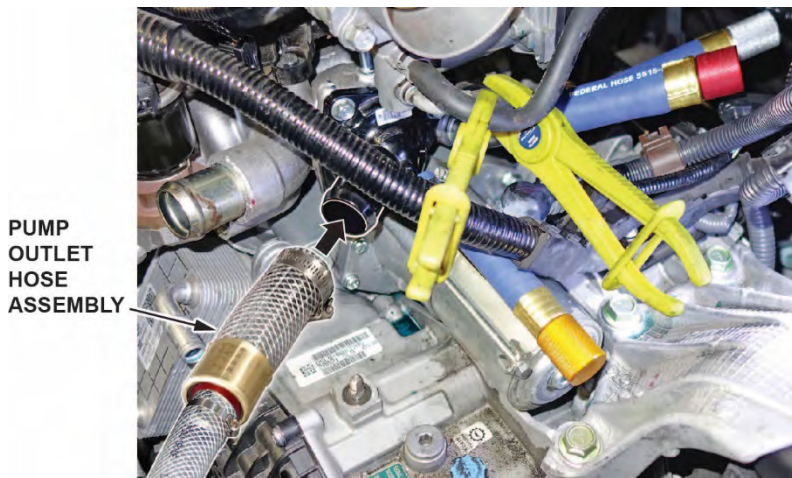
13. Install the pump outlet hose to the thermostat housing.

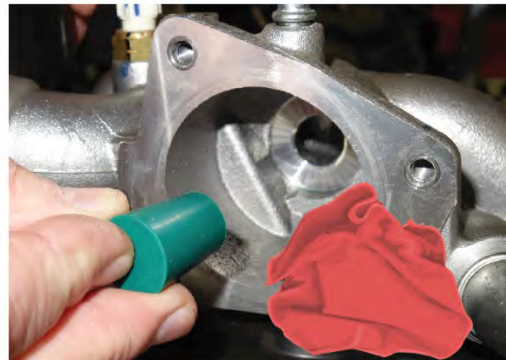
21. Remove the thermostat cover, remove the green rubber plug, and return it to the coolant flush kit. To prevent the plug from falling into the water passage, cover the passage with a shop towel.

**GREEN RUBBER PLUG**      **THERMOSTAT WATER JACKET**  
**SHOP TOWEL**

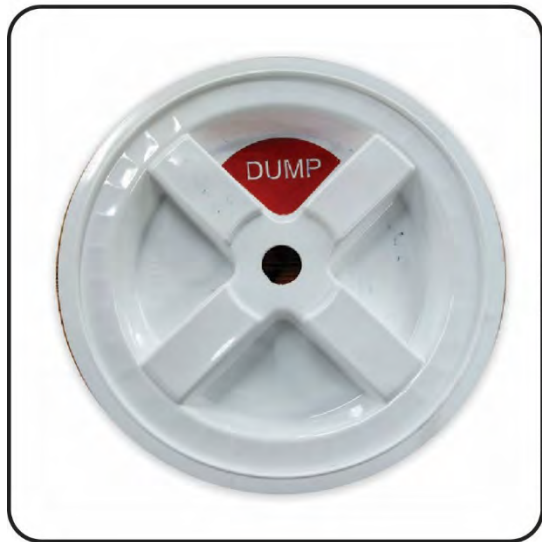
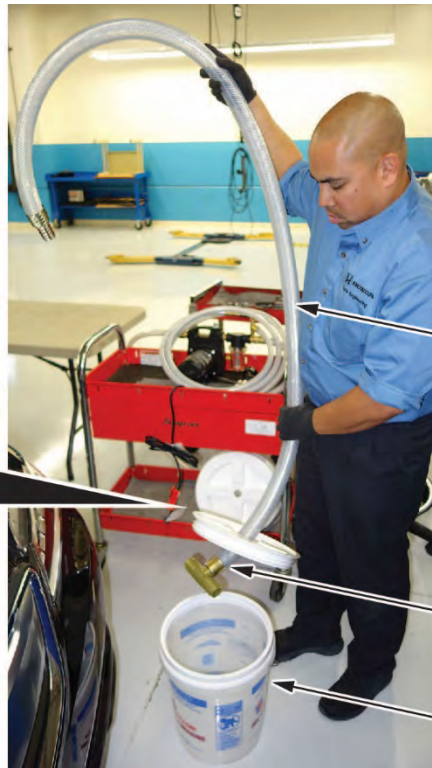
23. Install the heater core return hose through the DUMP bucket lid.

HEATER CORE RETURN HOSE

T-FITTING

DUMP BUCKET

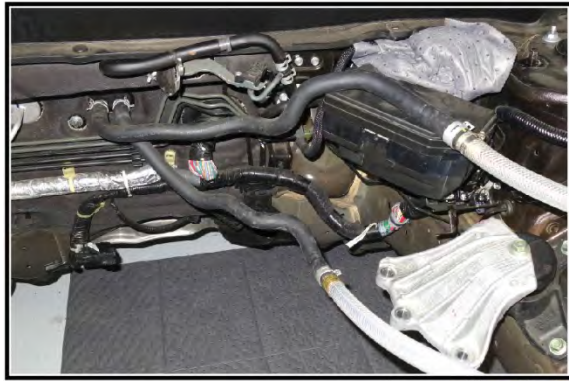
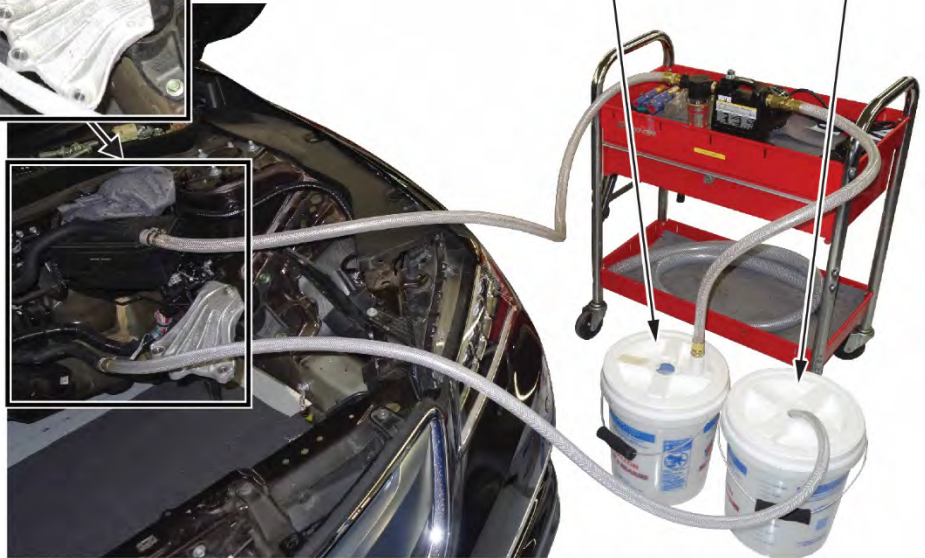
6. Fill the SUPPLY bucket with water, and run the pump until the SUPPLY bucket is empty.

**SUPPLY BUCKET**  
Fill with water and run the pump until bucket is empty.

**DUMP BUCKET**  
Empty into waste coolant container.

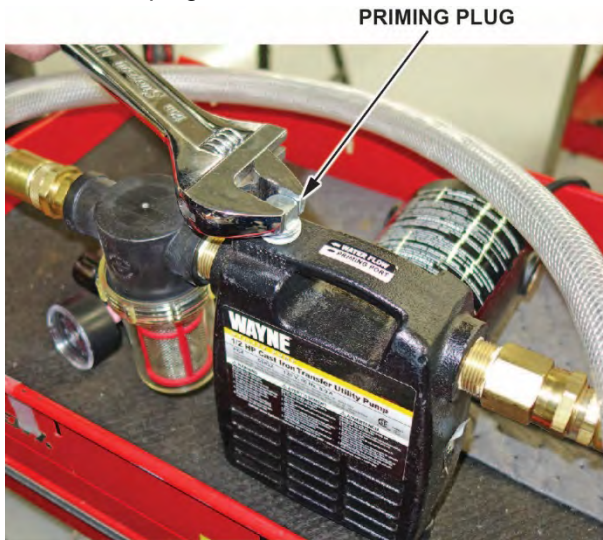
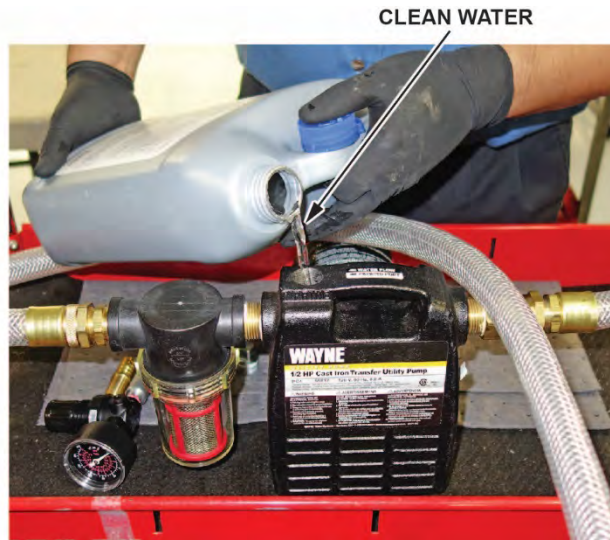
NOTE: If this is the first time using the pump, remove the priming plug, and fill the pump with clean water, then reinstall the plug.

PRIMING PLUG

CLEAN WATER
