Service Bulletin

17-012

Product Update: TLX 9-Speed Transmission Warmer (Transmission Previously Replaced for Transmission Warmer Leaking)

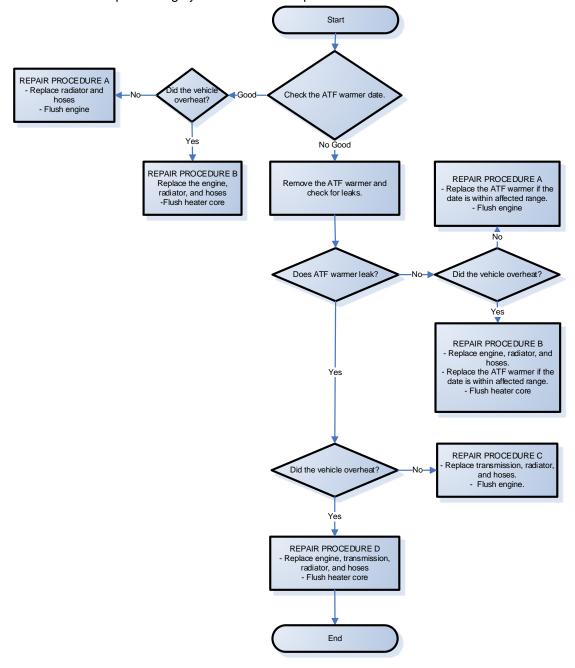
The flowchart below provides a summary to help navigate the inspection and repair procedure. Make sure you read the service bulletin steps thoroughly for the detailed repair information.

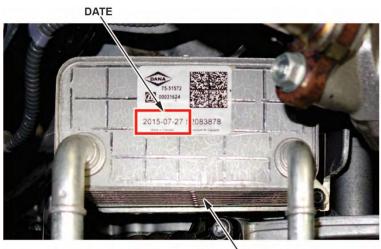
- 1. Inspect the date on the transmission warmer. The affected transmission warmers were built between April 28, 2015 (2015-04-28) and July 15, 2015 (2015-07-15).
 - If the build date is within the date range, go to ATF WARMER INSPECTION.
 - If the build date is before or after the date range, go to step 2.

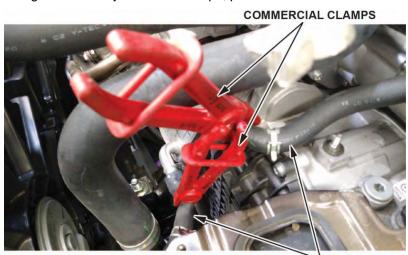
COOLANT HOSES

9. Remove the coolant hoses from the transmission warmer.

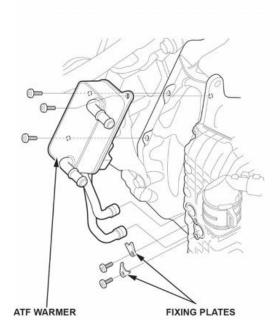
11. Remove the 3 hold down bolts and 2 fixing plate bolts to remove the transmission warmer. Place the warmer on a clean surface.

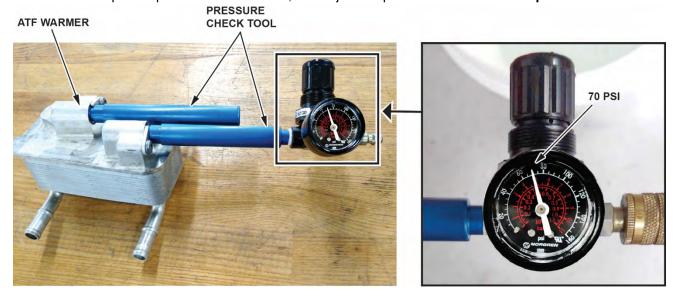
- 12. Prepare the transmission warmer to check for leaks.
 - Remove the original ATF lines from the warmer.
 NOTE: Be careful not to damage the lines as you may reuse them.
 - Install the pressure check tool as shown with the fixing plates, and torque the bolts to 10 N-m (7 lb-ft).
 - Fill a bucket with warm water.
 - Connect shop air to pressurize the warmer, and adjust the pressure check tool to **70 psi**.

13. Check the transmission warmer for leaks by submerging the warmer completely under the water and watching for bubbles.

NOTE: Some bubbles are normal when the transmission warmer is first submerged and will come to a stop. If there is a leak, there will be a steady stream of bubbles coming from the transmission warmer.

- If there are no bubbles coming from the warmer, continue with the warmer replacement. Go to step 14.
- If there are bubbles, take photos (see Photos) and check to see if the vehicle also overheated by checking the customer responses on the RO.
 - If the transmission warmer leaks but the engine did not overheat, go to REPAIR PROCEDURE C.
 - If the transmission warmer leaks and the engine overheated, go to REPAIR PROCEDURE D.

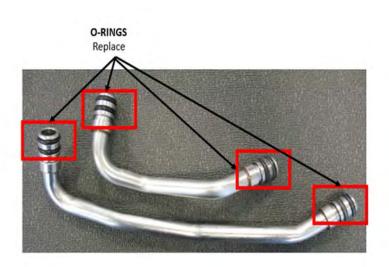
15. Clean the pipes, then install four new O-rings.

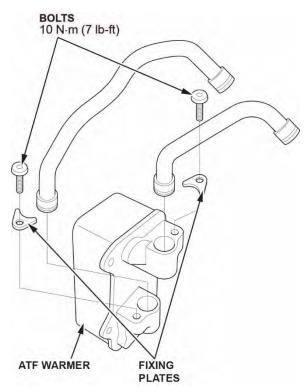
17. Install the original ATF warmer pipes onto the new transmission warmer using the fixing plates. Torque the bolts to 10 N-m (7 lb-ft).

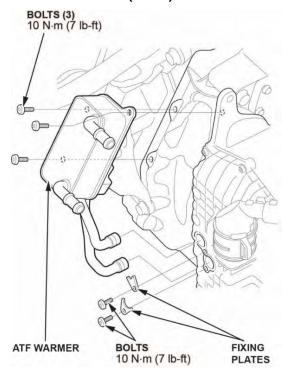
18. Install the new transmission warmer to the transmission. Install the ATF warmer pipes using fixing plates. Torque the bolts to 10 N·m (7 lb-ft).

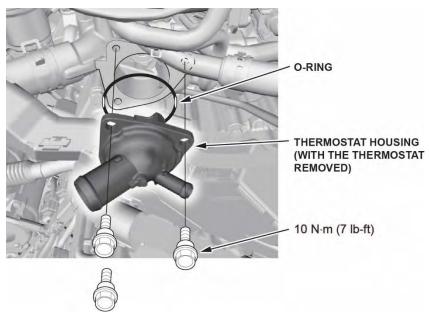
7. Remove the shop towel, and install the thermostat housing without the thermostat.

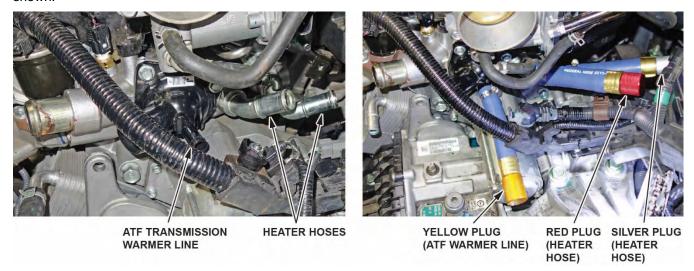
8. Using the three colored plugs from the flush kit, cap off both heater hoses and the ATF transmission warmer line as shown.

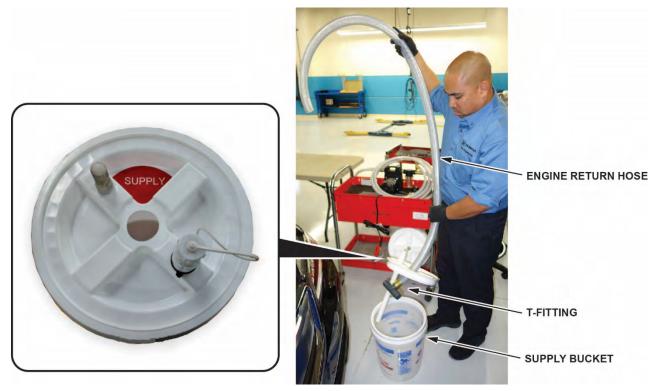
10. Remove the lid from the SUPPLY bucket, and install the large (1.5 in.) return hose with the T-fitting through the hole in the lid as shown.

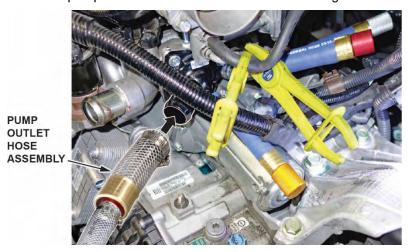
12. Install the pump outlet hose onto the thermostat housing.

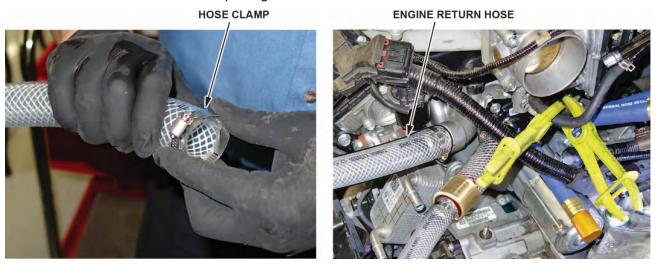
13. Install the return hose onto the water passage as shown.

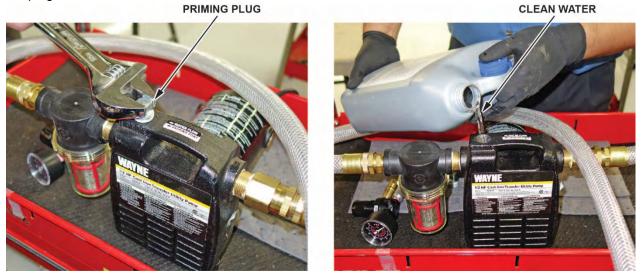
16. Turn on the pump, and let it run for 10 minutes.

NOTE: If this is the first time using the pump, remove the priming plug, fill the pump with clean water, then reinstall the plug.

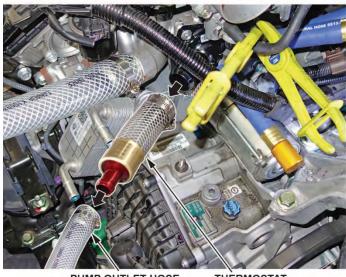
- 19. After 10 minutes, turn the pump off and dump all the contents of the SUPPLY bucket into the waste coolant container. Refill the SUPPLY bucket with coolant, and run the pump for 10 minutes.
- 20. Disconnect the pump outlet line from the engine, and remove the thermostat adaptor. Replace the outlet adaptor with the 0.75 in. heater hose adaptor.

PUMP OUTLET HOSE Disconnect.

THERMOSTAT ADAPTER

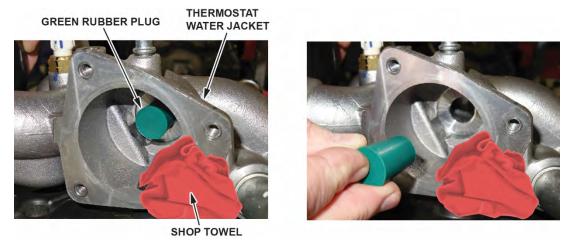
21. Remove the thermostat cover, remove the green rubber plug, and return it to the coolant flush kit. To prevent the plug from falling into the water passage, cover the passage with a shop towel.

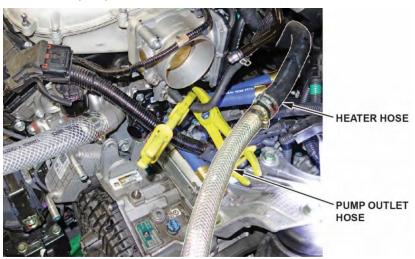
22. Connect the pump outlet hose to the heater hose as shown.

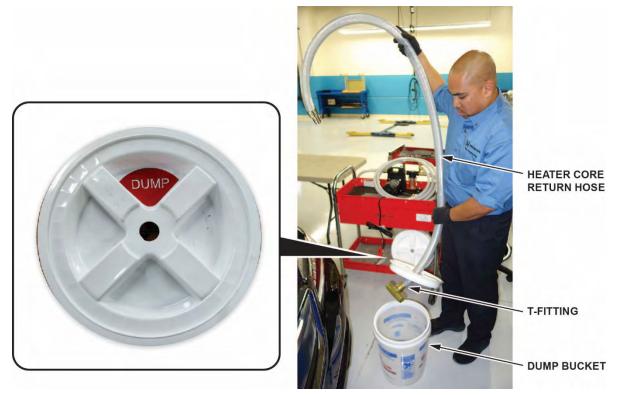
23. Install the heater core return hose through the DUMP bucket lid.

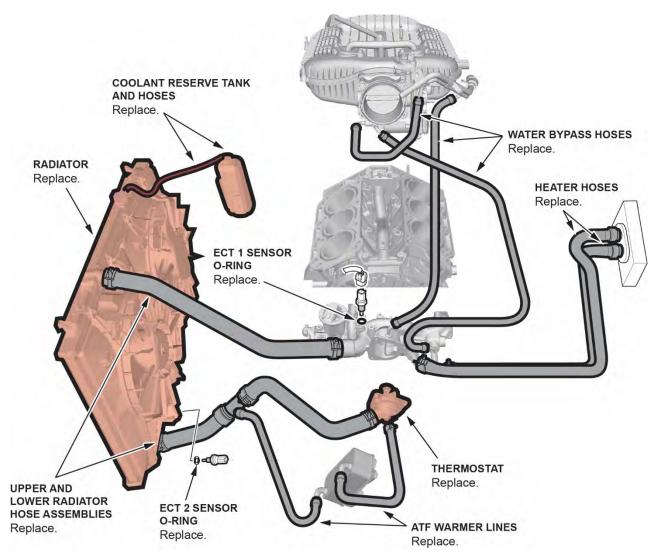
30. Replace the radiator, the 10 indicated coolant hoses, thermostat, coolant reserve tank and hoses, and the 2 ECT sensor (1 and 2) O-rings. Refer to the image for the location of all the components.

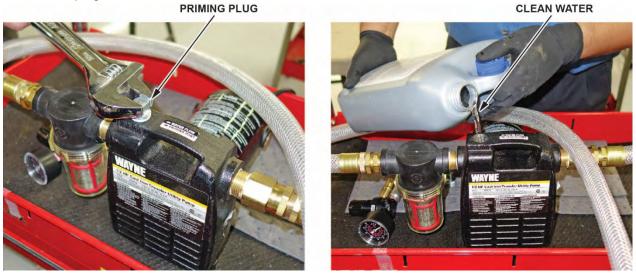
FLUSH 4 TIMES TOTAL.

NOTE: If this is the first time using the pump, remove the priming plug, and fill the pump with clean water, then reinstall the plug.

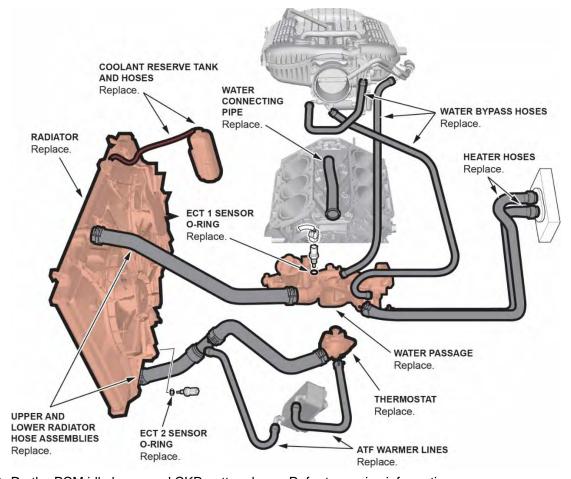
- 11. Install a new short block and new cylinder heads including the water pipe and water passage.
- 12. Replace the radiator, the 10 indicated coolant hoses, the thermostat, the water passage and water connecting pipe, the coolant reserve tank, the 2 ECT sensor (1 and 2) O-Rings, and the coolant reserve tank and hoses. Refer to the image for the location of all the components.

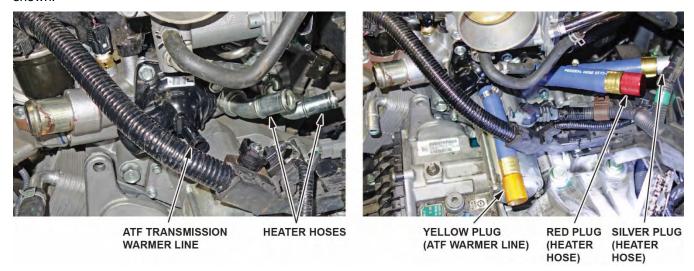
9. Using the three colored plugs from the flush kit, cap off both heater hoses and the ATF transmission warmer line as shown.

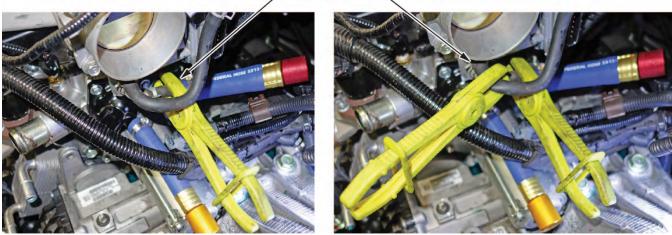
10. Using commercially-available clamps, clamp the throttle body coolant lines as shown.

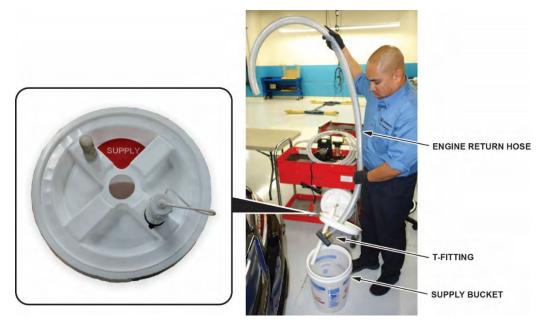
11. From the bucket marked SUPPLY, remove the lid and install the large (1.5 in.) return hose with the T-fitting through the hole in the lid as shown.

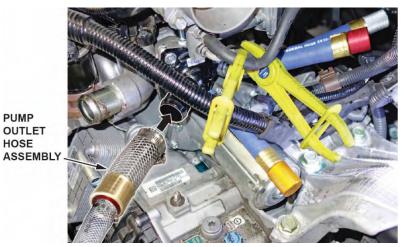
13. Install the pump outlet hose onto the thermostat housing.

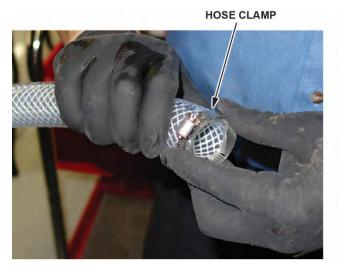
14. Install the return hose onto the water passage as shown, fill the bucket with 4.5 gallons of fresh water, and install the lid.

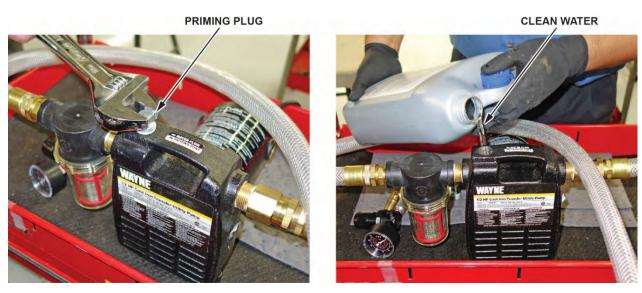
NOTE: If this is the first time using the pump, remove the priming plug, fill the pump with clean water, then reinstall the plug.

- 16. Turn on the pump, and let it run for 10 minutes.
- 17. After 10 minutes, turn the pump off and dump all the contents of the SUPPLY bucket into the waste coolant container. Wipe off any oil residue from the bucket, refill the bucket with water, then repeat the flush 4 more times (50 minutes total time flushing with water).

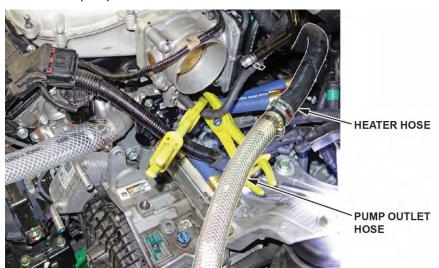
22. Connect the pump outlet hose to the heater hose as shown.

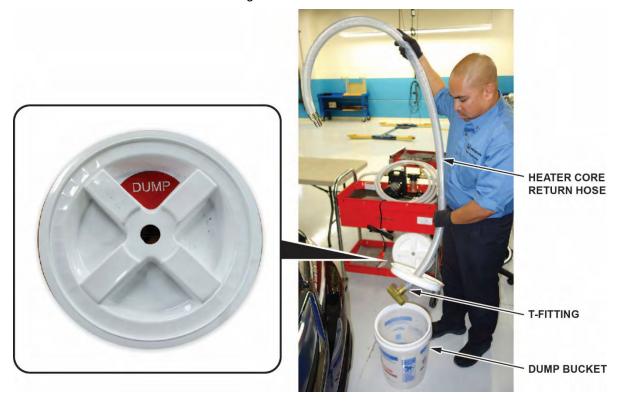
23. Install the heater core return hose through the DUMP bucket lid.

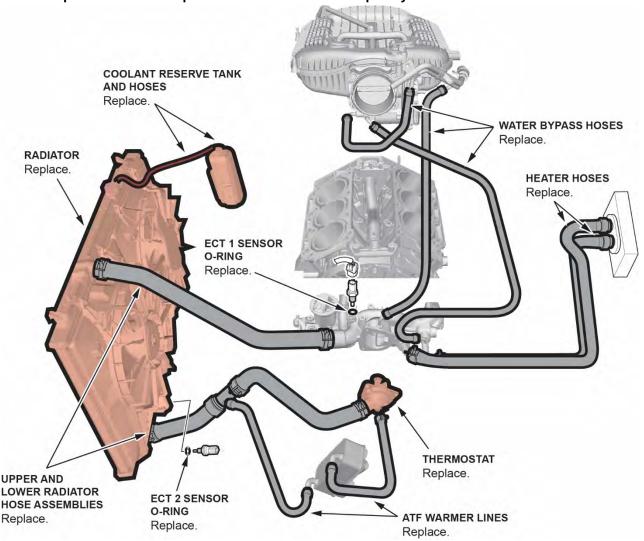
30. Replace the radiator, the 10 indicated coolant hoses, thermostat, coolant reserve and hoses, and the 2 ECT sensor (1 and 2) O-rings. Refer to the image for the location of all the components.
