08691 Version 5

Warranty Extension: TLX Transmission Chirps During 3-4 Shift, Poor Shift Quality, or Engine Overheats Because of Defective ATF Warmer Based on Client Complaint

Supersedes 17-027, dated October 18, 2017 to revise the information highlighted in yellow

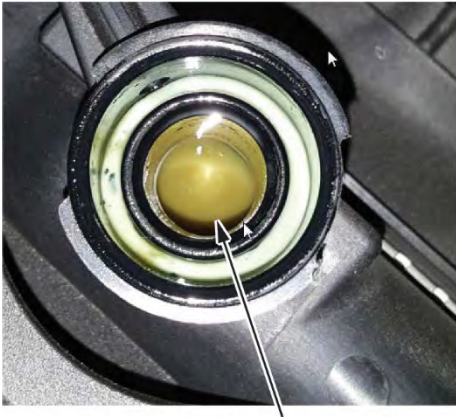
ATF IN THE COOLING SYSTEM

Remove the radiator cap and inspect for ATF in the coolant. If there is coolant contamination, the coolant will look brown.

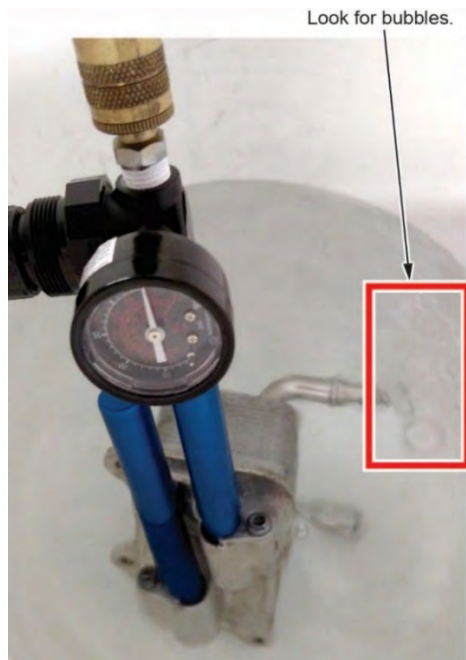
14. Check the transmission warmer for leaks by submerging the warmer completely under the water and watching for bubbles.

NOTE: Some bubbles are normal when the transmission warmer is first submerged and will come to a stop. If there is a leak, there will be a steady stream of bubbles coming from the transmission warmer.

- **If there are no bubbles** coming from the warmer, the 9-speed transmission warmer is OK. **Go to step 15 to install the original warmer** with new O-rings. Submit a claim for the warmer inspection only, then continue with normal troubleshooting to resolve the original customer complaint.
- **If there are bubbles**, take photos (see Photos) and check to see if the vehicle also overheated by checking the customer responses on the RO.
 - If the transmission warmer leaks, but the vehicle did not overheat, go to [REPAIR PROCEDURE A](#).
 - If the transmission warmer leaks, and the vehicle did overheat, go to [REPAIR PROCEDURE B](#).

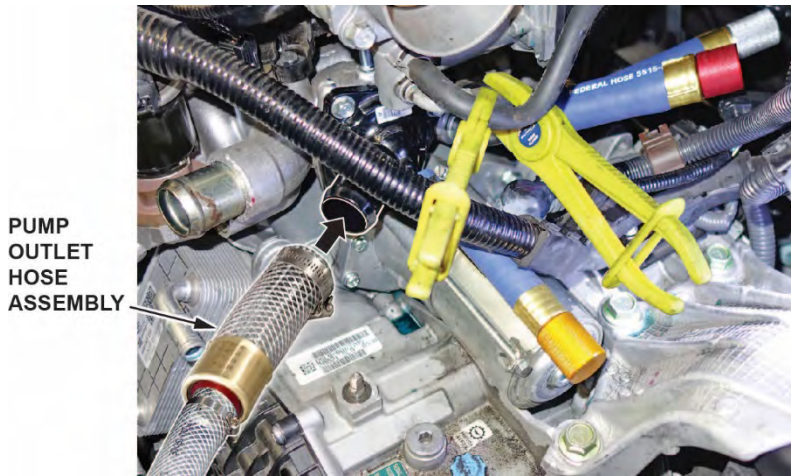
13. Install the pump outlet hose onto the thermostat housing.

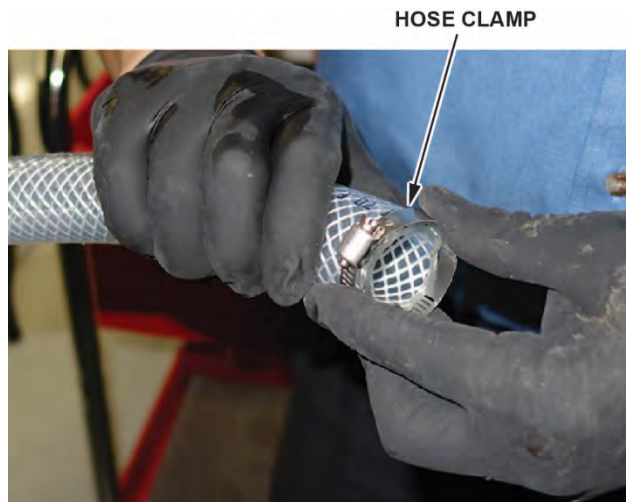
14. Install the return hose onto the water passage as shown, then fill the bucket with 4.5 gallons of fresh water, and install the lid.

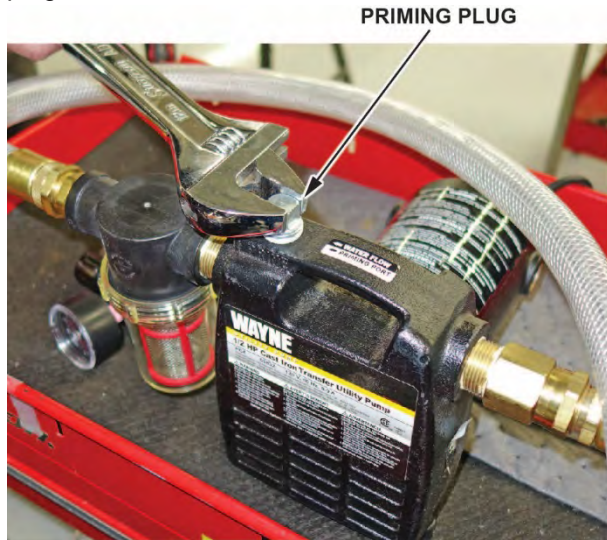
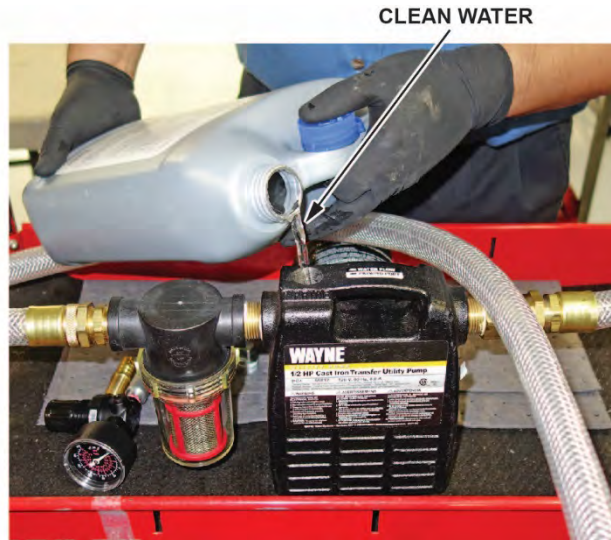
16. Turn on the pump, and let it run for 10 minutes.

NOTE: If this is the first time using the pump, remove the priming plug, fill the pump with clean water, then install the plug.

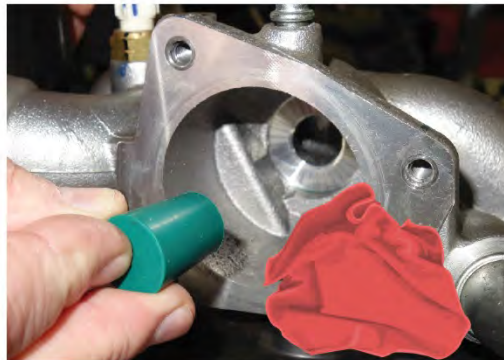
21. Remove the thermostat cover, remove the green rubber plug, and return it to the coolant flush kit. To prevent the plug from falling into the water passage, cover the passage with a shop towel.

GREEN RUBBER PLUG

THERMOSTAT WATER JACKET

SHOP TOWEL
