SERVICE CAMPAIGN BULLETIN

NTB18-002a

VOLUNTARY SERVICE CAMPAIGN 2016-2017 ROGUE; LEFT HAND ENGINE MOUNTING INSULATOR

CAMPAIGN ID #: PC601
APPLIED VEHICLES: 2016-2017 Rogue (T32)

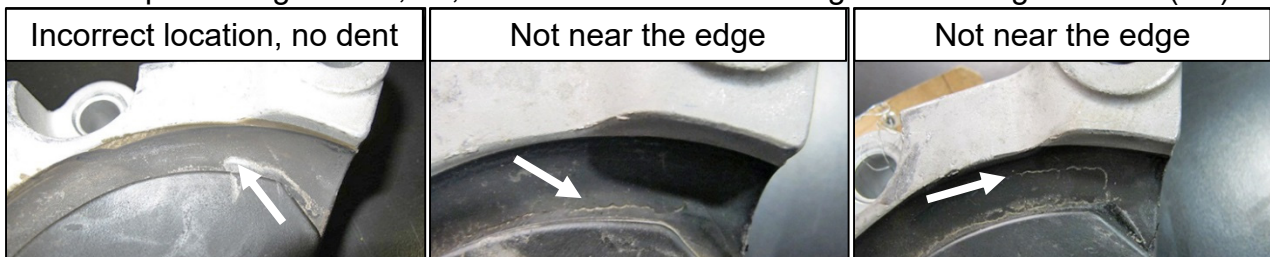
Figure 19

The examples in Figures 19, 20, and 21 show a **GOOD** engine mounting insulator (LH).

Marks above are commonly mistaken as dent/scratch but are GOOD.

NO: Proceed to step 29.
