Service Alert

Subject: SIRIUSXM SATELLITE RADIO DOES NOT DISPLAY ALBUM ART, ARTIST BIOGRAPHIES OR STATION LOGOS	Service Alert No.: SA-005/18
	Last Issued: 02/08/2018

2014-2018 Mazda3	2016-2018 CX-3	2016-2018 CX-9
2016-2017 Mazda6	2016-2018 CX-5	2016-2018 MX-5

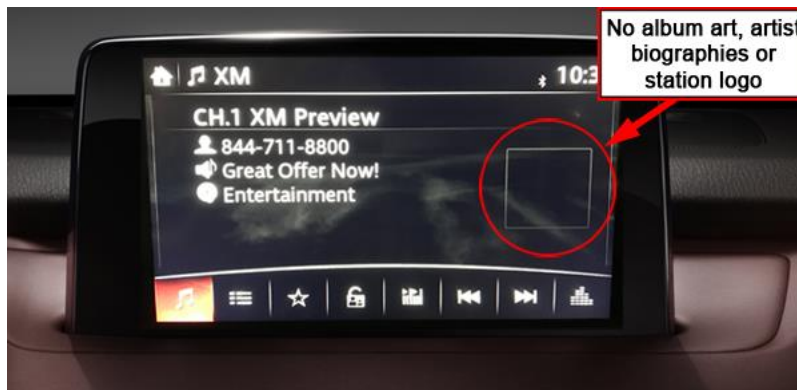
Some customers may complain about SIRIUSXM satellite radio does not show album art, artist biographies or station logos in the center display. This is a normal condition.

Album art and artist biographies are not provided by SiriusXM Satellite Radio, a blank white square frame is shown in place of the album art.

SIRIUSXM satellite radio hardware is in the Tuner and Amp Unit (TAU). The station logo is not shown in the center display because there is no visual data communication cable between the TAU and the Connectivity Master Unit (CMU). A blank white square frame is shown in place of the station logo.

Do NOT perform any repairs for these concerns.
