Technical product information

Topic	Service info: body/equipment: front exterior lighting steamed up/leaks
Market area	Bentley: worldwide (2WBE),Hongkong-Macau (5HK)
Brand	Bentley
Transaction No.	2050542/1
Level	EH
Status	Approval
Release date

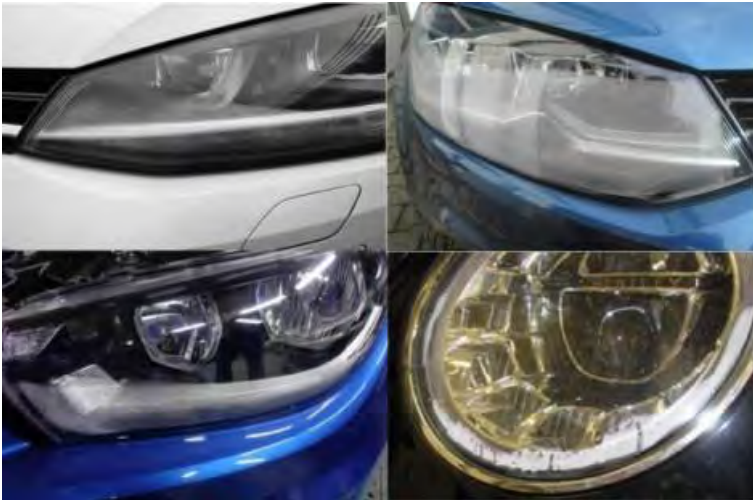
Illustration 1a (example for headlights)

1. The lenses of the headlights (illustration 1a) / front fog lamps (illustration 1b) are steamed up/damp from the inside with minor drips.

Customer statement for 1 (illustration 1a/1b): The lenses of the headlights/front fog lamps are steamed up/damp from the inside with minor drips.

1. Damp air settles on the inner lens of the headlights/fog lamps, with recognisable misting in certain weather conditions (comparable with the steaming up of spectacle lenses when entering a warm room in winter or of the bathroom mirror after a shower).
2. Leak on the headlights/front fog lamps. For example through open covers, a damaged seal of the cap or similar.

1. In case of a headlight complaint the light emission surface on the lens (illustration 3, point 2) must be clear after a journey of 5-10 minutes with sufficient ventilation (for example country road/motorway) and switched-on dipped beam. It is no problem if the remaining surfaces of the inner lens (illustration 3, point 1) are steamed-up after a journey. But the time for the clearing process depends on the outside temperature, the vehicle speed (at higher speeds the ventilation of the headlights is better) and the relative air humidity.

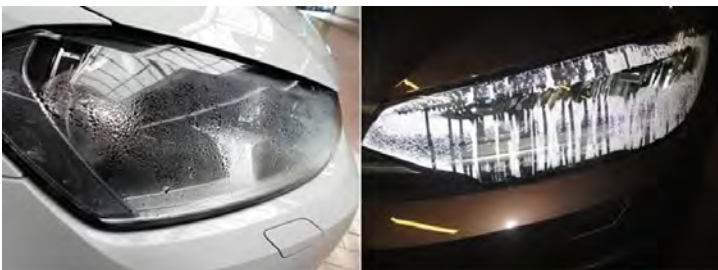
Illustration 2a (example for headlights)

2. Water is in the headlight (illustration 2a) / front fog lamp (illustration 2b), big drips.

Customer statement for 2 (illustration 2a/2b): Water is in the headlights/fog lamps, big drips on the complete lens. Leak on the headlights/front fog lamp.

2. In case of an obvious water ingress/leak (a lot of drips on the inside of the lens, illustration 2) check first the cover and the seals on the headlight/front fog lamp. In case of water ingress (damaged seal, lens and so on) perform the appropriate repairs according to the repair manual/parts catalogue.

Ask the customer to keep an eye on the situation. If despite above repair the customer complains again about leaking headlights/front fog lamps and water ingress or lots of drips can still be recognised after the checks, replace the headlights/front fog lamps according to the repair manual/parts catalogue.

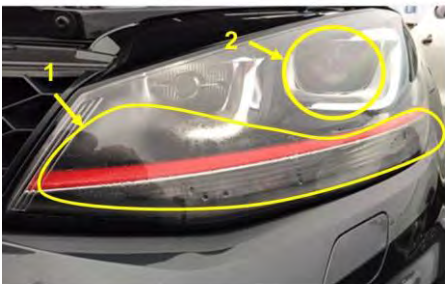
Illustration 3

The above situation is shown in illustration 3:

1 = steaming-up in the headlight

2 = light emission surface

If the headlights/front fog lamps are steamed up, the light emission surface on the lens (illustration 3, point 2) must be clear after a journey of 5-10 minutes with sufficient ventilation (for example country road/motorway) and switched-on dipped beam. It is no problem if the remaining surfaces of the inner lens are steamed-up after a journey.
