Dash Center Vent Damaged/Broken

Topic number	LI83.10-N-067607
Version	1
Function group	83.10 Ventilation
Date	01-23-2018
Validity	Metris 447.603/.703
Reason for change	
Reason for block

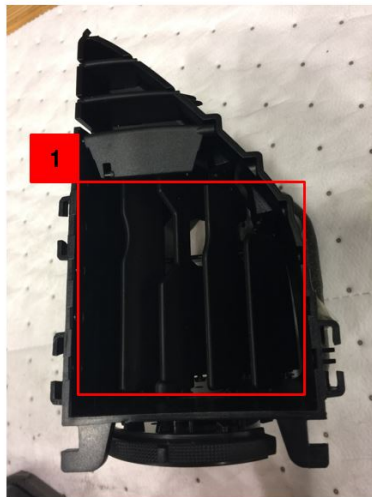
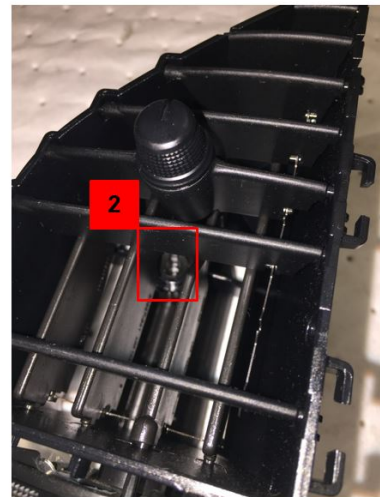
Center air vent with broken fins and knob controls are a result of improper operation, abuse, or incidental damage.

Center Vent Damage. (1) Parts missing / (2) adjustment knob not attached
JPG:

Replacement of the air vent.

Note: Replacement parts and labor are not covered under warranty. Please refer the customer to the owners manual section "Adjusting the air vents" for coaching.

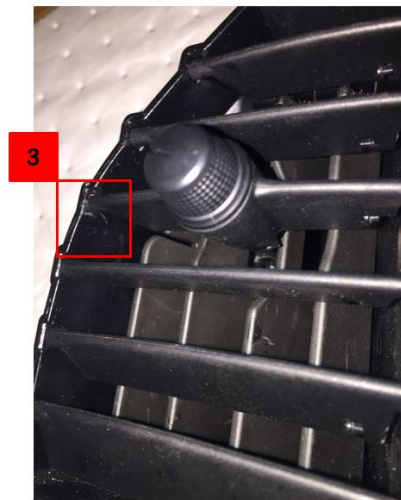
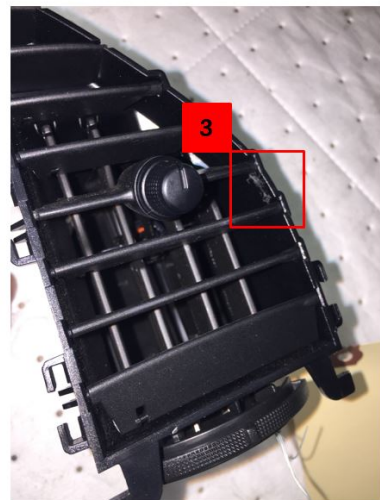
Center Vent Damage 2. (3) Scratches caused by loose parts
JPG:
