08977 Version 8

Warranty Extension: MIL Comes On With DTCs P0301 thru P0304

Supersedes 13-080, dated February 3, 2018, to revise the information highlighted in **yellow**.

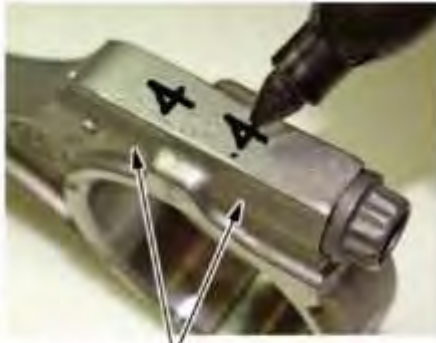
Mark the connecting rod and rod cap with the cylinder number.

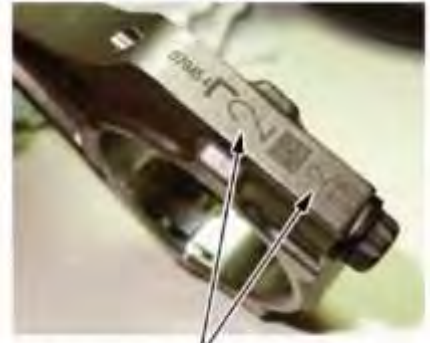
These are manufacturing marks, and do not indicate the cylinder number.

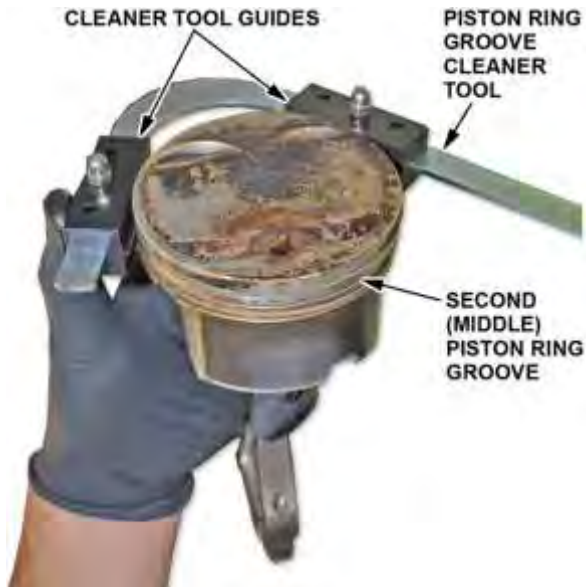
3. While holding the piston upright in your left hand, take the piston ring groove cleaner tool in your right hand and line up the cleaner tool guides with the second (middle) piston ring groove.

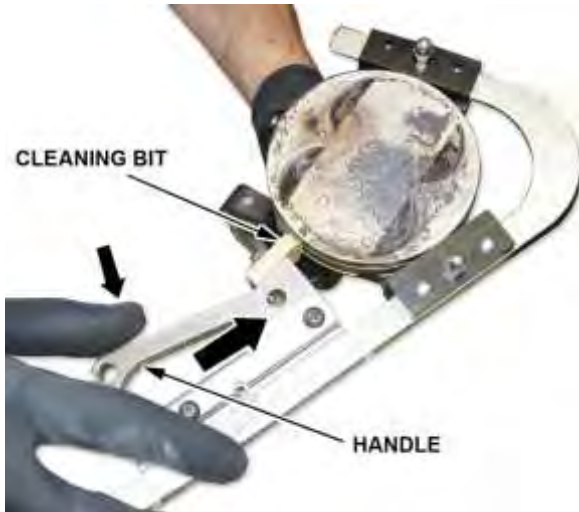
4. Press the handle on the piston ring groove cleaner tool and slide the cleaning bit onto the appropriate piston ring grooves.

5. Once the cleaning bit is in the appropriate ring grooves of the piston, make sure the tool handle clicks into place.
NOTE: There is only one notch on the tool for the handle to engage.

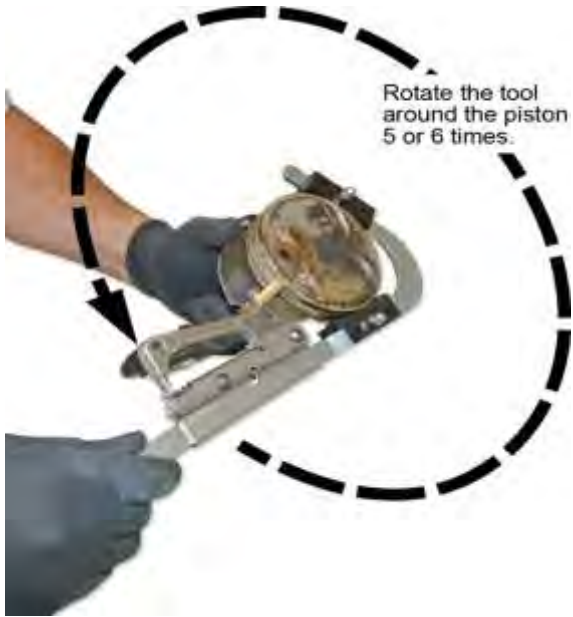
6. Hold the piston steady and rotate the tool counter-clockwise five to six times to remove any carbon deposits in the piston ring grooves. **Do not** rotate the tool clockwise.

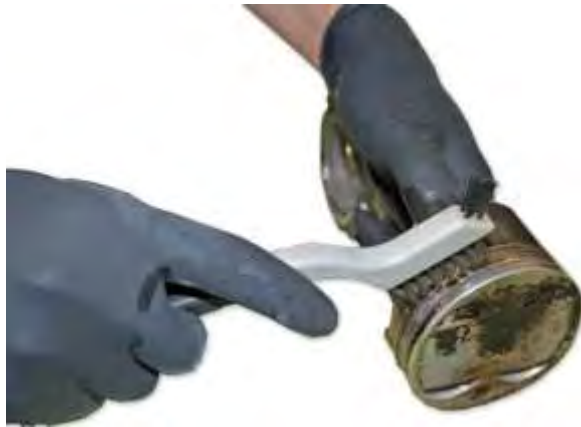
7. Remove the piston groove cleaning tool and clean off the carbon from the tool bit.
8. Finish cleaning the piston with throttle plate cleaner and the nylon brush. **Do not** use a steel wire brush.

NOTE: Below are some examples of before and after pictures. Depending on mileage and running conditions, the pistons will achieve different levels of cleanliness.
