GROUP FUE	MODEL 2014-2018MY Soul (PS) 2012-2017MY Rio (UB) 2014-2017MY Forte (YD, YDm)
	NUMBER 038	DATE April 2018

TECHNICAL SERVICE BULLETIN

SUBJECT: CANISTER CLOSE VALVE INSPECTION AND AIR DRAIN CASE REPLACEMENT

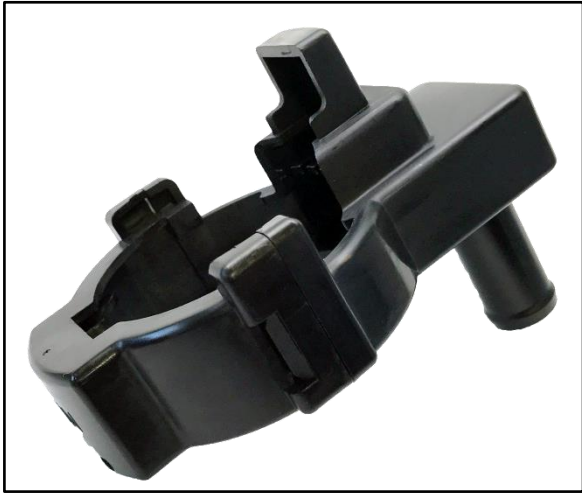
Air Drain Case
(YD & YDm)

This bulletin provides the procedure to inspect and if necessary, replace the Air Drain Case on some 2014-18MY Soul (PS), produced from July 21, 2013 through June 1, 2017, some 2012-2017MY Rio (UB), produced from June 21, 2011 through March 31, 2017, some 2014-2017MY Forte (YD) vehicles, produced from February 18, 2013 through March 2, 2017, and some 2017MY Forte (YDm) vehicles, produced from May 16, 2016 through March 6, 2017, which may experience an early shut-off during fuel refill and/or a malfunction indicator lamp (MIL) illumination with DTC(s) P0449 or P0451. Follow the procedure outlined in this bulletin to inspect and if necessary, replace the Air Drain Case.

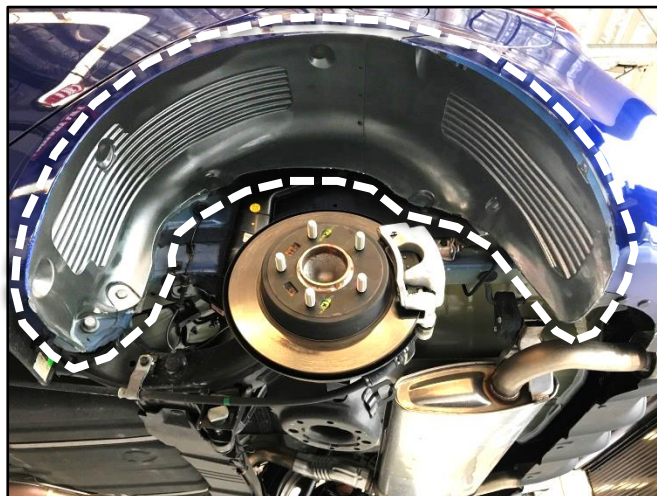
Forte (YD) and (YDm)

- 1a. **Rio (UB):** Remove the left passenger side rear wheel guard by referring to the “Body (Interior and Exterior) → Exterior → Body Side Molding → Repair procedures – scroll down to Rear Wheel Guard Replacement” chapter in the applicable shop manual.
- 1b. **Soul (PS), Forte (YD) and (YDm):** Remove the left passenger side rear wheel guard by referring to the “Body (Interior and Exterior) → Body Side Molding → Rear Wheel Guard → Repair procedures” chapter in the applicable shop manual.
2. Remove the gas cap (A) and loosen the four (4) filler neck retaining bolts (B) enough, as shown (C), to allow removal of Air Drain Case (D).

Tightening torque for bolts (B):
 69.03 – 104.43 lb.in (7.8 – 11.8 N.m,
 0.8 – 1.2 kgf.m).

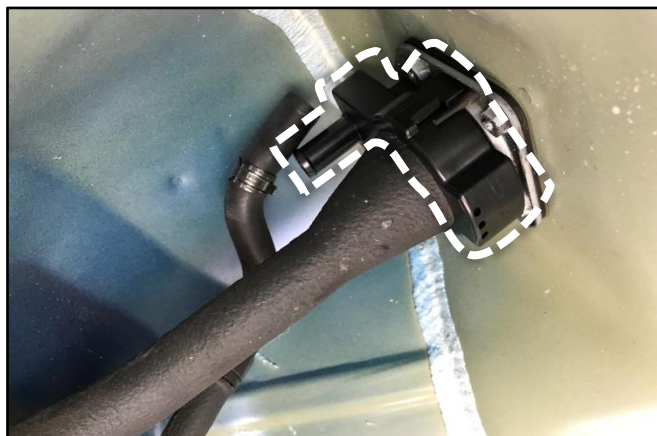
- 5a. **Forte (YD) and (YDm):** Install the new improved fuel filler neck air drain case in the reverse order of removal. Ensure the vent of the Air Drain Case (J) is inserted properly through the opening (K) and ensure a click is heard when installing the new air drain case assembly.

Ensure the outer air drain case half is installed in the correct orientation with the contacts aligned and not upside down.
