Service Bulletin

Subject: Intermittent MIL/Check Engine Light On, DTCs P0607 and/or P0138, Vehicle Stability Control Lamp On, Driveability Concerns in High Ambient Temperatures with A/C On (Clean HO2S Connector and Inspect/Unplug Evaporator Drain Tube)

Models: 2003-2010 Pontiac Vibe
Equipped with AWD

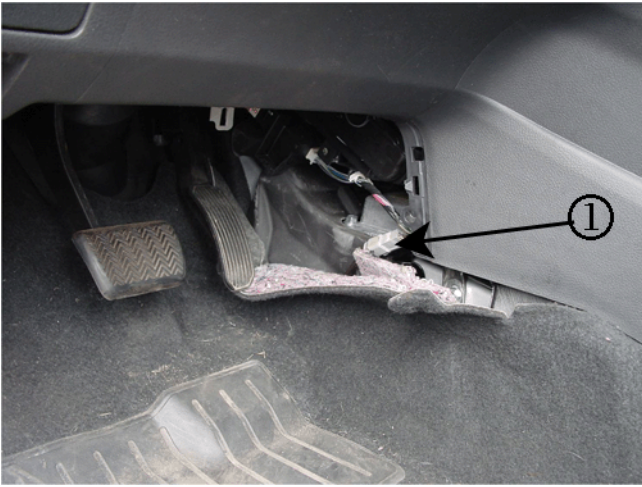
This condition may be caused by water leaking from the evaporator onto the electrical connector in the center IP area. The evaporator drain may be restricted, causing water to drip from the evaporator case onto the post HO2S connector. This creates a path for current to flow from the heater circuit to the HO2S signal circuit. There may not be carpet wet from this leak, only the connector.

2. Locate the HO2S connector (1). Clean the connector with compressed air and apply a small amount of silicone grease to the connector.
