Service Bulletin

Subject: Whistle Noise Heard from Engine Compartment, Rough Idle and/or DTC P0171 Set

Models: 2011-2012 Chevrolet Cruze
Equipped with 1.4L Engine (RPO LUJ)

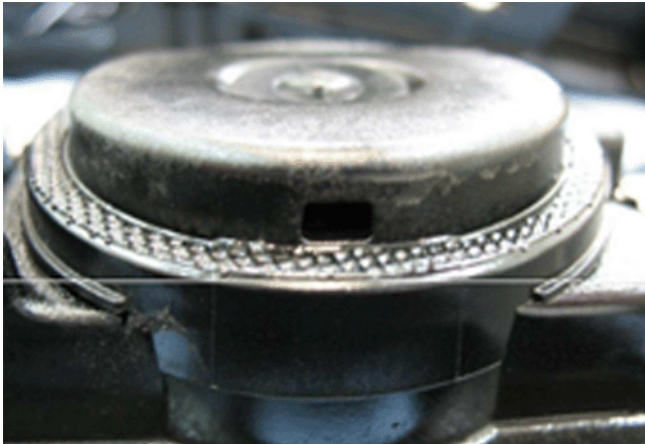
Note: The old style camshaft cover has a taller design PCV cap as shown in the illustration above.

With the engine running using your finger, place it over the breather port of the PCV diaphragm to see if the whistle noise goes away and/or the fuel trims are

high then return to normal levels.

If the noise goes away, replace the camshaft cover and clear the DTC.

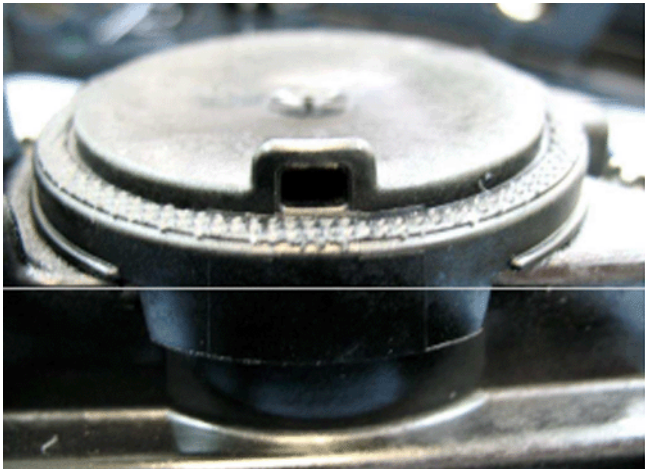
Note: The new design camshaft cover has a flatter/lower cap as shown in the illustration above.

Part Number	Description
55573746	Camshaft Cover
