Technical Service Bulletin

60 Noises in sunroof mechanism

60 18 22 2050904/1 March 29, 2018.

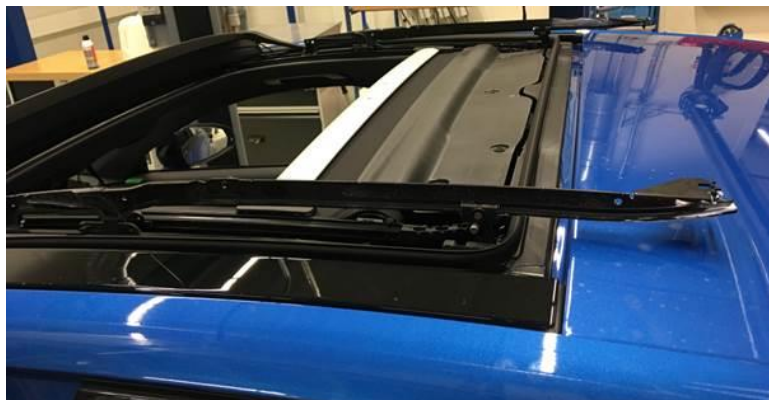
During a certain production period the sunroof mechanism sliding rails were contaminated with a lubricant incompatible with the approved lubricant. When the correct approved lubricant was applied to these contaminated areas the correct lubricant did not adhere to these areas. These areas were then susceptible to noises when in contact with adjacent components of the sunroof mechanism.

Figure 1. Sliding rails exposed showing the area of contamination.

1. The areas of contamination will need to be thoroughly cleaned and dried, then the correct lubricant can be applied. Open the Panoramic sunroof fully. While Figure 1 shows the glass panel removed for clarity, the glass panel does not need to be removed to perform this operation.

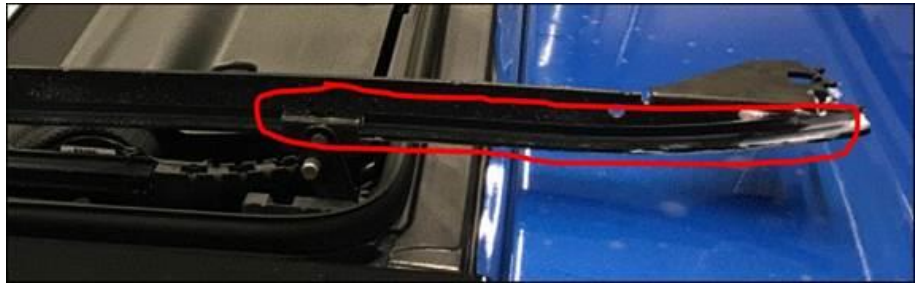
Figure 2. Area of the sliding rail to be cleaned.

2. Thoroughly clean the areas of the sliding rails shown in the illustration with All Purpose Cleaner G 065567A2 and a lint free cloth. The area to clean is 15 cm from the rearmost edge of the rail. Perform this cleaning procedure to both sides.

3. Finally, lubricate the cleaned areas with Special Lubricant G 060567A2. Perform this lubrication to both sides as well.
