SI B34 10 17  
Brakes

## LOW-SPEED BRAKE SQUEAL

G30 (5 Series Sedan)

# Brake Squeal Repair Guide

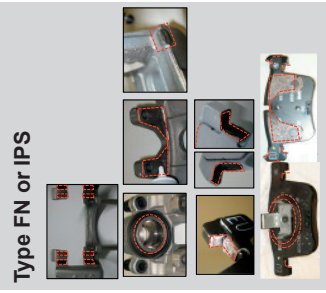
<b>Type FN or IPS</b>

- Greasing Brake Pads and Brake Caliper Contact Points**

**Floating Caliper (1 to 2 piston)**

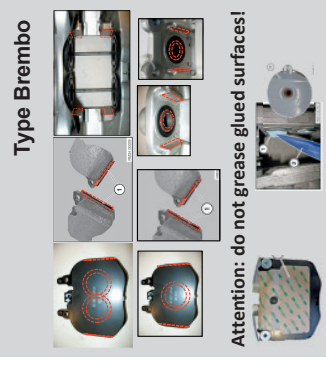
<b>Type Brembo</b>

<p>Attention: do not grease glued surfaces!</p>
---	--	--

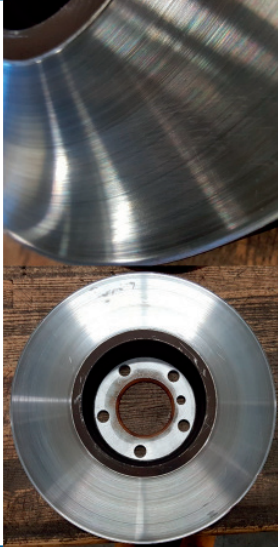
Category 1 – No corrosion found: OK to use new brake pads (resurfacing not needed)

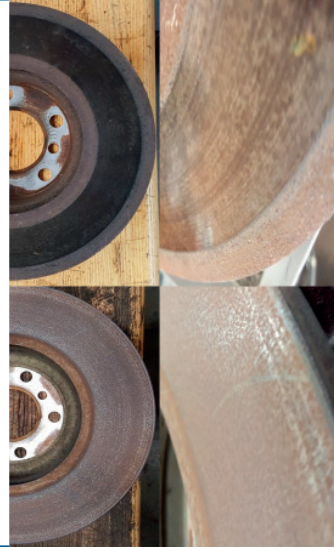
Category 2 – Corrosion : cannot be used with new brake pads. OK to resurface\*. After cutting, use new brake pads

\*If measured rotor thickness is above minimum thickness plus 0.5mm

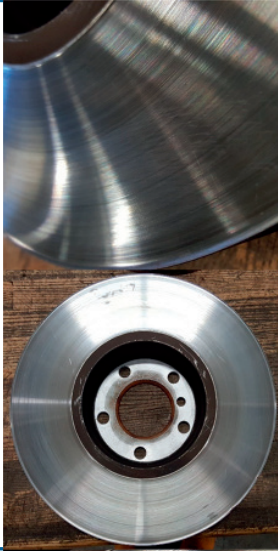
Category 1 – No grooves found: OK to use new brake pads (resurfacing not needed)

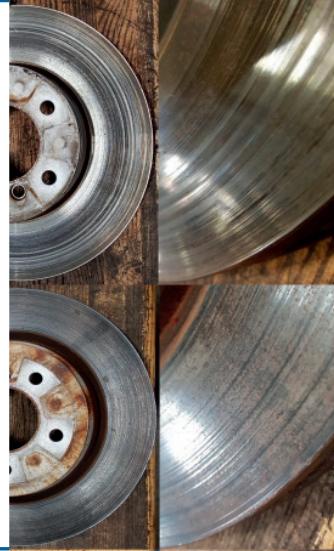
Category 2 – Grooves: cannot be used with new brake pads. OK to resurface\*. After cutting, use new brake pads

\*If measured rotor thickness is above minimum thickness plus 0.5mm

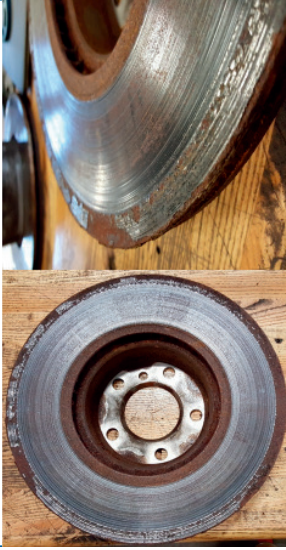
Category 3 – Severe corrosion : resurfacing not possible. Rotors must be replaced.

\*If deepest groove measured below minimum thickness

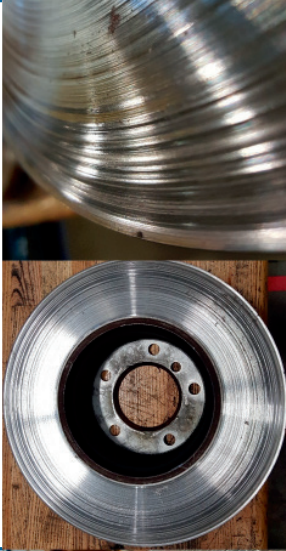
Category 3 – Severe grooves : resurfacing\* not possible. Rotors must be replaced.

\*If deepest groove measured below minimum thickness
