NUMBER: 23-018-16

Sunroof May Malfunction

2015 (LA) Dodge Challenger

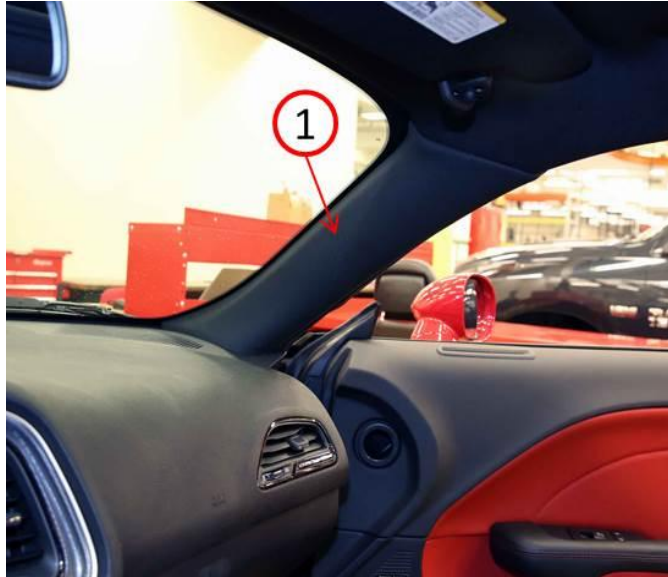
Fig. 1 A Pillar Cover

1. Remove the passenger A-Pillar trim piece ([Fig. 1](#)). Refer to the detailed service procedures available in DealerCONNECT> TechCONNECT under: 23 - Body/Interior/Panel, A-Pillar Trim/Removal.

1 - Trim Piece

2. Test the sunroof. Does it operate normally?
 - a. YES>>> Repair is complete. Reinstall the passenger A-Pillar trim piece (Fig. 1). Refer to the detailed service procedures available in DealerCONNECT> TechCONNECT under: 23 - Body/Interior/Panel, A-Pillar Trim/Installation.
 - b. NO>>> Further diagnosis may be needed. Refer to the detailed service procedures available in DealerCONNECT> TechCONNECT under: 23 - Body/Sunroof/Diagnosis and Testing>Sunroof.
3. Check the operation of the interior lights and any component that is located in the headliner for proper function.
4. Clear any DTCs that may have been set due to the loose connector. The wiTECH application will automatically present any DTCs and allow them to be cleared.

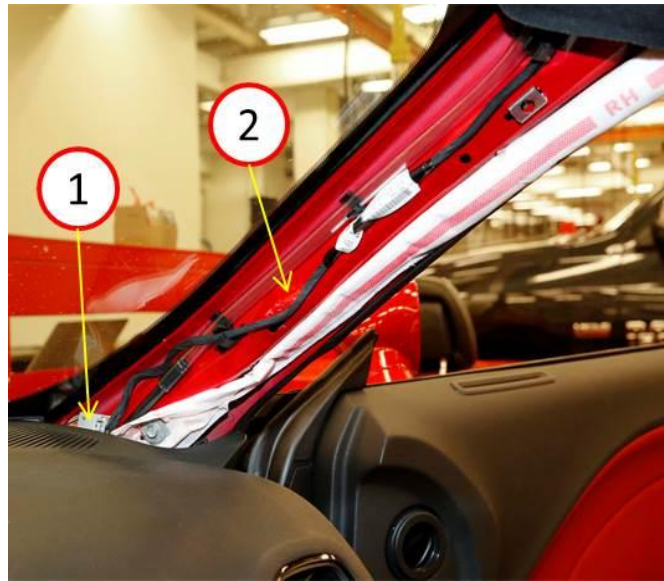
Fig. 2 Electrical Connector

2. Locate the sunroof circuit wiring connector. Examine the harness running up the A Pillar. If the harness is tight or stretched (causing connector stress), it may be pulling on the connector pins causing an intermittent connection. The figure shown shows a good wire harness with proper length ([Fig. 2](#)).

1 - Electrical Connector

2 - Wiring

3. Is the harness found to be tight or stretched?
 - a. YES>>> Separate the sunroof connector and inspect the connector and pins for damage. Proceed to [Step #1](#).
 - b. NO>>> Further diagnosis may be needed. Refer to the detailed service procedures available in DealerCONNECT> TechCONNECT under: 23 - Body/Sunroof/Diagnosis and Testing>Power Top Sunroof.

NOTE: When repairing the wire harness, lengthen the wires enough to avoid any stress on the connector as in ([Fig. 2](#)).

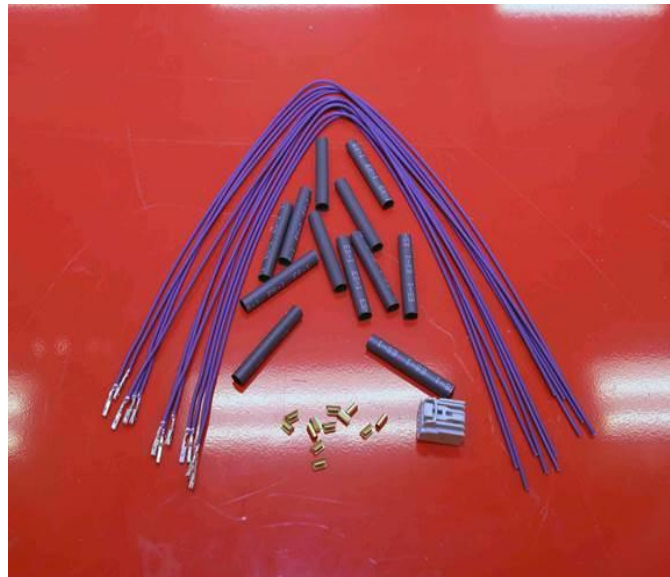
Fig. 3 Connector Repair Kit

1. Repair and lengthen the sunroof male 12-pin connector with a replacement connector and wiring in the kit ([Fig. 3](#)) and stagger each wire repair to the individual wires repair all 9 wires. See figures ([Fig. 4](#)), ([Fig. 5](#)) & ([Fig. 6](#)) for reference. Refer to the detailed service procedures available in DealerCONNECT> TechCONNECT under: 29 - Non-DTC Diagnostics/Circuit Testing Procedures/Standard Procedure>Wire Splicing. After repair is completed proceed to [Step #2](#).

Qty.	Part No.	Description
1 (AR)	68316916AA	Sunroof Connector Kit
