**NUMBER:** 19-002-14 REV. A

**GROUP:** Steering

Steering Column Squeak / Moan While Turning Wheel

This bulletin involves removing/installing the steering column, removing/installing the bulkhead pass through boot, removing the wiper seal, and applying lubricant to the intermediate shaft bearing sleeve.

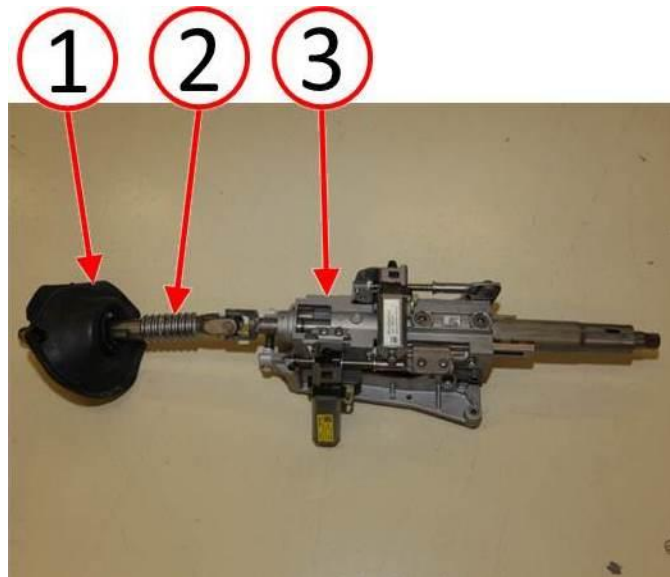
**Fig. 1 Steering Column Assembly**

- 1 - Bulkhead Pass Through Boot
- 2 - Intermediate Shaft
- 3 - Steering Column

1. Remove the steering column assembly (1, 2, 3) from the vehicle. Discard the intermediate shaft pinch bolt \*\*and the steering wheel mounting bolt.\*\* Refer to the detailed service procedures available in DealerCONNECT> TechCONNECT under: Service Info> 19 - Steering> Column> Removal (Fig. 1).

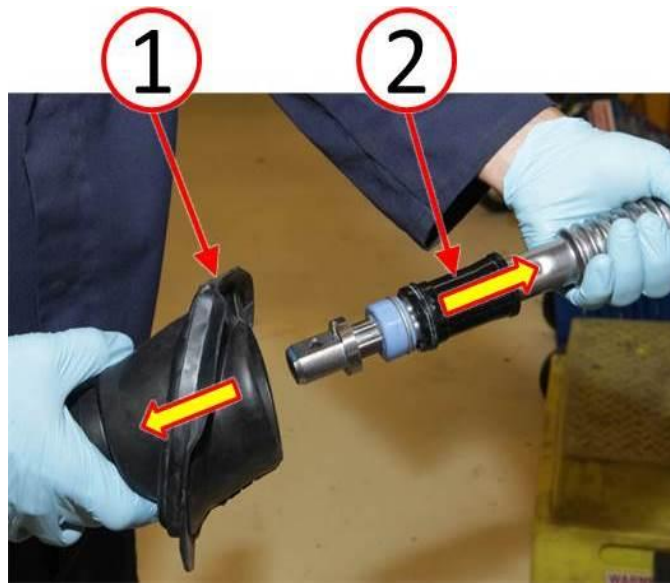
**Fig. 2 Remove Boot From Intermediate Shaft**

- 1 - Bulkhead Pass Through Boot
  - 2 - Inner Bearing Sleeve
-

- 
2. Use a quick tug action to remove the intermediate shaft bulkhead pass through boot and outer bearing sleeve assembly (1) from the intermediate shaft inner bearing sleeve (2) (Fig. 2).

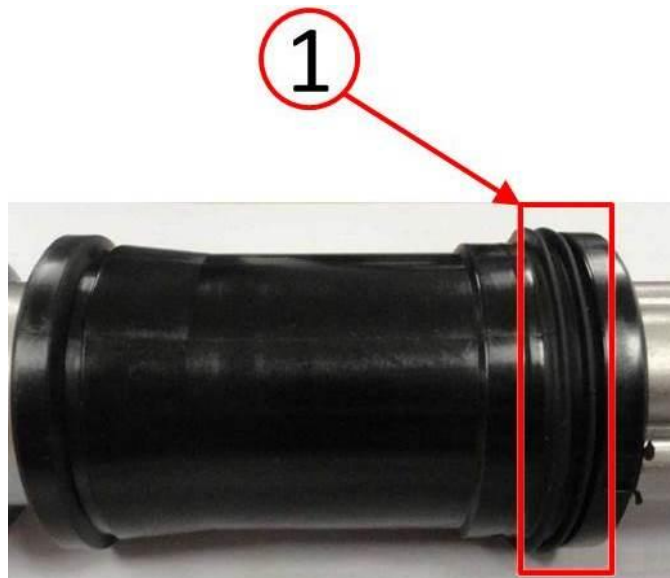
**Fig. 3 Wiper Seal To Be Removed**

- 1 - Wiper Seal
-

3. Completely remove the rubber wiper seal (Fig. 3).

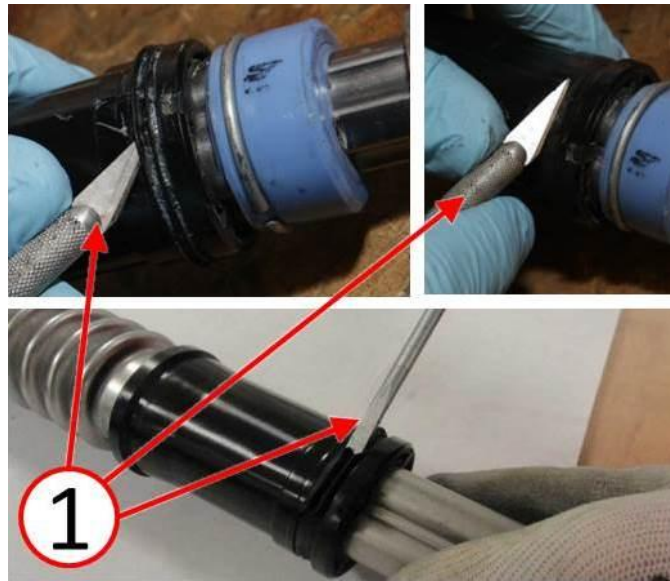
**Fig. 4 Wiper Seal Removal**

1 - Wiper Seal Removal Tools

4. Using an appropriate tool, cut and/or scrape the rubber wiper seal from the plastic inner bearing sleeve (Fig. 4).

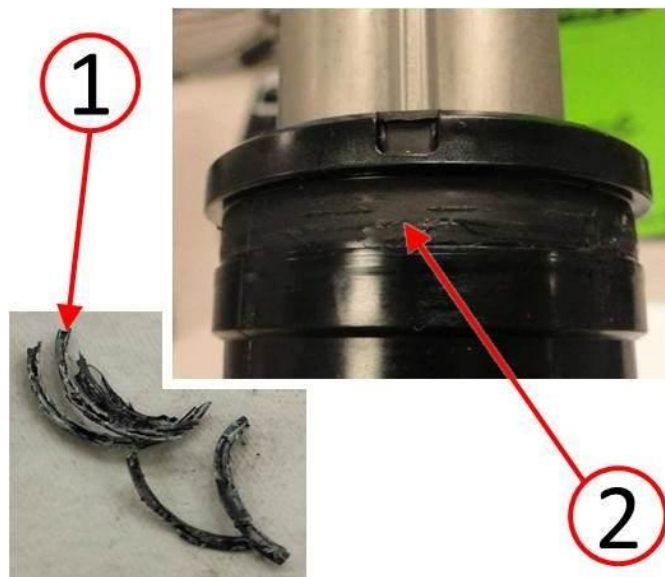
**Fig. 5 Wiper Seal Removed**

1 - Wiper Seal Pieces

2 - Inner Bearing Sleeve With Wiper Seal Removed

- 
5. Ensure that the rubber wiper seal (1) has been completely removed from the plastic inner bearing sleeve (2) (Fig. 5).

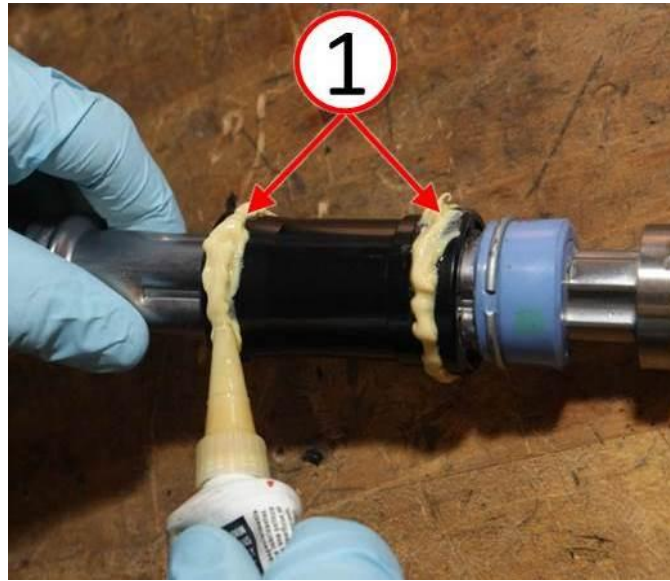
**Fig. 6 Apply White Lithium To Inner Bearing Sleeve**

1 - White Lithium Grease

6. Apply white lithium grease to the contact surface at each end of the inner bearing sleeve (Fig. 6).

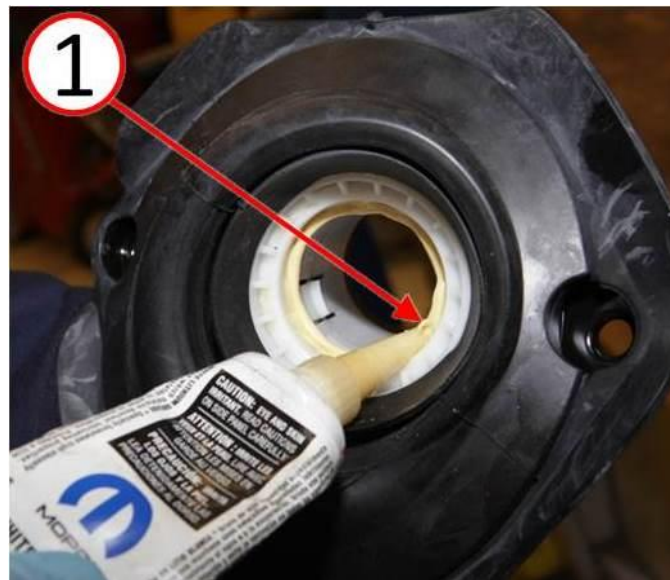
**Fig. 7 Apply White Lithium To Outer Bearing Sleeve**

1 - White Lithium Grease

7. Apply white lithium grease to the contact surface at each end of the outer bearing sleeve (Fig. 7).

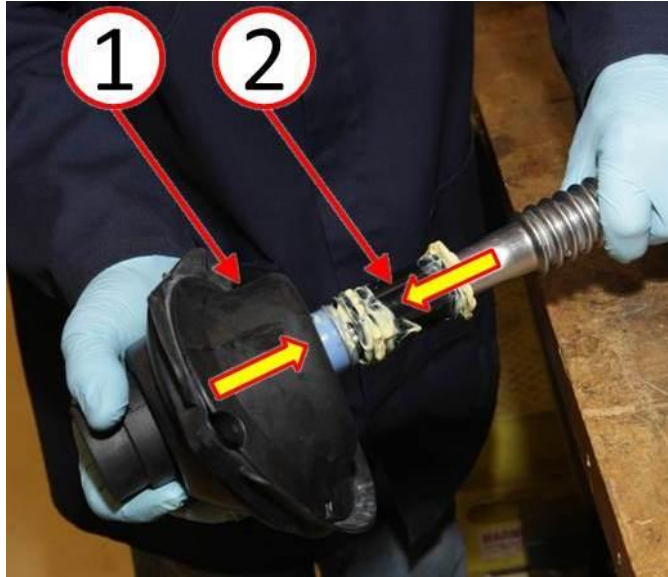
**Fig. 8 Install Boot To Intermediate Shaft**

- 1 - Bulkhead Pass Through Boot
- 2 - Inner Bearing Sleeve

8. Use a quick push action to install the intermediate shaft bulkhead pass through boot and outer bearing sleeve assembly (1) to the intermediate shaft inner bearing sleeve (2) (Fig. 8).

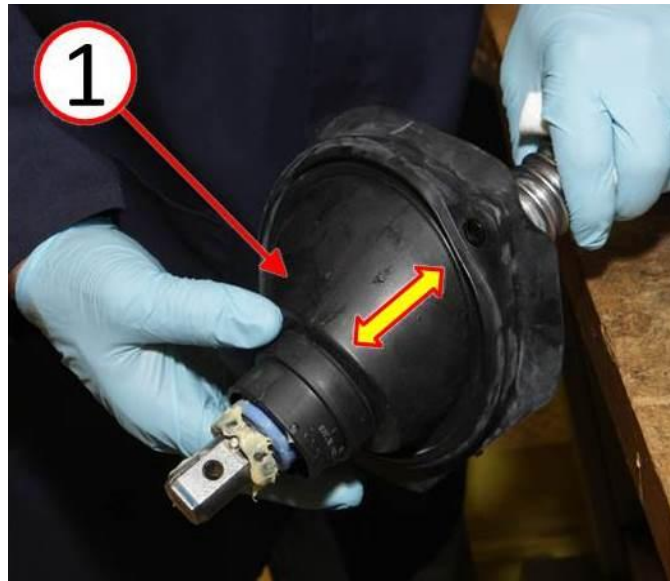
**Fig. 9 Check Installation**

1 - Bulkhead Pass Through Boot

- 
9. Slide the intermediate shaft bulkhead pass through boot and outer bearing sleeve assembly back and fourth to distribute the white lithium grease and to ensure that the outer bearing sleeve is properly engaged with the inner bearing sleeve (Fig. 9).
