## SERVICE BULLETIN

**APPLICABILITY:** 2003-2012MY Legacy & Outback  
 2002-2011MY Impreza  
 2003-2013MY Forester  
**2002-2014MY WRX**  
**2004-2017MY STI**  
 All models listed with 4-cylinder “EJ” Engine Type

**NUMBER:** 02-172-18R

**SUBJECT:** Oil Seepage- New Oil Filler Tube O-Ring

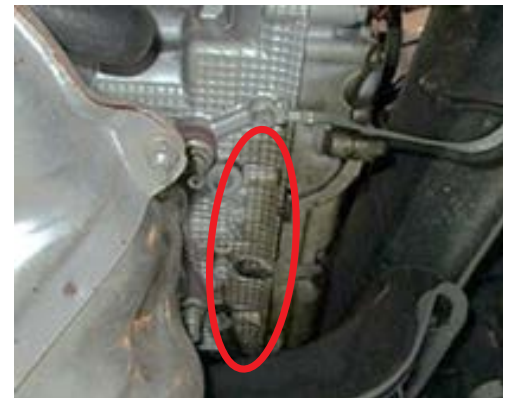
This bulletin provides details regarding a new oil filler tube o-ring developed to address engine oil seepage concerns. This seepage may accumulate along the bottom sealing surface of the rocker cover. The new o-ring utilizes material which has an increased resistance to engine heat.

The part number for the new o-ring is: **806922120**.

**NOTE:** In some cases where the oil fill tube (DUCT) is being replaced, part numbers 15250AA062 and 15250AA041 include the new o-ring.

When replacing the o-ring and / or filler pipe, follow the procedure outlined in the applicable Service Manual.

**REMINDER:** The o-ring is one-time use and **must** be replaced whenever the oil filler pipe is removed.
