## SERVICE INFORMATION

**APPLICABILITY:** 2012-2016MY Impreza 2.0L Models  
 2013-2016MY XV Crosstrek  
 2015-2016MY WRX and WRX STI  
 2014-2016MY Forester  
 2013-2016MY BRZ

**NUMBER:** 05-61-16

**SUBJECT:** “Popping” Sound from Front Strut Mounts on Low Speed Turns

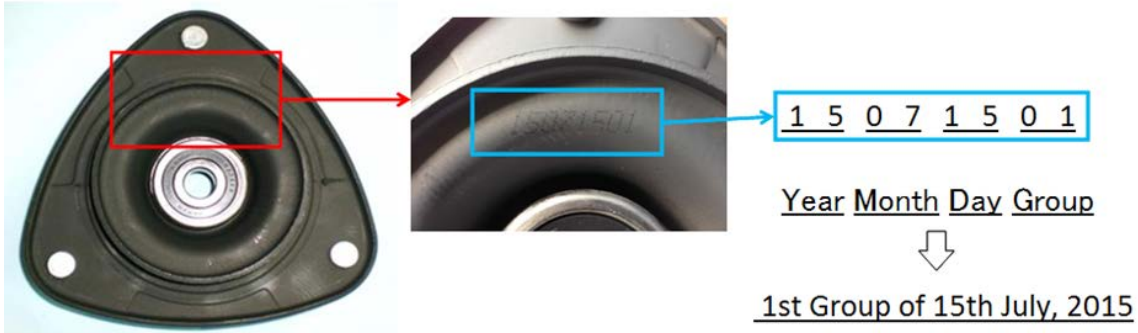
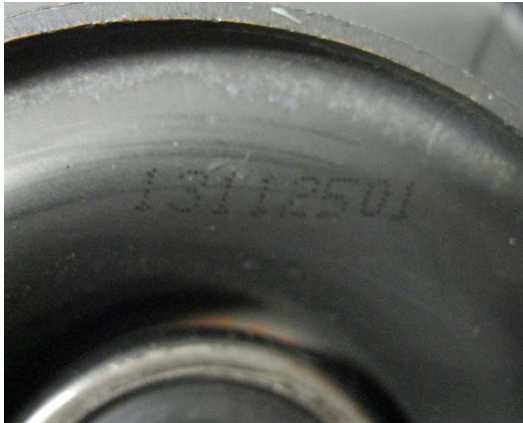
The new strut mounts are identified by a printed date code on the underside of the strut mount as shown in the photos and illustrations below. Strut mounts with a date code of 151225\*\* (12/25/2015) and newer are the new type. (The 2-digit “Group” number (\*\*)) is insignificant for this bulletin.)

**NOTE:** The lot numbers are fairly small and may be difficult to see. The strut mount must be removed to see the number.

- Road test the vehicle to confirm the customer concern.
- If the condition is confirmed and the sound determined to be coming from the strut mount(s), inspect the date code as outlined above.
- If the date code is determined to be before 12/25/2015, replace the affected strut mount(s) following the procedure in the applicable Service Manual.
- When complete, road test the vehicle again to confirm the repair.
