## SERVICE INFORMATION

**APPLICABILITY:** 2014-16MY Forester

**NUMBER:** 07-108-16

**SUBJECT:** Diagnostic TIPS for ODS DTC B1760

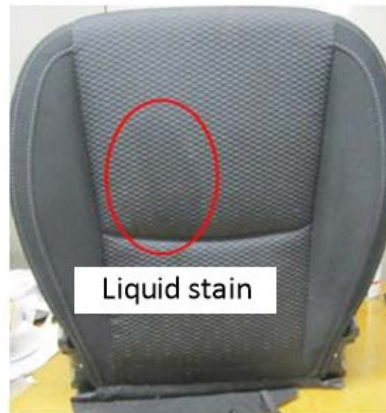
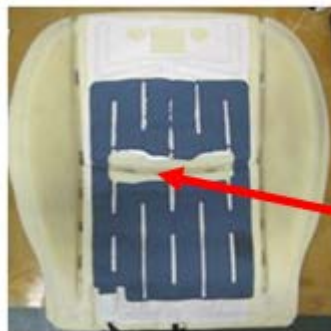
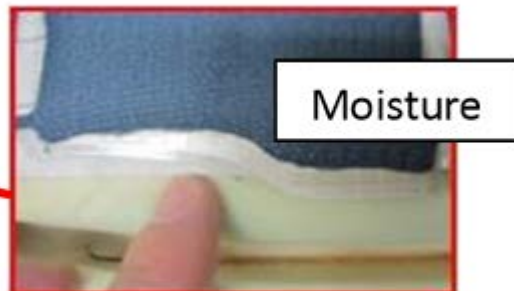
Inspect the seat cushion / frame assembly for evidence of moisture as shown in the example photos below then use the flow chart provided on pg. 2 to continue diagnosis.

This Service Information bulletin provides a procedure for diagnosis of Occupant Detection System (ODS) DTC B1760 / Sensor Mat Abnormal. This information replaces the current procedure until the Service Manual is updated in the near future. DTC B1760 may set if liquid inadvertently spilled onto the seat cushion (or rain water entering from a window left open) penetrates the upholstery and reaches the sensor mat. This DTC can also set under high humidity conditions.

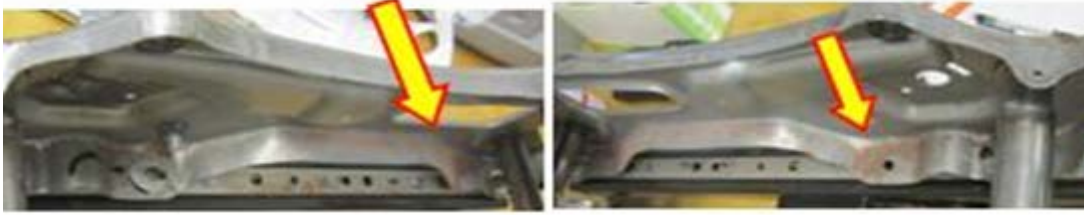
## Evidence of rust seen on the seat frame
