HVAC Servo Motor Noise

Service Category Vehicle Interior

Section Heating/Air Conditioning

YEAR(S)	MODEL(S)	ADDITIONAL INFORMATION
2015	Highlander, Highlander HV

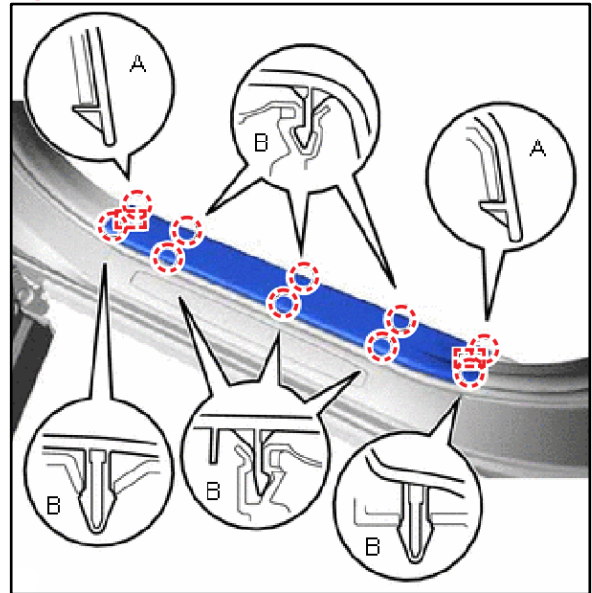
Figure 1.

3. Remove the front door scuff plate LH.
 - A. Disengage the 2 claws.
 - B. Disengage the 8 claws and 2 guides to remove the front door scuff plate LH.

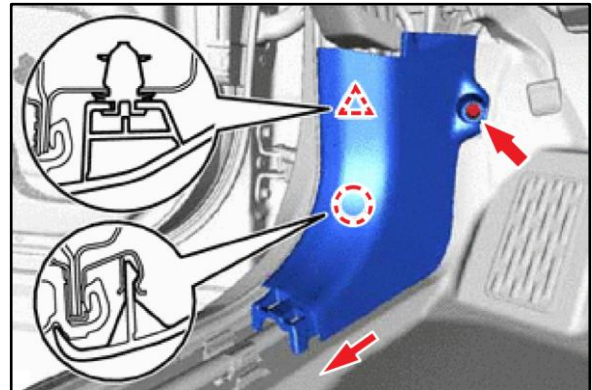
Figure 2.

4. Remove the cowl side trim sub-assembly LH.
 - A. Remove the clip.
 - B. Disengage the claw and clip to remove the cowl side trim sub-assembly LH.

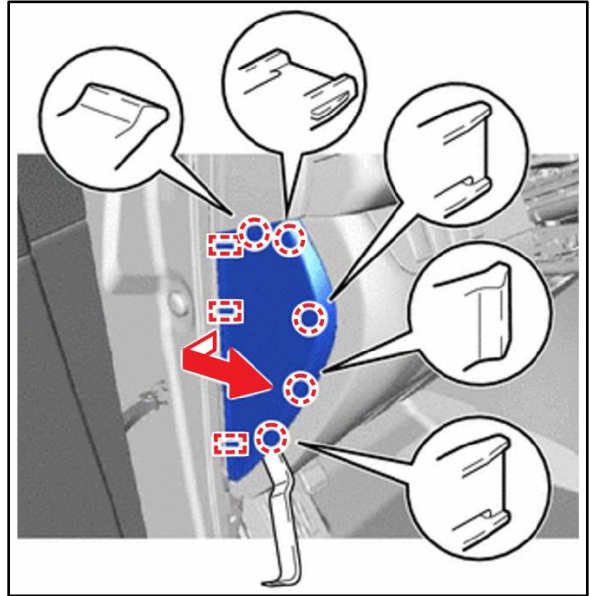
Figure 3.

6. Remove the instrument panel finish panel end LH by using a molding remover and disengaging the 5 claws and 3 guides.

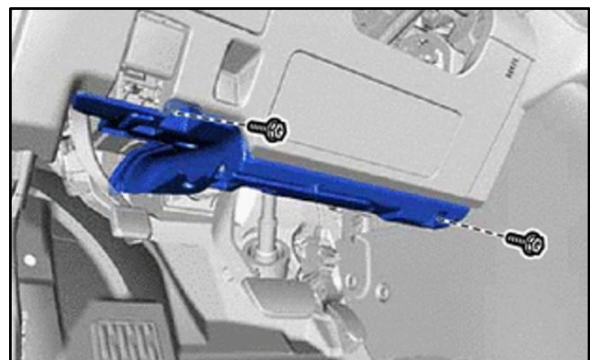
Figure 4.

7. Remove the No. 1 instrument panel under cover sub-assembly.
 - A. Remove the 2 screws.

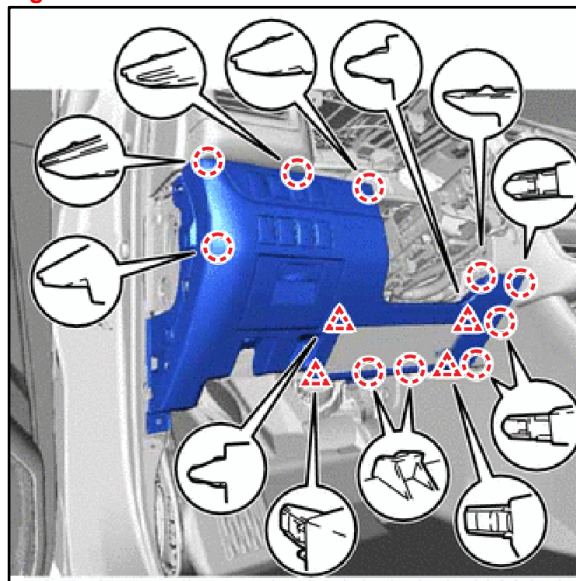
Figure 6.

- 8. Disconnect the hood lock control lever sub-assembly by disengaging the claw and 2 guides.

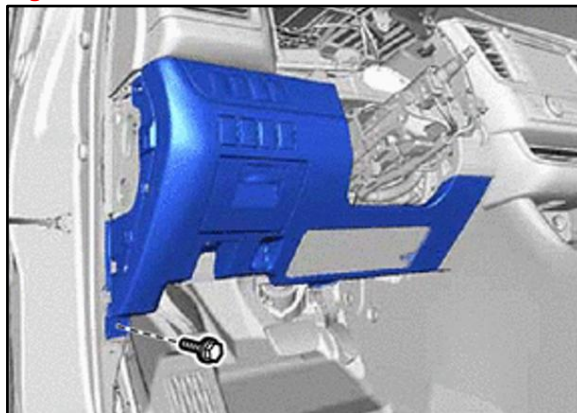
Figure 7.

9. Remove the lower instrument panel finish panel sub-assembly.
 - A. Remove the bolt.

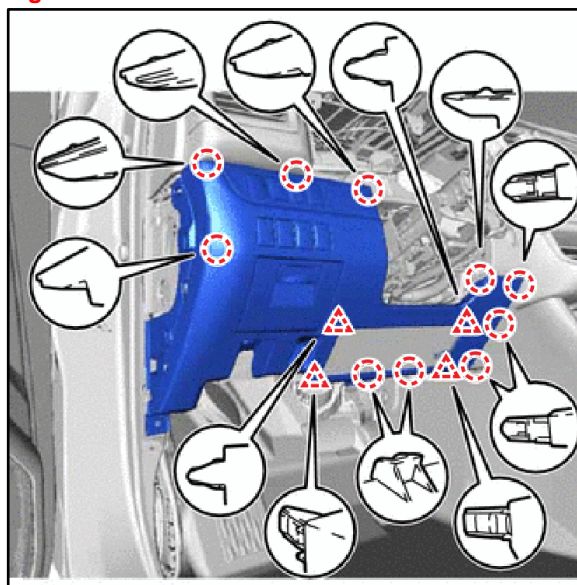
Figure 8.

- B. Disengage the 10 claws and 4 clips.

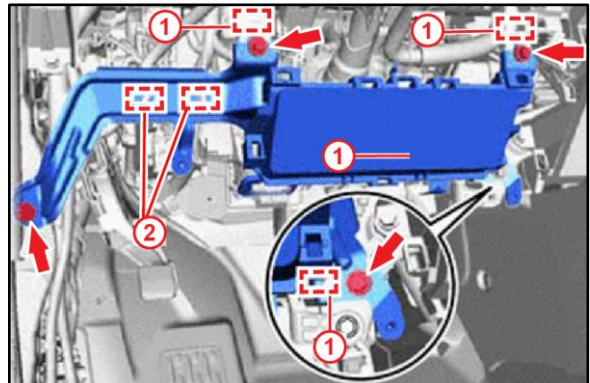
Figure 9.

- A. Check that the ignition switch is off.
- B. Check that the cable is disconnected from the negative (-) battery terminal.
- C. Remove the 4 bolts.
- D. Disengage the 2 clamps and the 3 hooks to separate the lower No. 1 instrument panel airbag assembly.

1	Hook
2	Clamp

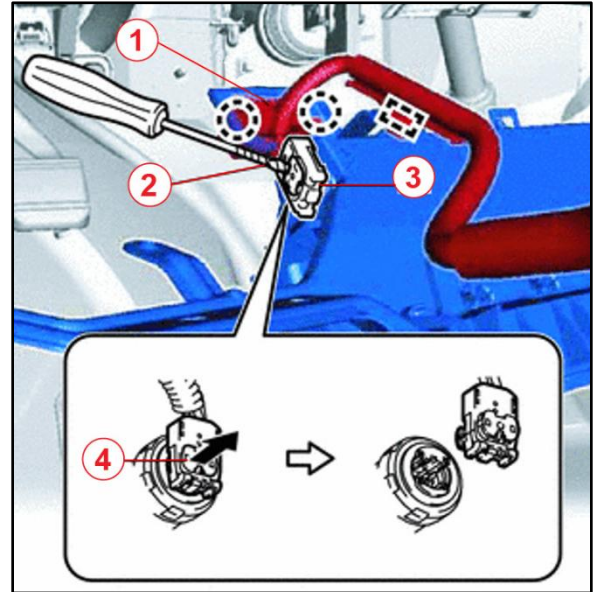
Figure 10.

- E. Disengage the 2 claws and clamp to disconnect the DLC3.

1	DLC3
2	Protective Tape
3	Airbag Connector
4	Airbag Connector Lock

- F. Using a screwdriver with its tip wrapped with protective tape, release the airbag connector lock.
- G. Disconnect the airbag connector to remove the lower No.1 instrument panel airbag assembly.

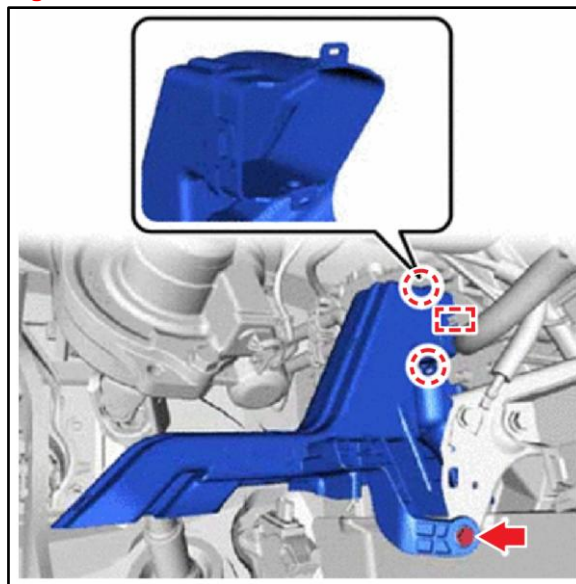
Figure 11.

11. Remove the No. 4 air duct sub-assembly.
 - A. Remove the bolt.

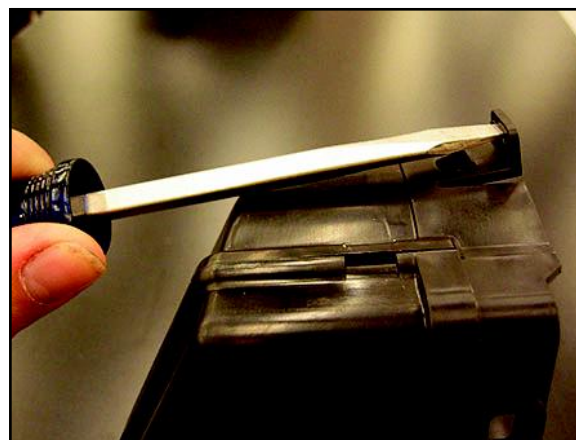
Figure 12.

- B. Disengage the 2 claws (use a screw driver to gently lift and release the claws) and guide to remove the No. 4 air duct sub-assembly.

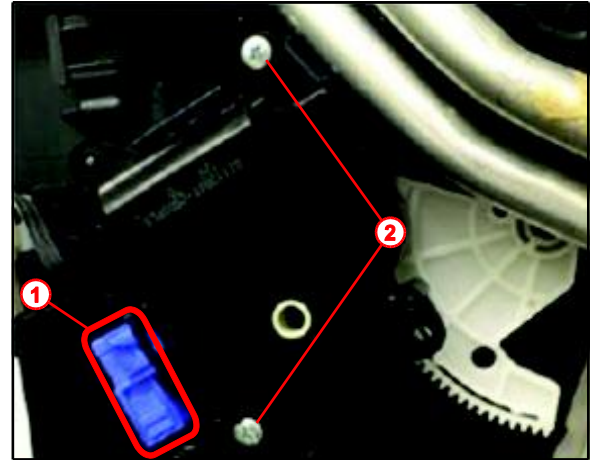
Figure 13.

12. Remove the driver side HVAC servo motor.
 - A. Disconnect the servo motor connector.
 - B. Remove the 2 servo motor screws.

Once the servo motor is removed, the gear on the HVAC case will drop down.

1	Servo motor connector
2	Servo motor screws

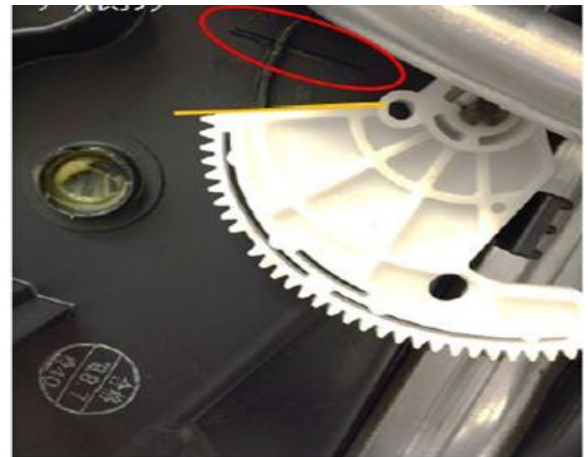
Figure 14.

13. Install the NEW Driver Side HVAC servo motor.
 - A. Position the gear on the HVAC case to the initialized position.

- (1) Use your finger and line up the top of the gear with the rib on the side of the HVAC case.

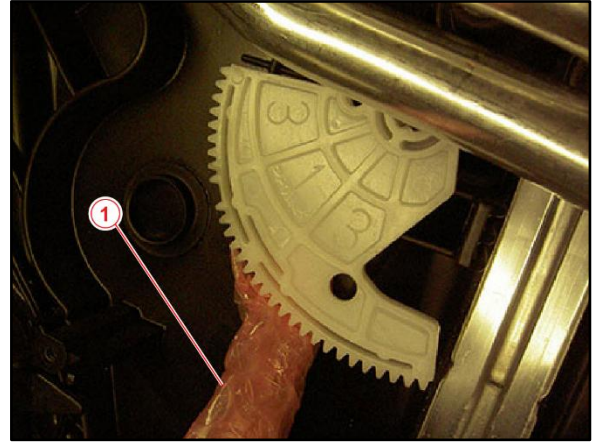
Figure 15.

- (2) Hold the HVAC gear in the initialized position by placing bubble wrap, foam, paper, etc. (rolled-up bubble wrap shown), between the inside of the gear and the HVAC case.

1 Packing material (bubble wrap, foam, paper, etc.)

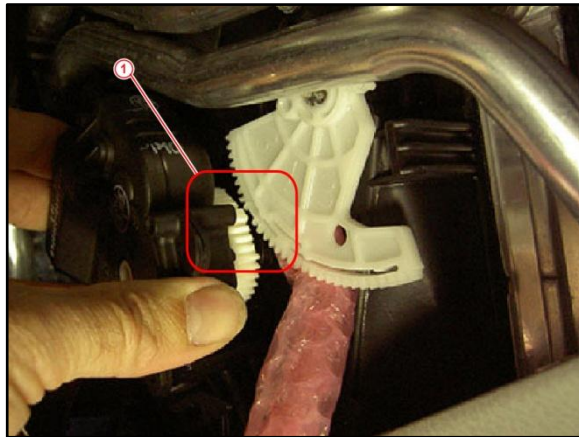
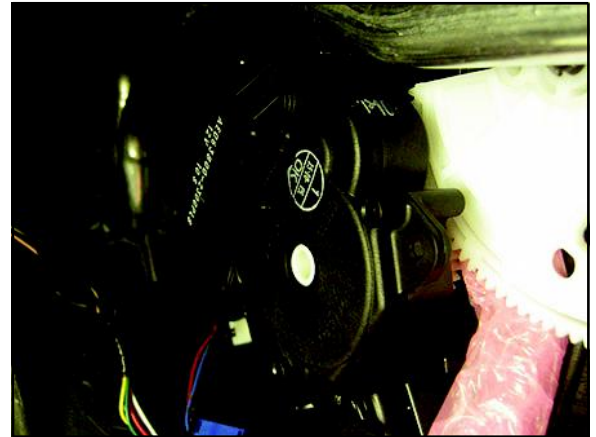
Figure 16.

- (3) Install the NEW servo motor by aligning the key feature on the servo motor gear with the corresponding key feature on the HVAC case gear.

1 Align servo motor and HVAC case gear key features

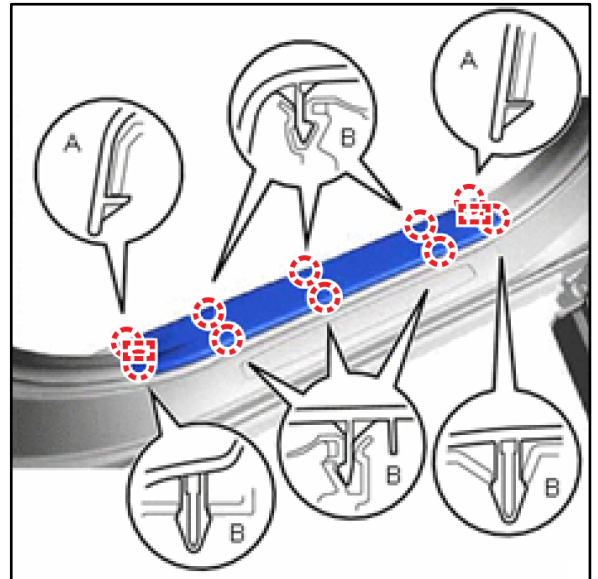
Figure 18.

- (4) Reinstall the 2 servo motor screws.
 - (5) Reconnect the servo motor connector.
 - (6) Remove the material (bubble wrap, foam, paper, etc.) used to hold the HVAC case gear in place.
- B. Reinstall all the driver side trim panels in the reverse order of removal.
14. Disassemble the Passenger Side Trim Panel.
- A. Remove the front door scuff plate RH.
- (1) Disengage the 2 claws.
 - (2) Disengage the 8 claws and 2 guides to remove the front door scuff plate RH.

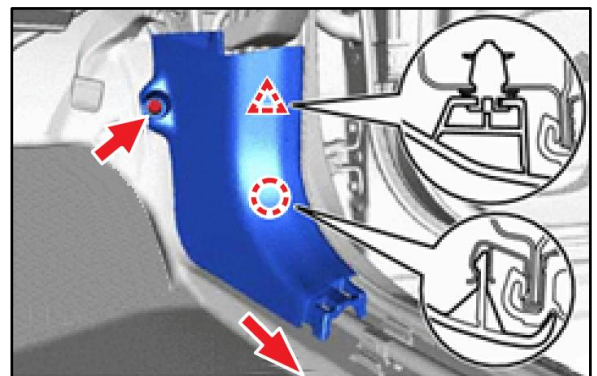
Figure 19.

- B. Remove the cowl side trim sub-assembly RH.
- (1) Remove the clip.
 - (2) Disengage the claw and clip to remove the cowl side trim sub-assembly RH.

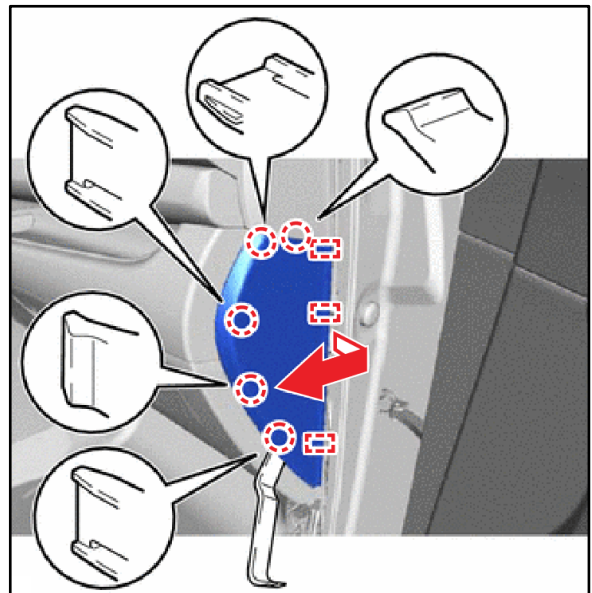
Figure 20.

- C. Remove the front door opening trim weather strip to the extent that allows the removal of the instrument panel finish panel end.
- D. Remove the instrument panel finish panel end RH by using a molding remover and disengaging the 5 claws and 3 guides.

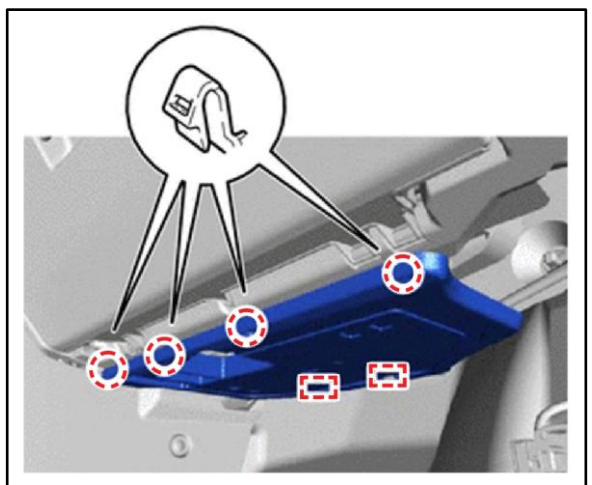
Figure 21.

- E. Remove the No. 2 instrument panel under cover sub-assembly by disengaging the 4 claws and 2 guides.

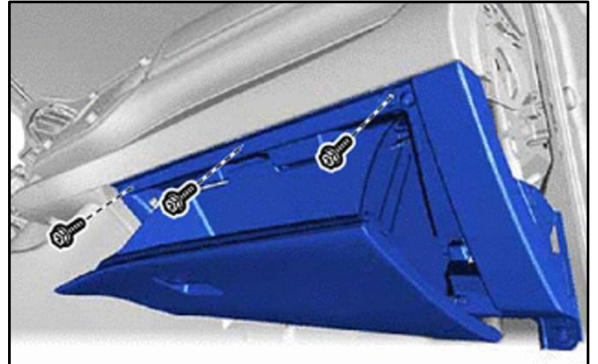
Figure 22.

- F. Remove the lower instrument panel sub assembly.
- (1) Open the lower instrument panel sub-assembly door.
 - (2) Remove the 3 screws.

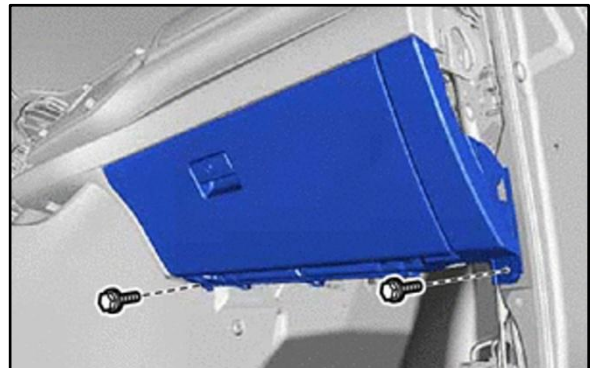
Figure 23.

- (3) Close the lower instrument panel sub-assembly door.
- (4) Remove the 2 bolts.

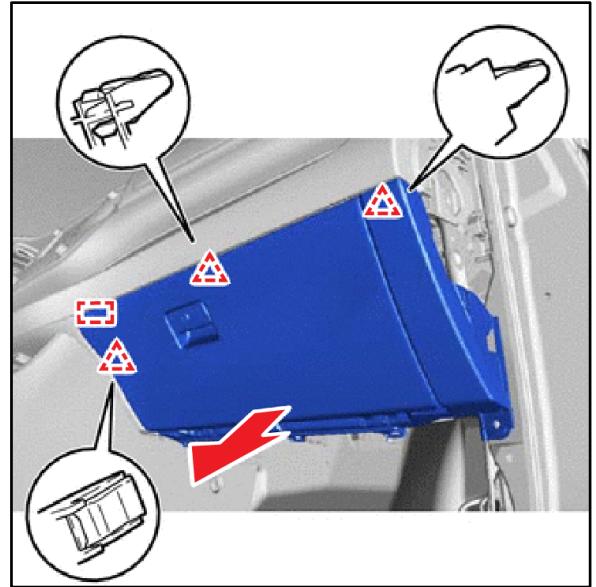
Figure 24.

- (5) Disengage the 3 clips and guides.
- (6) Disconnect each connector and remove the lower instrument panel sub-assembly.

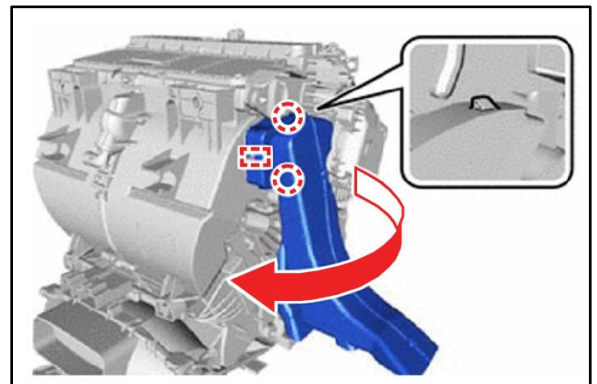
Figure 25.

- G. Remove the No. 3 air duct sub-assembly by disengaging the 2 claws and guide.

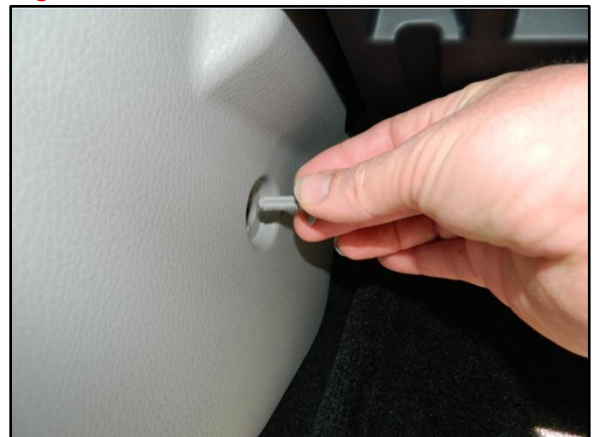
Figure 26.

- H. Remove the push pin from the lower trim panel.

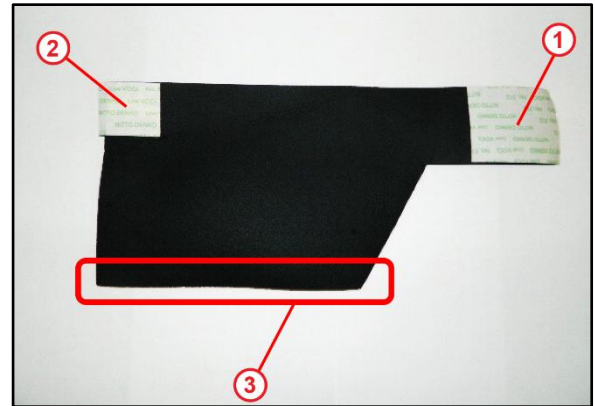
Figure 27.

- (1) Place the narrow side of the insulation sheet adhesive against the center console/dash metal brace.
- (2) Place the wide side of the insulation sheet adhesive against the blower motor case covering the servo motor and wire harness.

1	Insulation sheet, narrow side
2	Insulation sheet, wide side
3	Insulation sheet, bottom portion

The insulation sheet has adhesive applied to the top corners of the inside of the sheet. The adhesive areas are used to attach the insulation sheet in place. The bottom portion of the insulation sheet should be tucked (NOT adhered) to the inside of the lower trim panel.

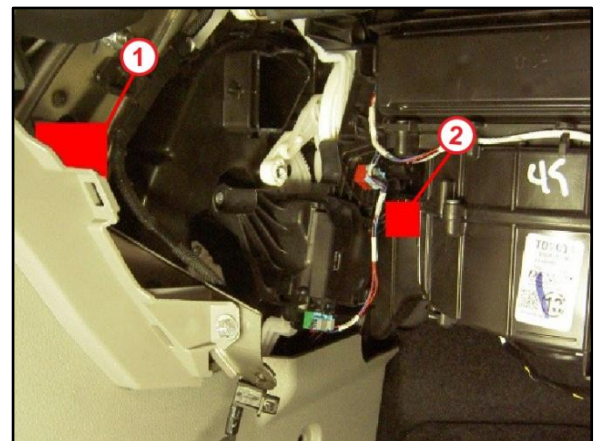
Figure 28.

1	Center console/dash metal brace
2	Blower motor case

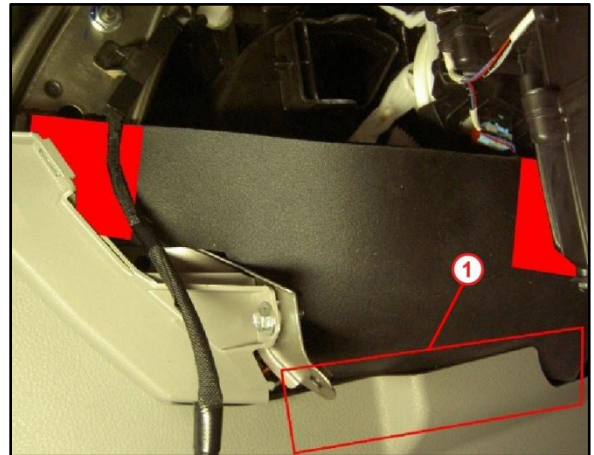
Figure 29.

- (3) Tuck the bottom portion of the insulation sheet to the inside of the lower trim panel.
- (4) Remove the two adhesive liners and adhere to the respective locations.

1	Lower trim panel
----------	------------------
