# Technical Service Bulletin

**Technical Service Bulletin:**  
TSB160088

**New Intake and Exhaust Rocker Levers**

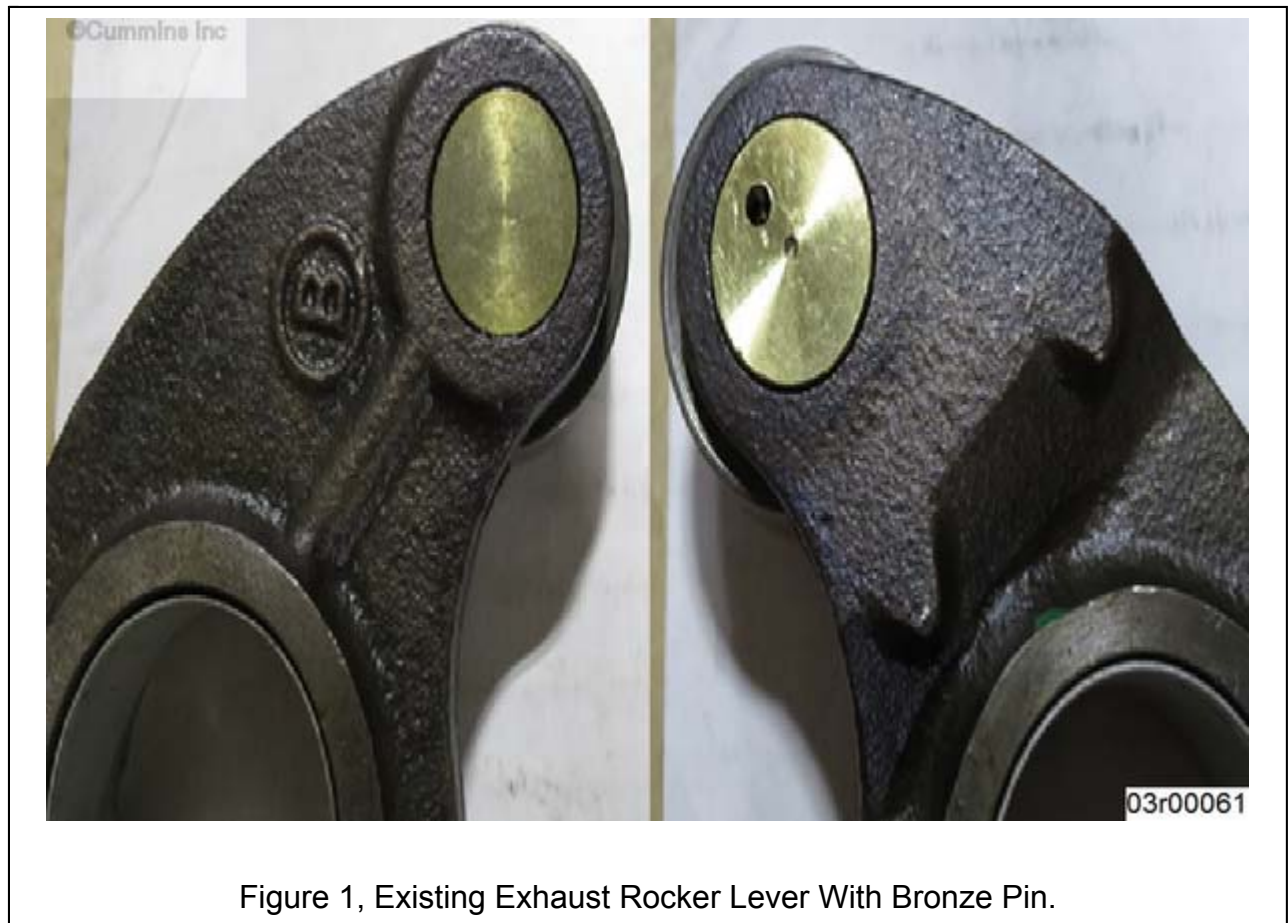
- A bronze colored, solid pin. See Figure 1 below.

Figure 1, Existing Exhaust Rocker Lever With Bronze Pin.

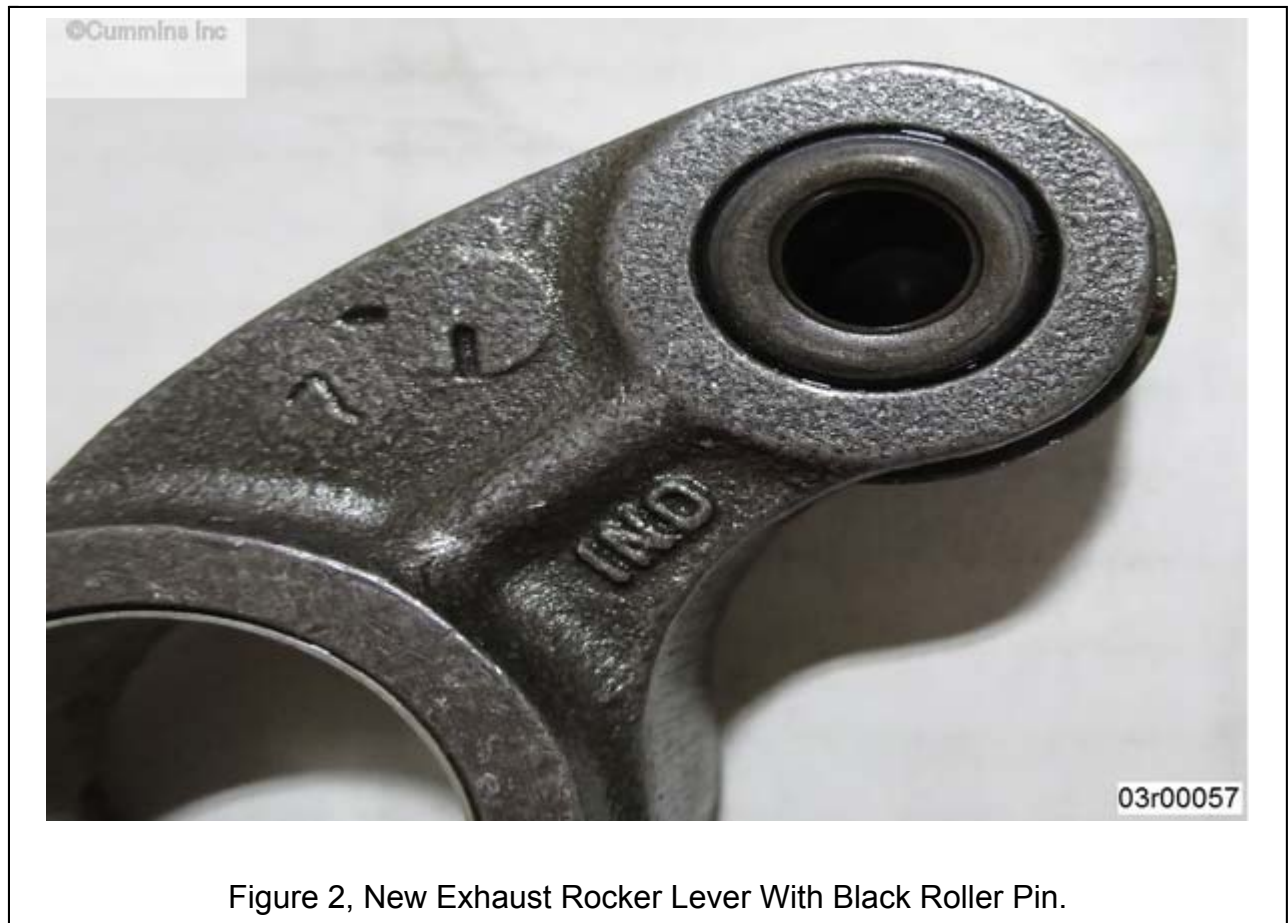
- A roller pin which is black in color. See Figure 2 below.
- A drilling on bottom leg of rocker lever. See Figure 3 below.

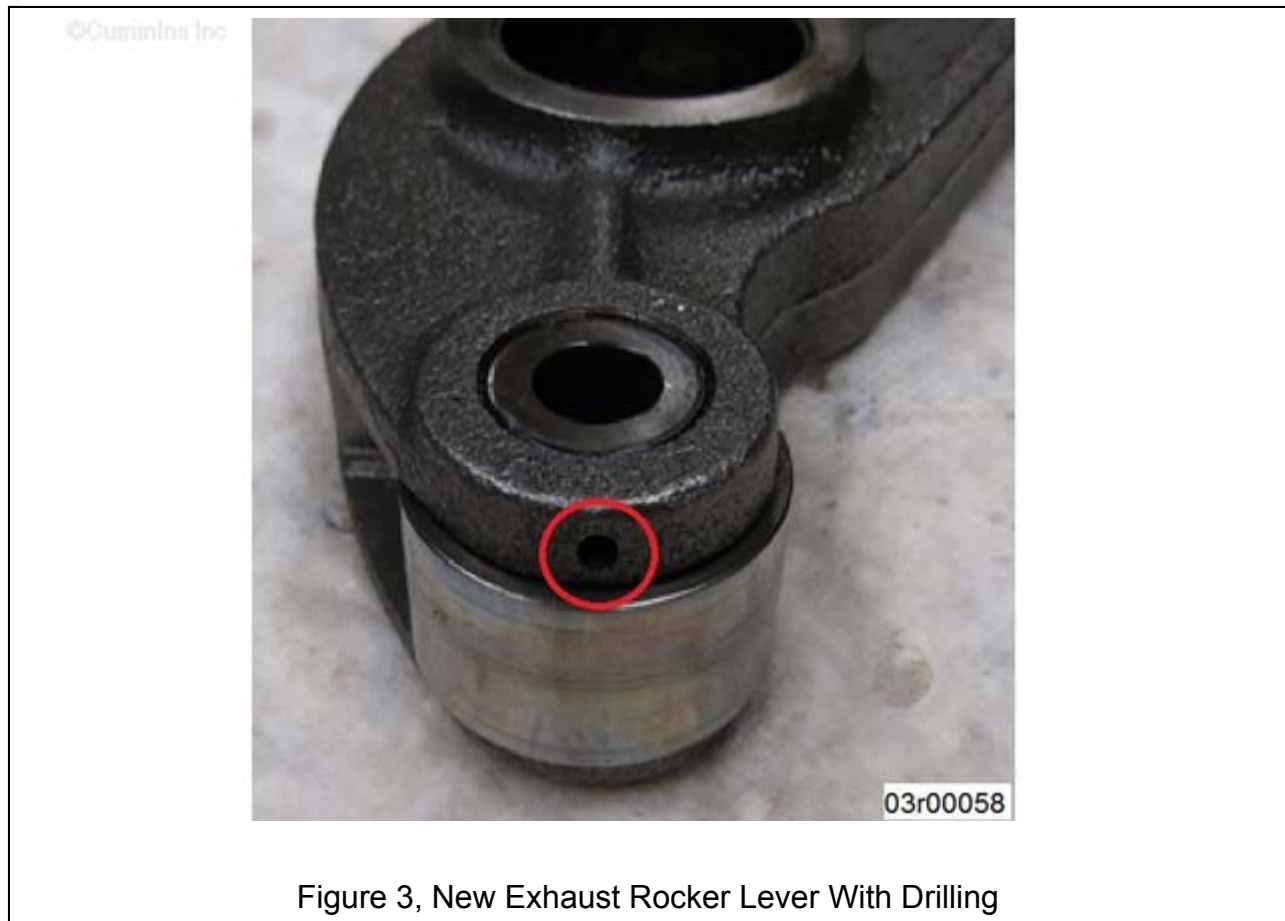
**Pin Protrusion:** Since the introduction of the new pin design, in some cases, it has been identified to have the cam follower pin to be protruding out of the side of the rocker lever cast surface. This condition is often associated with a pin and roller seizure issue (See Figure 3 below). Visual appearance condition does also exist on new production parts and is considered normal. Graphics below provide an anticipated range of pin position (See Figure 4 below). Amount of pin that protrudes may vary due to normal manufacturing processes. If rocker levers are found to exceed specifications provided, rocker lever may need replaced.

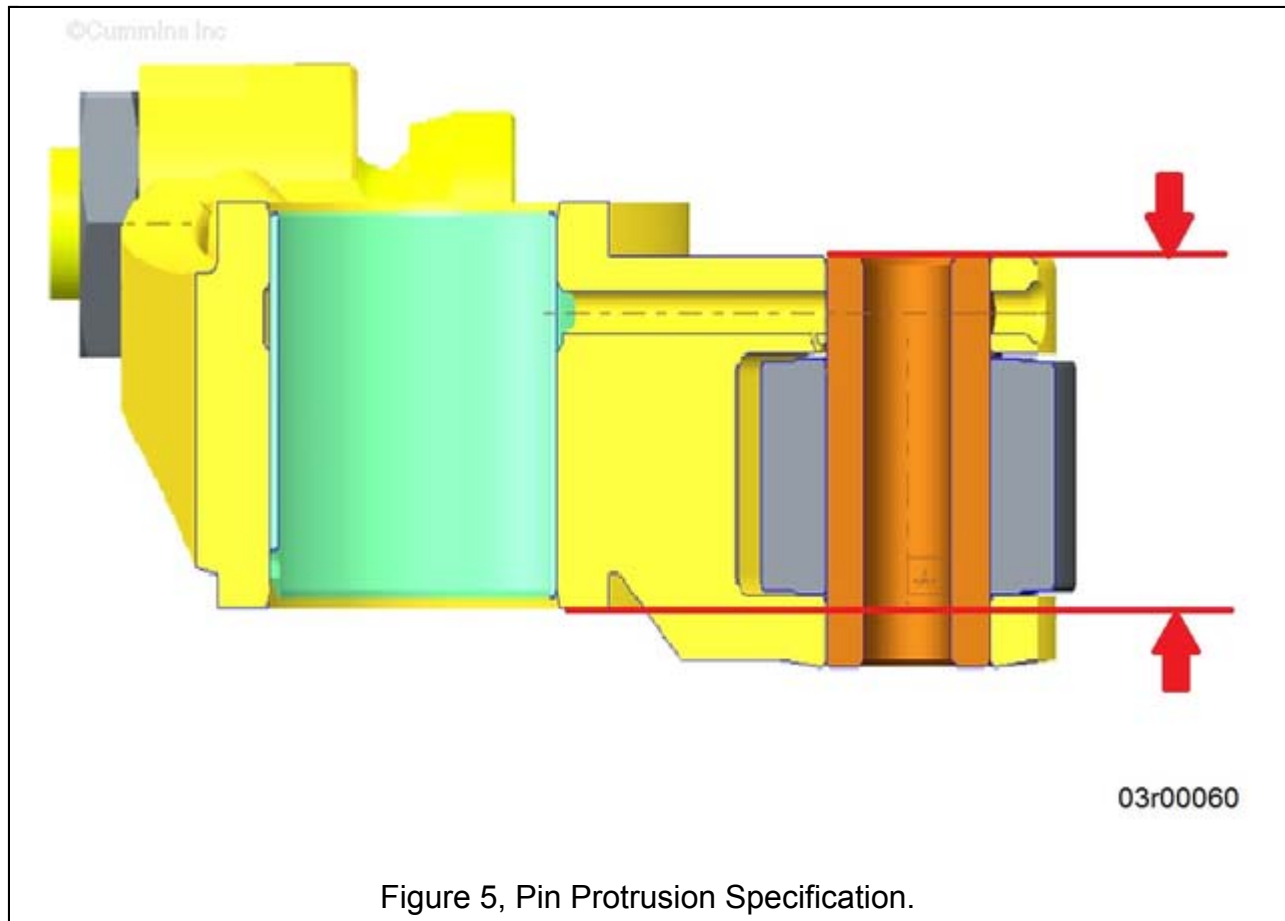
Figure 5, Pin Protrusion Specification.

The pin location is determined by measuring the distance from the face of the cam follower pin from the side of the rocker lever that has the thick cast leg (it is also the surface that is on the same side of the lever as the adjusting screw) to the opposite thrust face of the rocker lever. The specification limit for this distance is 25.25 +/- 0.3 mm.
