## Technical Service Bulletin

GROUP <b>FUEL SYSTEM</b>	NUMBER <b>18-FL-003</b>
DATE <b>JUNE, 2018</b>	MODEL <b>VELOSTER (FS)</b>

<b>SUBJECT:</b>	<b>AIR DRAIN CASE REPLACEMENT</b>
-----------------	-----------------------------------

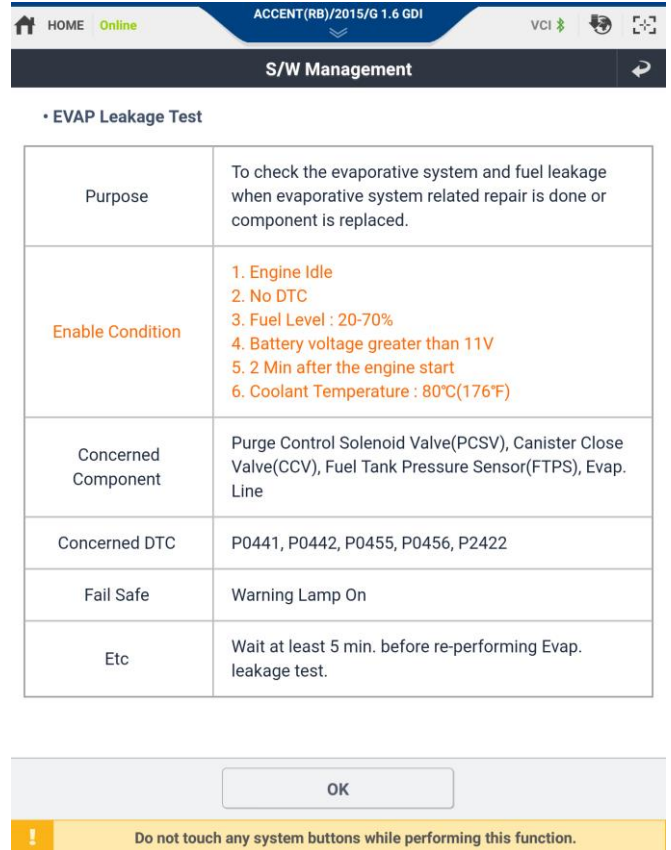
• EVAP Leakage Test	
Purpose	To check the evaporative system and fuel leakage when evaporative system related repair is done or component is replaced.
Enable Condition	1. Engine Idle 2. No DTC 3. Fuel Level : 20-70% 4. Battery voltage greater than 11V 5. 2 Min after the engine start 6. Coolant Temperature : 80°C(176°F)
Concerned Component	Purge Control Solenoid Valve(PCSV), Canister Close Valve(CCV), Fuel Tank Pressure Sensor(FTPS), Evap. Line
Concerned DTC	P0441, P0442, P0455, P0456, P2422
Fail Safe	Warning Lamp On
Etc	Wait at least 5 min. before re-performing Evap. leakage test.

OK

! Do not touch any system buttons while performing this function.

8. Connect the GDS and perform the **Evap Leakage Test** to ensure a result of **No Leak Detected**. This will confirm proper installation and that the original DTC P0455 condition has been resolved.

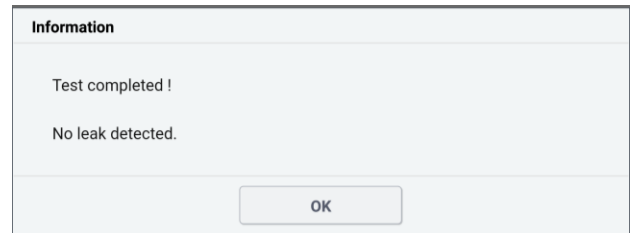
This is the result when Evap Leakage Test completes successfully with “No leak detected.” →

**Information**

Test completed !  
No leak detected.
