2GR-FKS Engine Oil Leak From Cam Sensor Bolt Hole(s)

Service Category Engine/Hybrid System

Section Lubrication

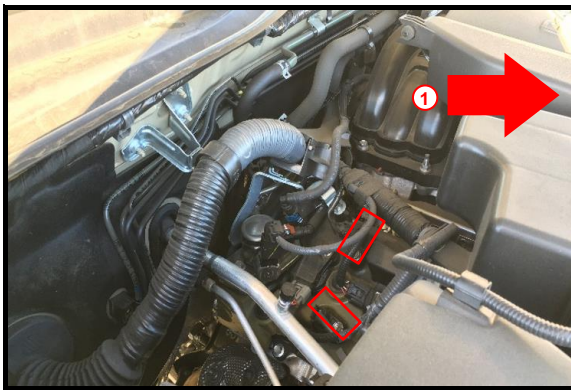
Figure 1. Cam Sensor Locations

1	Front of Vehicle
----------	-------------------------

Does the vehicle exhibit an oil leak from one or more cam sensor bolt holes?
(Refer to Figures 1 – 4.)
