Loss of Power and Check Engine Light with Fault Codes P15FF00 or P245411

Topic number	LI07.08-N-065219
Version	3
Function group	07.08 Governor
Date	03-21-2018
Validity	Model 906.### #N as of 574794 up to 605428 with engine 642 Model 906.### #S as of 874134 up to 977452 with engine 642
Reason for change	Content of remedy updated and additional step (operation step 5) inserted.
Reason for block

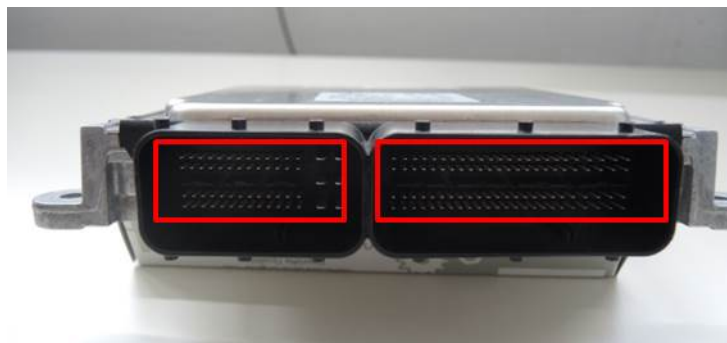
1.jpg:

4.1 A total of 154 contact pins have to be cleaned on the engine control unit (see 1.jpg).

Attachments	
File	Description
1.jpg	View of contact pins on control unit
2.jpg	View of color-marked areas (connection M)
3.jpg	View of color-marked areas (connection F)
4.jpg	Apply cleaning fluid to cleaning contact, Avoid dropping any fluid onto the felt!
5.jpg	Slide cleaning contact onto pins (small) (connection M)
6.jpg	Slide cleaning contact onto pins (large) (connection F)
7.jpg	Slide cleaning contact onto pins (small) (connection F)
8.jpg	Differential pressure sensor plug not fastened
9.jpg	Differential pressure sensor plug fastened
