Automatic Transmission Torque Converter Housing Cracked: Damage Resulting From Cracked Diesel Particulate Filter Mount

Topic number	LI49.00-N-067929
Version	1
Function group	49.00 General
Date	03-23-2018
Validity	Model 906 with OM651 and transmission G42 (7G-Tronic Plus)
Reason for change	
Reason for block

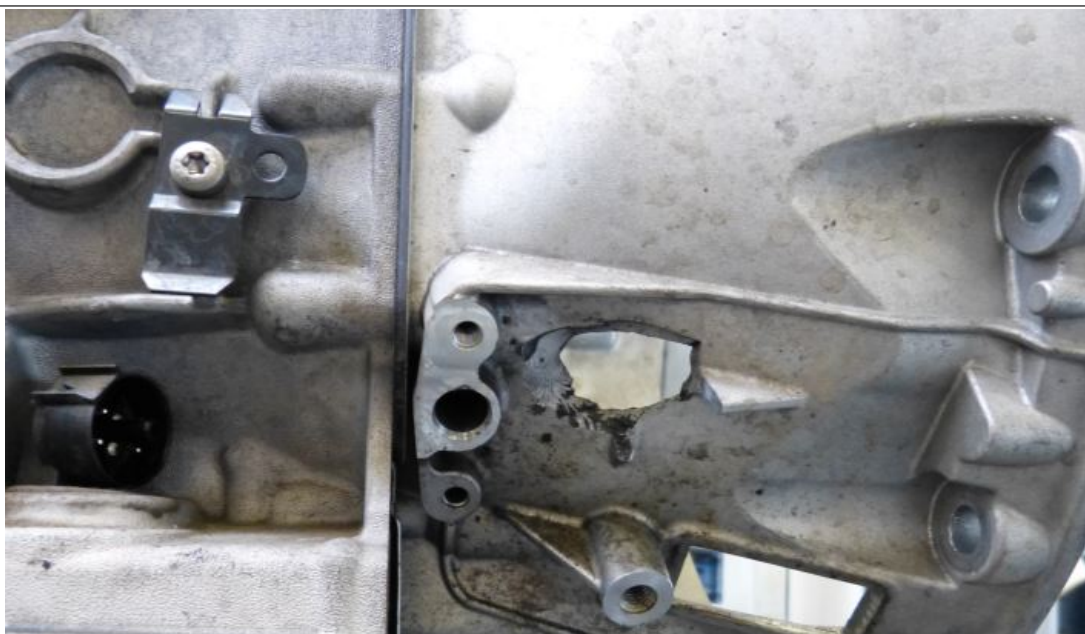
Schadensbild Gehäuse außen.JPG:

Torque converter housing in area of diesel particulate filter mount has cracked. May be accompanied by banging or clunking noise.

Damage is likely due to excessive loading caused by failure of diesel particulate filter mount.

If the diesel particulate filter mount has cracked and caused damaged to the transmission mounting location (see example photos), ONLY the torque converter housing is to be replaced.

-
- #1 - Uninstall torque converter housing with multidisk brake B1 and oil pump still attached - (AR27.50-D-0602A).
 - #2 - Remove multidisk brake B1 and oil pump (AR27.50-D-0721WE) from original bell housing.
 - #3 - Replace torque converter housing and reinstall multidisk brake B1 and oil pump - (AR27.50-D-0721WE). Please refer to EPC for correct part number.
 - #4 - Reinstall new torque converter housing.
-
