GROUP	NUMBER		
BODY ELECTRICAL	18-BE-009		
DATE	MODEL(S)		
AUGUST, 2018	SONATA (LF)

OUTSIDE MIRROR ACTUATOR PART INFORMATION AND INSPECTION/REPLACEMENT PROCEDURE

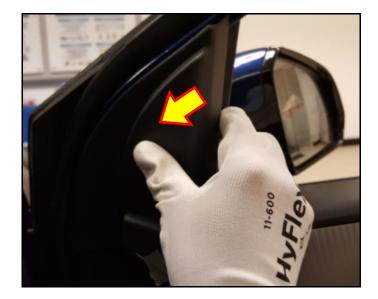
If the mirror is inoperative, remove the Delta cover and check the condition of the connector from the mirror to the door harness.

If the connector is fully engaged and the mirror will not actuate as designed, proceed to replacing the actuator.

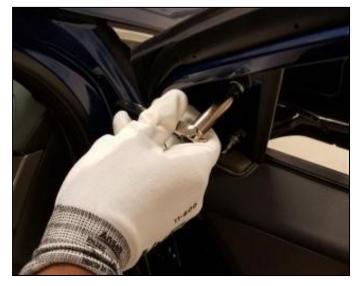
1. Remove the three 10mm nuts holding the outside mirror.

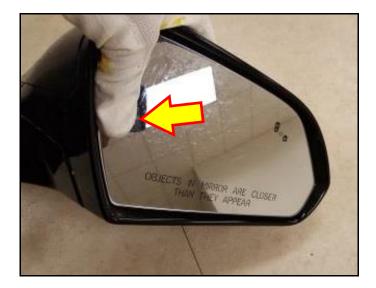
2. Remove the outside mirror assembly from the door.

Apply pressure on the inside end of the mirror until there is no more glass movement.

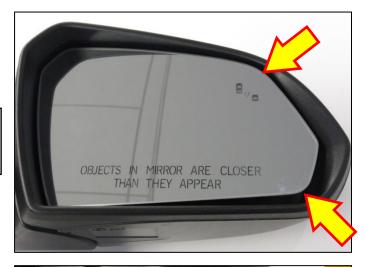
4. Use a small torx (T10) screwdriver to remove the screw holding the actuator to the base housing.

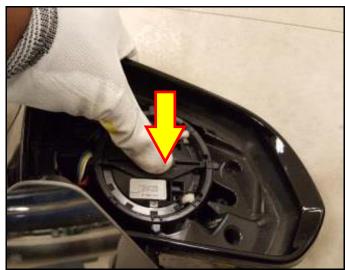
When installing the actuator onto the outside mirror assembly, do not forcefully press it into place. When aligned correctly, it should snap into place with minimum force.

The actuator will not snap into place until it is aligned in the correct position. If necessary continue to rotate the actuator until the alignment is met, then press downward to lock it into place.

8. Confirm the outside mirror is operating as designed.
