NUMBER: 07-005-15

Intermittent Coolant Weepage From Upper Radiator Hose

This bulletin involves installing an additional clamp on the upper radiator hose

2015 (LA) Dodge Challenger

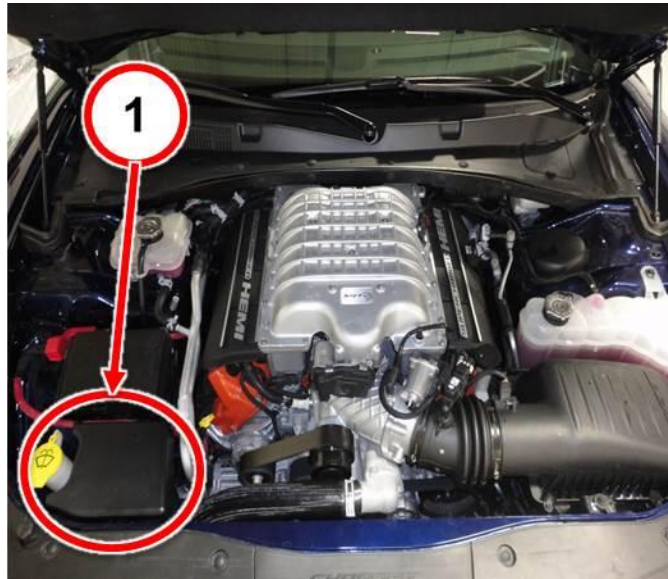
Fig. 1 Underhood View

2. If equipped, remove the impact cover located above the ABS module, See (Fig. 1), by removing the 2 push pin retainers located between the cover and the Power Distribution Center (PDC) and then sliding the cover rearward.

1 - ABS Module Impact Cover

- 6. Install the impact cover over the ABS module.
- 7. Verify that the cooling system is at the proper level. Top off if necessary before proceeding.
- 8. Start the vehicle and allow the engine to warm up for approximately 5 minutes
- 9. Verify there is no coolant leaking from the upper radiator hose connection.

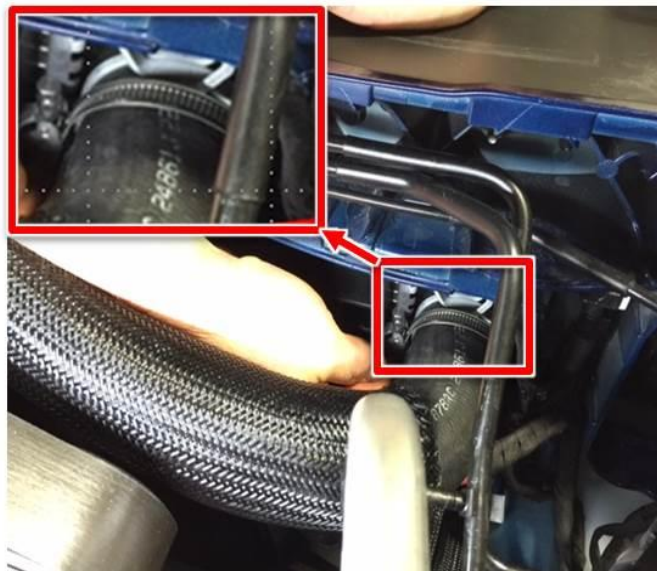
Fig. 2 Radiator Hose Clamp Orientation

3. Inspect the upper radiator hose and verify it is properly seated onto the radiator. The end of the hose should be tight against the stop molded onto the radiator.
4. Open the new clamp and place it over the radiator hose. The hex head of the clamp should be facing up and be oriented on the core side of the radiator. See (Fig. 2).

NOTE: When installing the new clamp, the original will remain in place. The new clamp should be positioned between the existing clamp and the radiator outlet flange. Take care not to overlap the clamps.

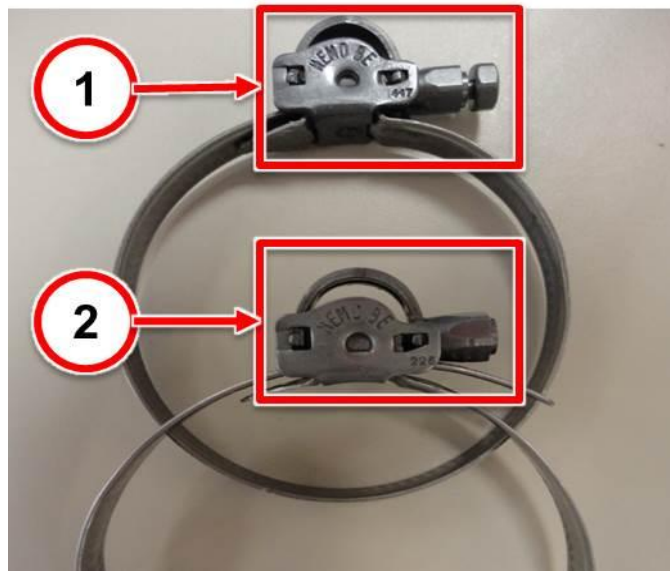
Fig. 3 Hose Clamp Torque Limiting Head

- 5. Using a 7mm shallow socket and swivel, tighten the new clamp until the torque limiting head breaks free. See (Fig. 3).

- 1 - Before tightening
- 2 - After tightening

NOTE: The new clamp will have a torque limiting head. The head will break free once proper torque of 3 nm (26 in lb) is achieved. Care must be taken to ensure the socket used only engages the head of the bolt to prevent over tightening the clamp.
