Technical Service Bulletin

GROUP CAMPAIGN	NUMBER 18-01-029
DATE SEPTEMBER, 2018	MODEL(S) VELOSTER (JS)

SUBJECT LUGGAGE COVERING SHELF DAMPER REPLACEMENT (SERVICE CAMPAIGN T3E)

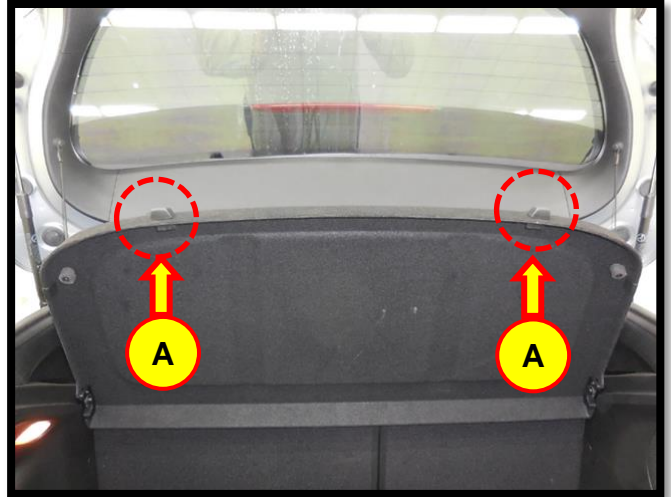
1. Open the tailgate and check the location of the luggage covering shelf dampers (A).

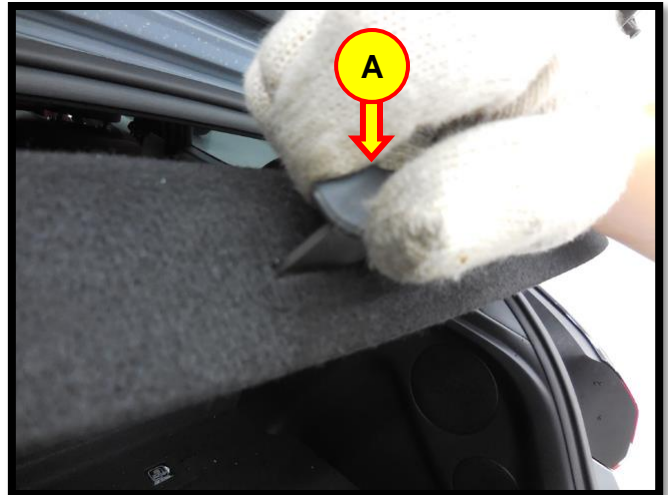
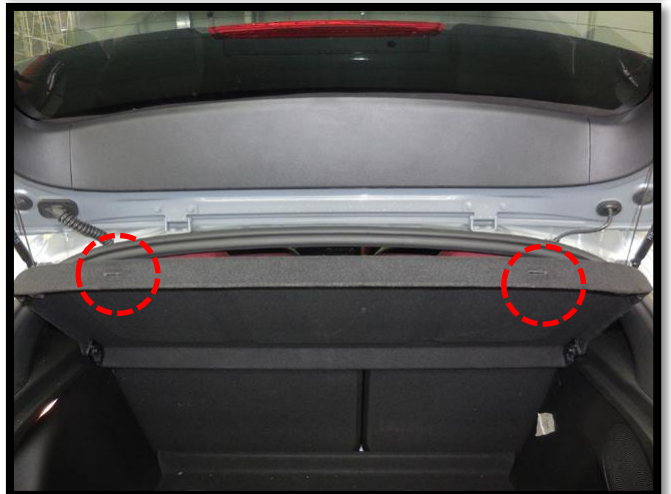
2. Gently remove damper by hand and set aside.

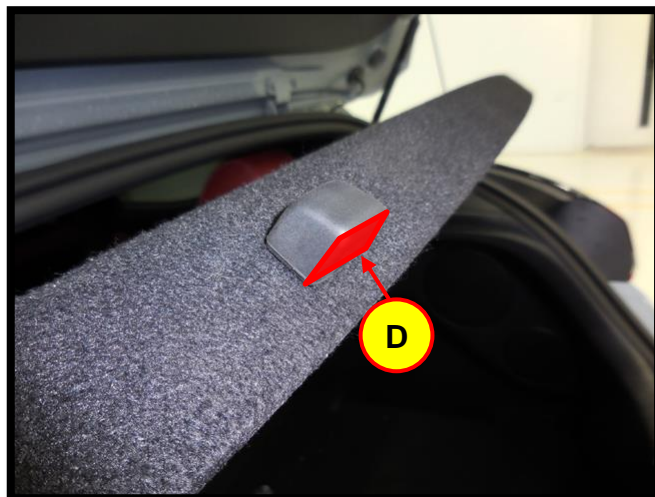
NOTICE

Longer side of the damper (D) should face to the lower side of the covering shelf.

Insert the damper firmly and check that there is no gap between the damper and covering shelf.

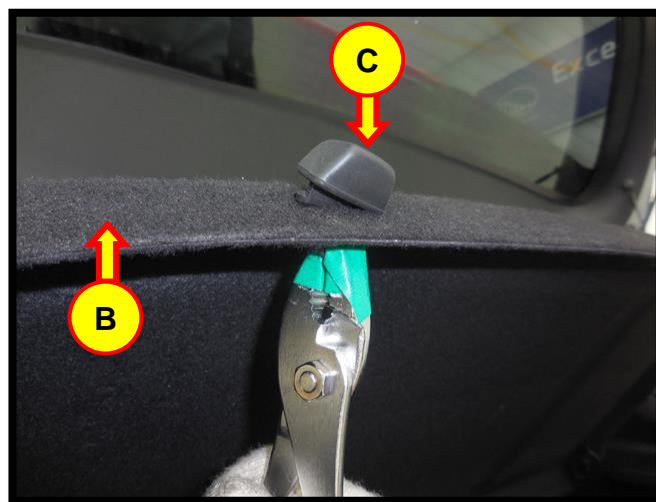
3. Insert the new damper (C) to the covering shelf (B). Pull the damper to clip against the covering shelf using a plier or a similar hand tool.

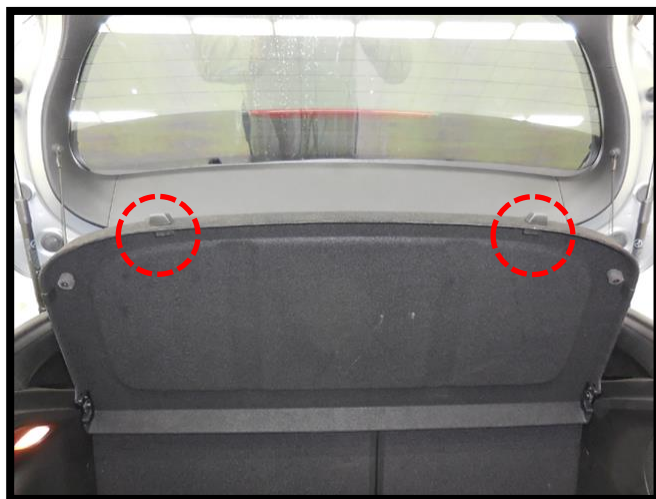
4. Once the new dampers are installed, check proper operation of the tailgate by performing an open/close cycle.
