**** TECHNICAL INFORMATION NOTICE ****

DATE: September 24, 2018
TO: Mitsubishi Motors US & Puerto Rico Dealer Service and Parts Managers
RE: Coolant Leaking from Water Hoses at CVT8 Fluid Cooler
TIN NO. TIN-18-23-004

AFFECTED VEHICLES: 2016 - 2018 Outlander Sport equipped with CVT8 transmission (F1CJC/W1CJC)

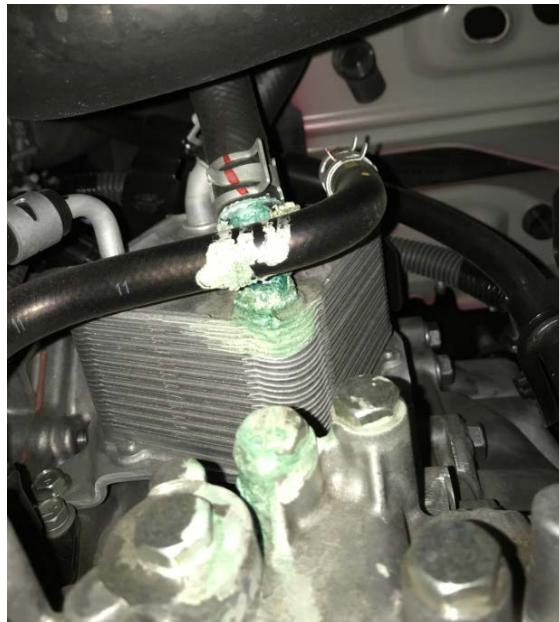
Dealers have reported coolant leaking from the water hoses at the CVT8 fluid cooler (see photo below). Normal dealer repairs have been to replace the water hose and/or clamps on the affected area.

(View looking up from the bottom of the vehicle)

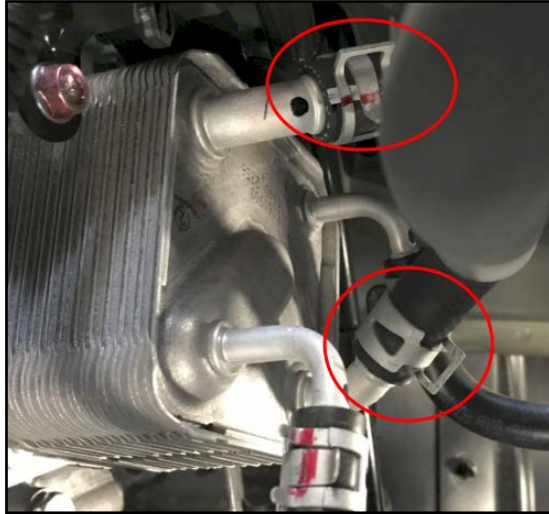
In order to investigate this condition further, MMNA is looking to collect 3 complete sets of CVT8 fluid coolers with the water hoses and clamps **undisturbed**. Please **do not remove** the water hose clamps and hoses indicated by the circled areas in the photo below (the other hoses are for the CVT8 oil, not coolant). This is important since MMC needs to perform a duplication test to confirm the area of leakage.

Please open a Techline case, attach photos of the condition, and contact Techline (800-446-6064) to review the findings. Product Support will then contact the dealership to arrange return of the original parts to MMNA.
