TECHNICAL INSTRUCTIONS
FOR
SPECIAL SERVICE CAMPAIGN JSD
CONTINUOUSLY VARIABLE TRANSAXLE SOFTWARE UPDATE
CERTAIN 2014-2017 TOYOTA Corolla
CERTAIN 2017 TOYOTA Corolla iM
CERTAIN 2016 SCION iM

UPDATE 9-17-2018

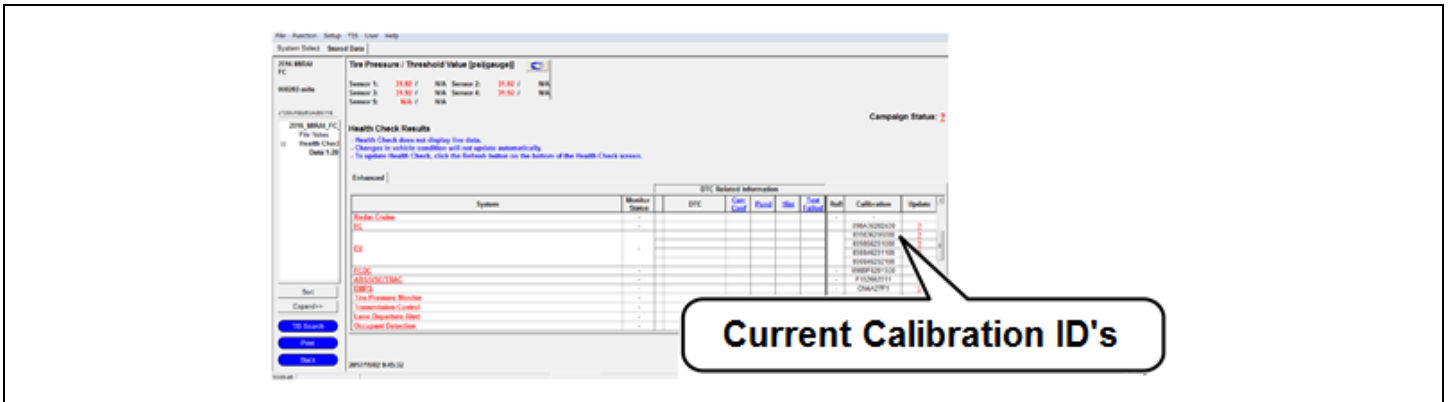
- Identify the Calibration ID for the ECM in the Health Check Results.
- Referencing the table below, verify if the ECM has the updated Calibration.

Vehicle Specification				ECM Calibrations	
Model	MY	Engine	Shift Type	Current CID	New CID
COROLLA	2014	2ZR-FAE	Gate	302Y <u>6000</u>	302Y<u>6500</u>
				302Y <u>6100</u>	
				302Y <u>6200</u>	
				302Y <u>6300</u>	
				302Y <u>6400</u>	
		2ZR-FE	Gate	302W <u>8000</u>	302W<u>8500</u>
				302W <u>8100</u>	
				302W <u>8200</u>	
				302W <u>8300</u>	
				302W <u>8400</u>	
	2015 - 2016	2ZR-FAE	Gate	302Y <u>7000</u>	302Y<u>7500</u>
				302Y <u>7100</u>	
				302Y <u>7200</u>	
				302Y <u>7300</u>	
				302Y <u>7400</u>	
2015 - 2016	2ZR-FAE	Gate	302U <u>1000</u>	302U<u>1300</u>	
			302U <u>1100</u>		
	2ZR-FE	Gate	302U <u>1200</u>		
			30Z5 <u>8000</u>	30Z5<u>8300</u>	
30Z5 <u>8100</u>

Vehicle Specification				ECM Calibrations	
Model	MY	Engine	Shift Type	Current CID	New CID
COROLLA	2015 - 2016	2ZR-FE	Gate	30Z58200	<u>30Z58300</u>
			Sequential	30Z59000	<u>30Z59300</u>
				30Z59100	
				30Z59200	
	2017	2ZR-FAE	Gate	30ZC1000	<u>30ZC1200</u>
				30ZC1100	
		2ZR-FE	Gate	30ZC2000	<u>30ZC2200</u>
				30ZC2100	
			Sequential	30ZC3000	<u>30ZC3200</u>
				30ZC3100	
iM	2016	2ZR-FAE	Sequential	30W01000	<u>30W01200</u>
				30W01100	
COROLLA iM	2017	2ZR-FAE	Sequential	30W03000	<u>30W03200</u>
				30W03100

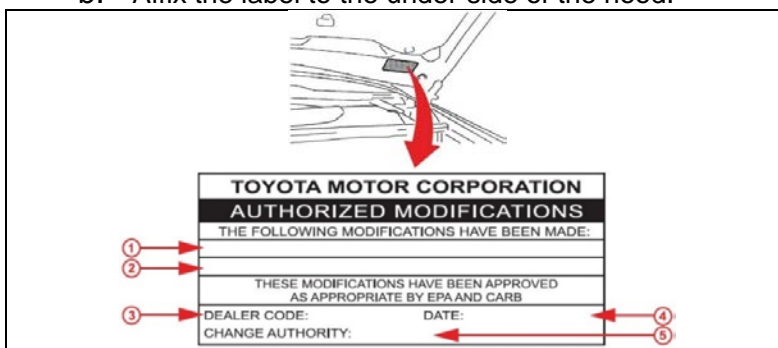
- a. Fill out the label.
- b. Affix the label to the under-side of the hood.

1	ECM P/N
2	New Calibration ID
3	Dealer Code
4	Date Completed
5	Campaign Code (XXX)

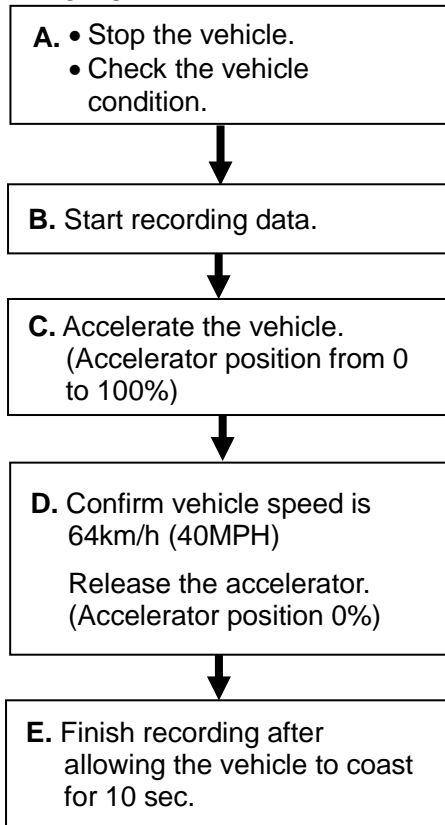
< FLOWCHART >

- Confirm A/C ON.
- Confirm 0km/h (0MPH).
- A/T Oil Temperature is higher than 40°C (104°F).
- Confirm that the Techstream displays the required data items.

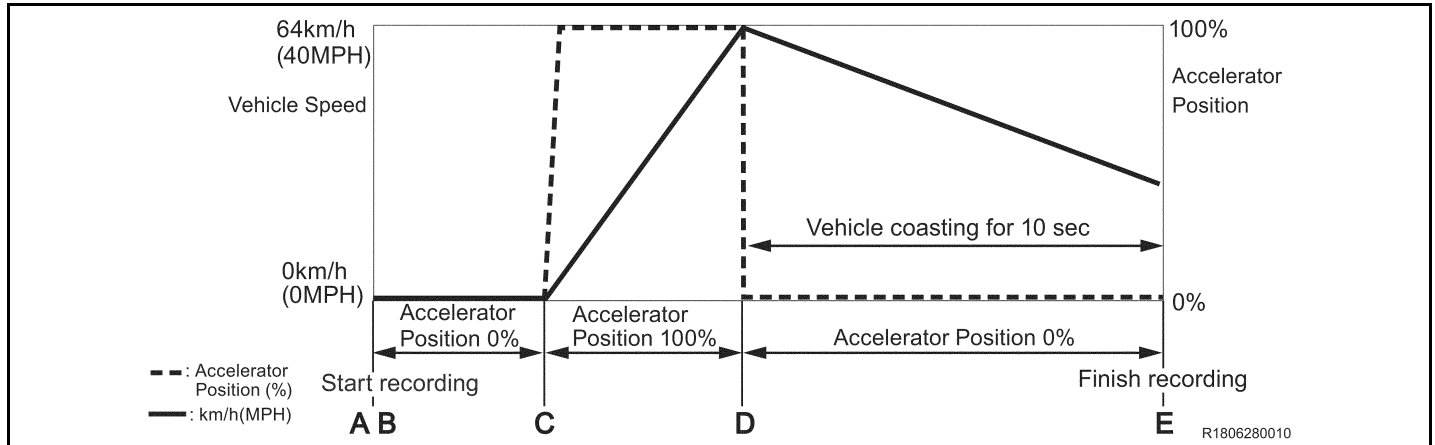
f. With the vehicle stopped, fully depress the accelerator pedal (wide open throttle) so that the accelerator position becomes 100 % and accelerate the vehicle to 40MPH (64 km/h),

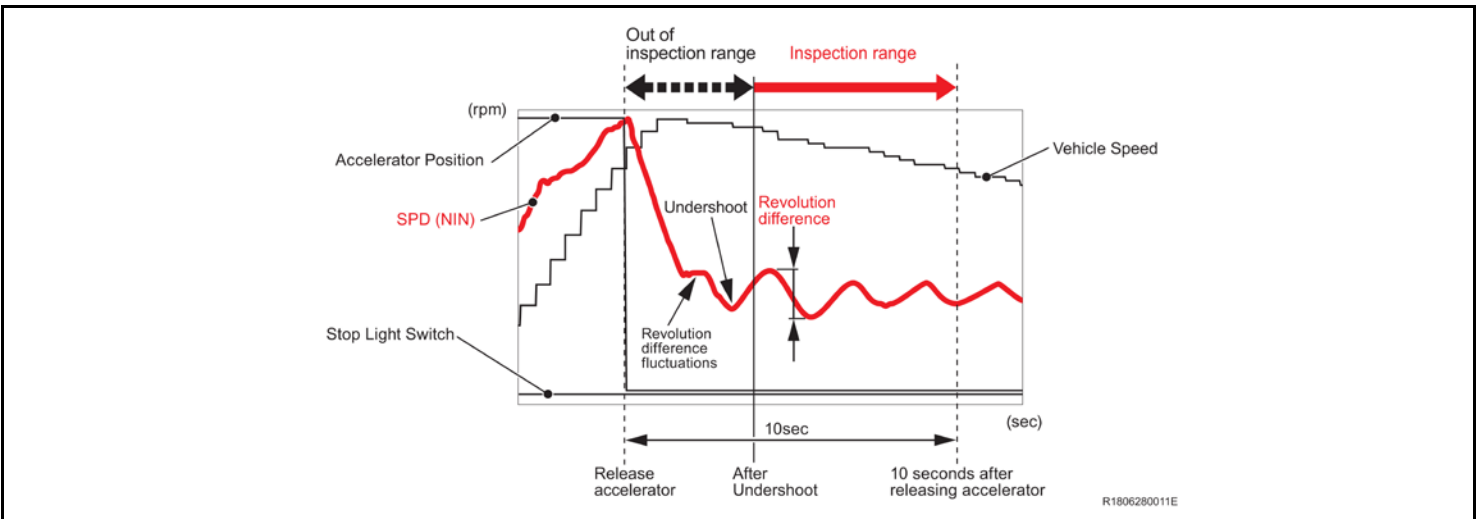
- Confirm that a scale of SPD (NIN) represents 50 rpm.
- The recorded time of the data can be checked at (sec) on the graph.

Judgment	Check Result	To do
OK	RPM difference is less than 250 rpm. 	CAMPAIGN COMPLETE Return the vehicle to the customer
NG	RPM difference is greater than or equal to 250 rpm even at one place. 	Valve body assembly replacement is required. Go to next page and follow the instructions on how to release the parts for valve body replacement

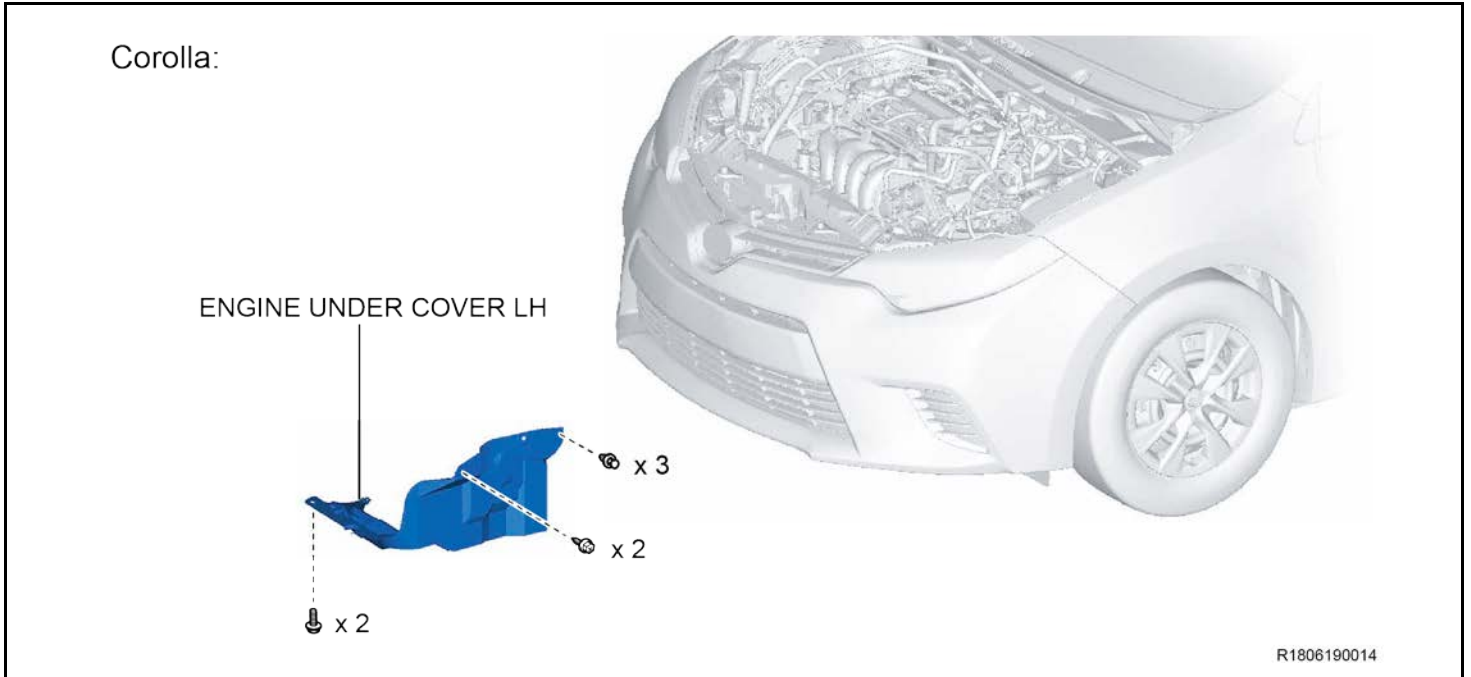
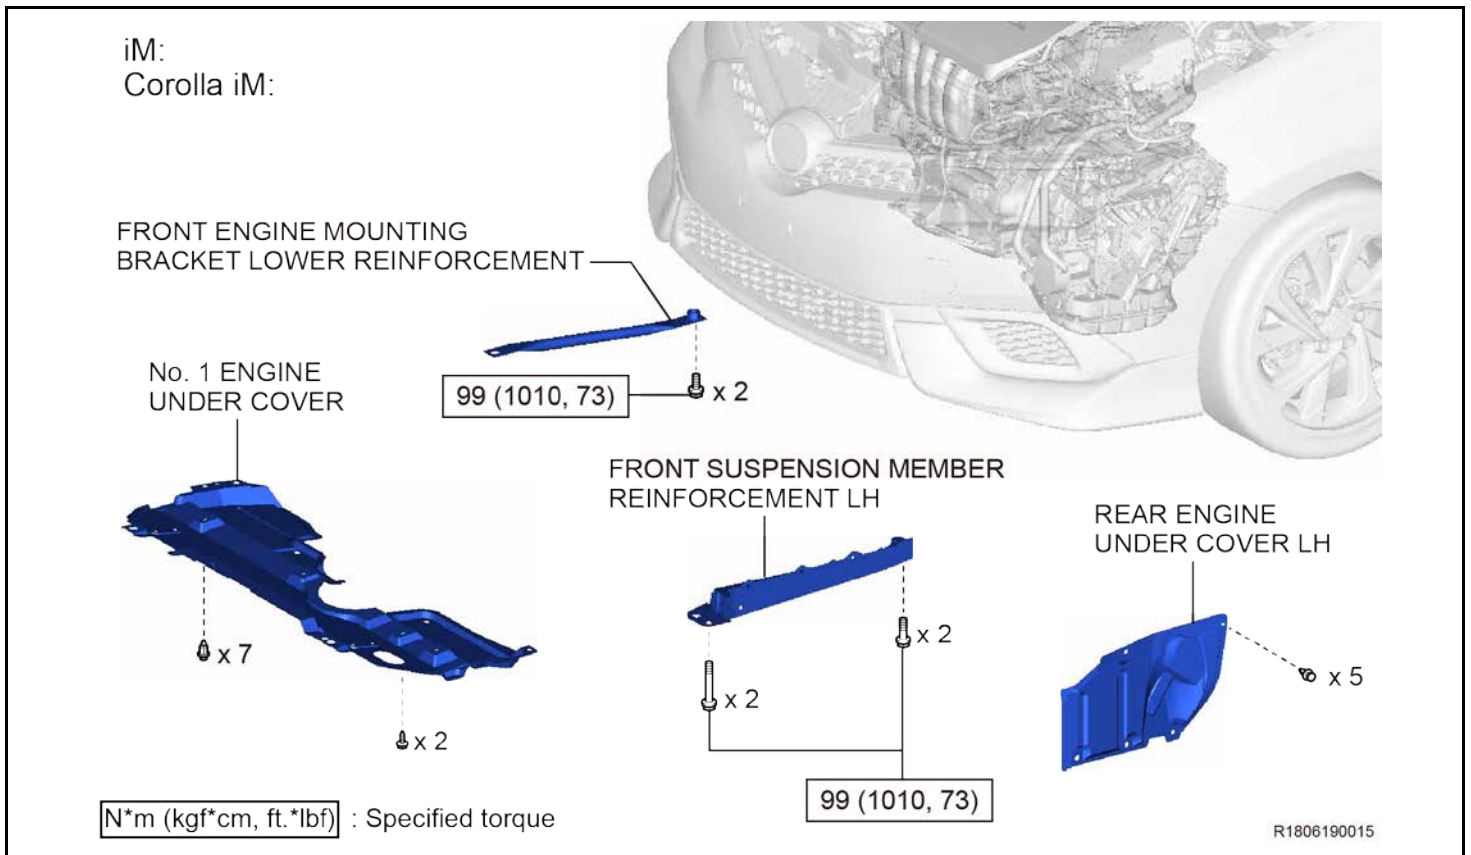
COMPONENTS

● : Replacement part

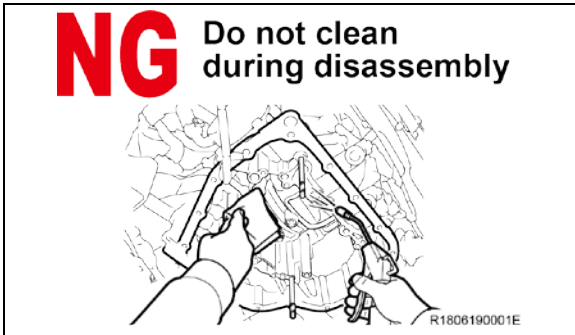
Clean off oil off before disassembling, knock the area to be cleaned with a lint free cloth to absorb oil. **DO NOT** perform a wiping action, or the lint free cloth may be caught by burrs and lint may be generated.

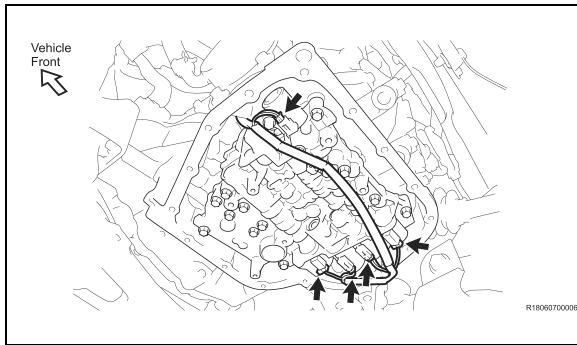
13. REMOVE THE TRANSMISSION HARNESS

- a) Disconnect 5 connectors of transmission harness from the transmission valve body assembly.

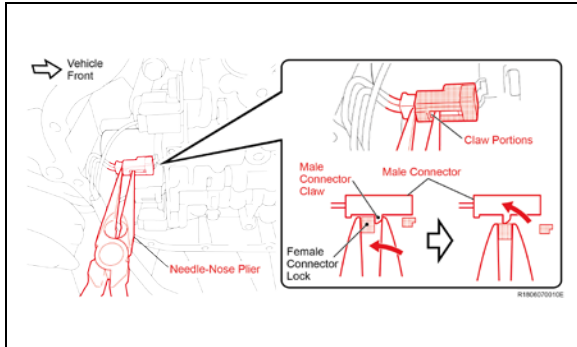
- b) To remove the connector, apply the needle-nose plier end to the male connector tab.
 c) Gently hold the needle-nose plier and then push the male connector tab out.

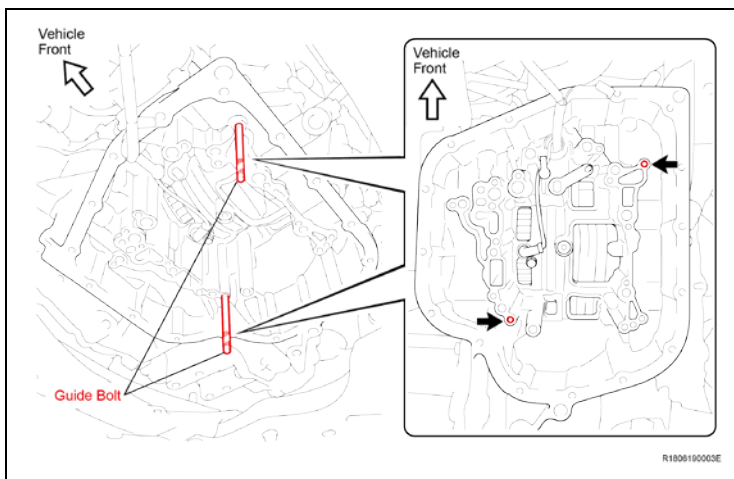
3. Install the 2 guide bolts at the positions shown in the illustration.

Make sure to use the guide bolts, since the valve body may slide and cause the transaxle case gasket to fall off.

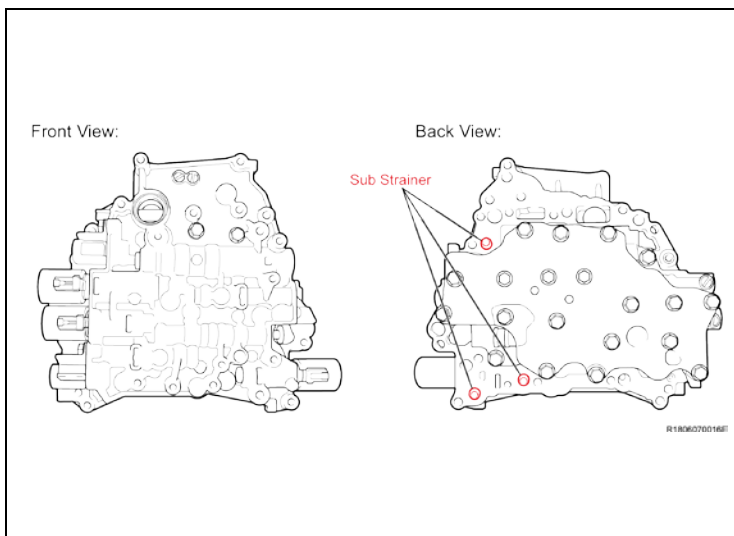
- When installing the **NEW** transmission valve body assembly, fit it into the transmission case carefully as to **NOT** damage the top of the sub strainers that are positioned at the back of the transmission valve body assembly.
- When installing the **NEW** transmission valve body assembly, hold the transmission valve body assembly horizontally to prevent the manual valve from falling off.

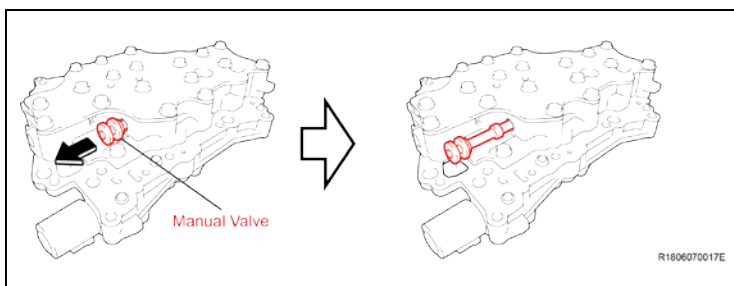
- a) Pull out the manual valve as shown in the illustration.

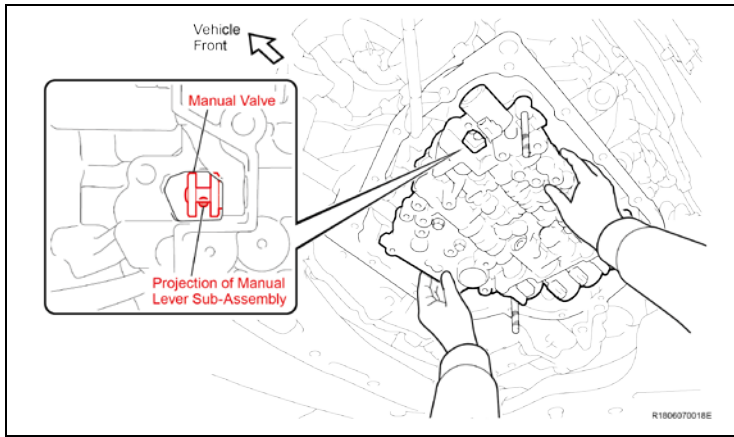
4. Match the position of the holes of the **NEW** transmission valve body assembly to the guide bolts and hold the valve body assembly in place.
5. Ensure that the projection of the manual valve lever sub-assembly and the groove of the manual valve are matching as shown.

If the projection is not matching the groove, relocate the manual valve.

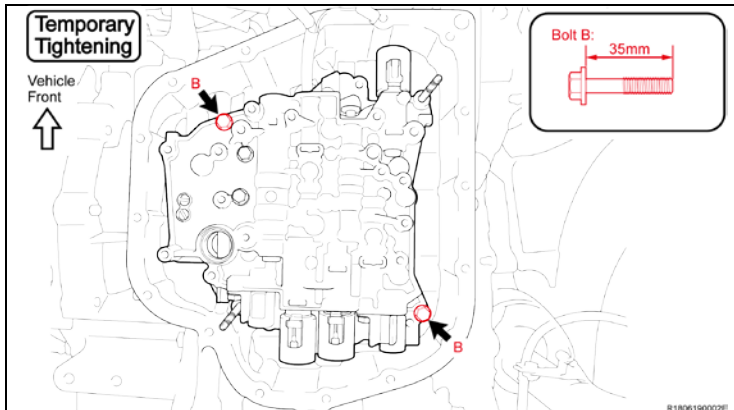
6. Push to install the **NEW** transmission valve body assembly to the transmission case and hold it in place.
7. Holding the transmission valve body assembly, install the 2 bolts (35 mm in length) to position B.

8. Temporarily tighten the bolts manually until they sit properly on the transmission valve body assembly.

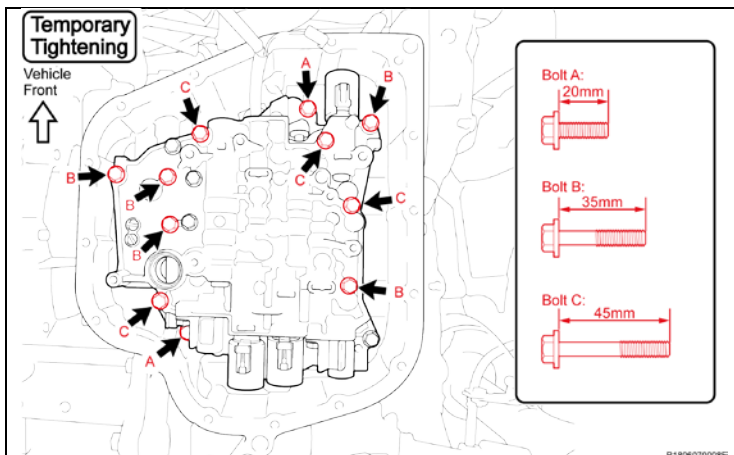
9. Remove the 2 guide bolts.
 10. Temporarily tighten the remaining 11 bolts manually until they sit properly.
- Bolt A: (2) 20mm in length**
Bolt B: (5) 35mm in length
Bolt C: (4) 45mm in length

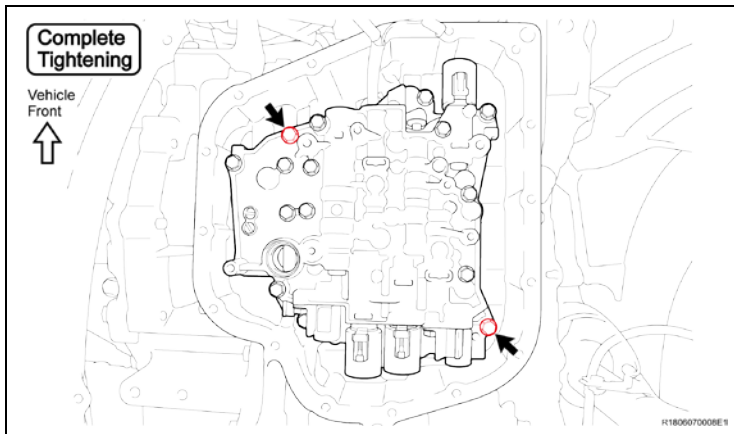
11. Tighten the 2 bolts.
Torque: 10.8 N*m (110 kgf*cm, 8 ft.*lbf)
12. Every time one of the bolts is complete-tightened, clean the bolt head and put a yellow paint mark

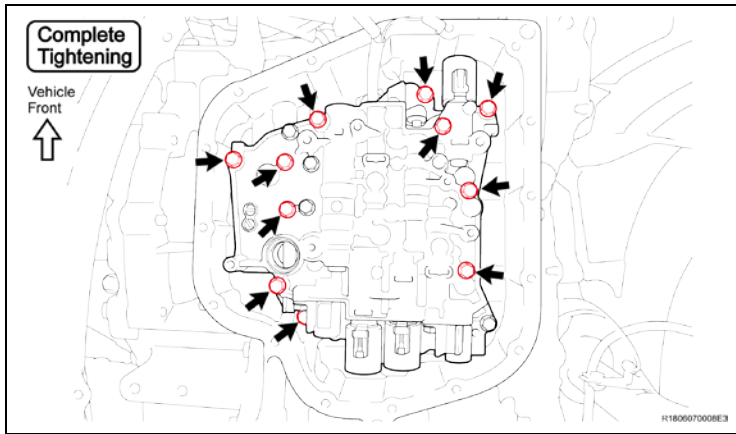
13. Tighten the other 11 bolts evenly.
Torque: 10.8 N*m (110 kgf*cm, 8 ft.*lbf)

14. Every time one of the bolts is complete-tightened, clean the bolt head and put a yellow paint mark.

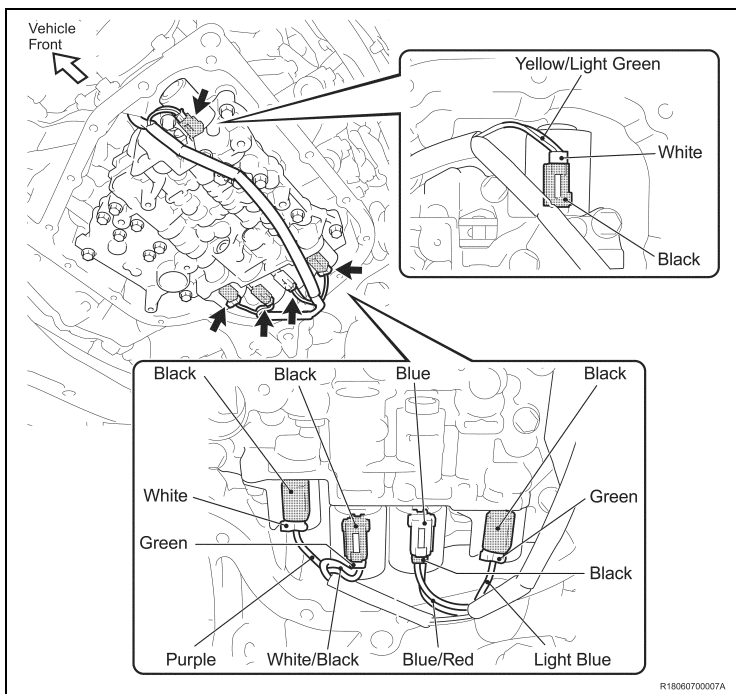
18. Reconnect the 5 connectors and install the transmission harness to the transmission valve.

STOP
Make sure to install the connector to the position shown in the illustration. If the installation position is mistaken, the CVT assembly may malfunction or need to be replaced.

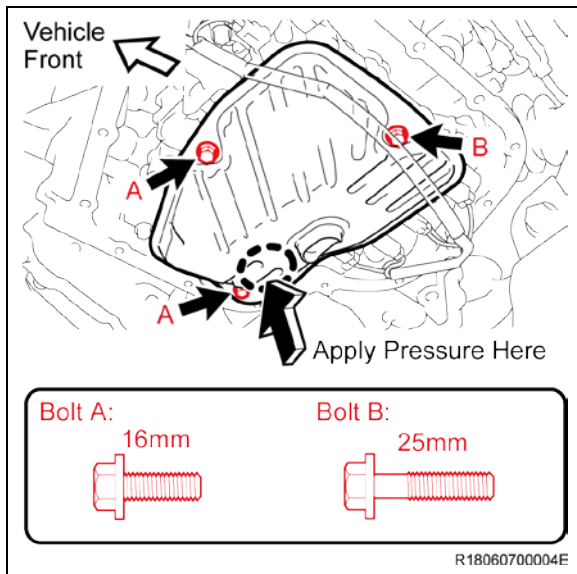
21. Tighten the 3 bolts evenly, temporarily reinstall the oil strainer to the transmission valve body assembly.

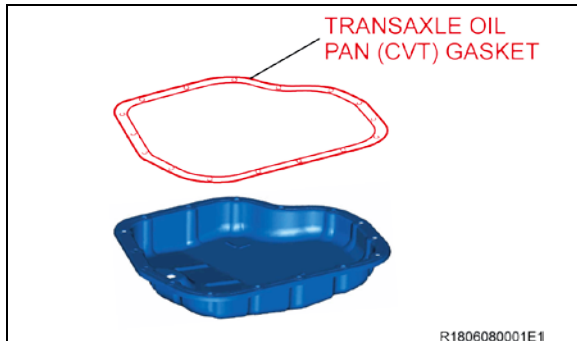
27. Tighten the 16 bolts evenly, and temporarily reinstall the transaxle oil (CVT) pan sub-assembly to the transmission case.
