**Squeak Noise from Front of Vehicle On Uneven Surfaces - FR RH (No.1) Body Mount Bushing
Squeak Noise from Front of Vehicle On Uneven Surfaces - FR RH (No.1) Body Mount Bushing**

2016-2018 MY Tacoma

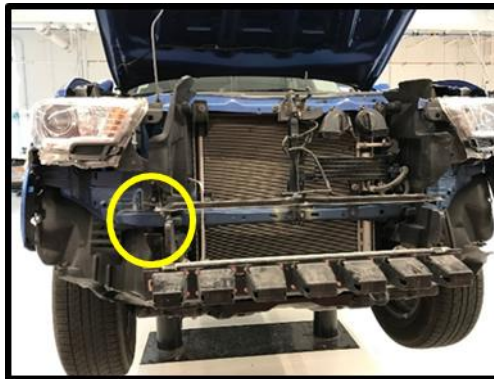
Some 2016-2018 model year Tacoma vehicles may exhibit a squeak or rattle noise from the FR RH (No.1) Body Mount Bushing when driving over uneven roads or bumps. Make sure to confirm that the noise is coming from the FR RH (No.1) Body Mount Bushing before proceeding.

Location of FR RH (No.1) Body Mount

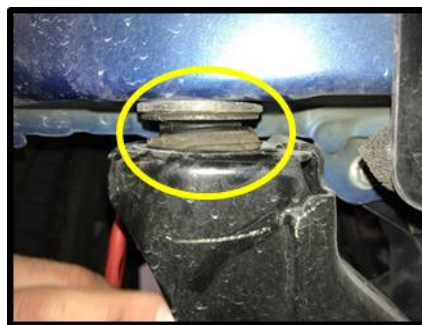
Example of bushing condition photo

1. BEFORE uninstalling the bolt from the FR RH (No.1) Body Mount, take a photo of the bushing condition and position in relation to the frame.

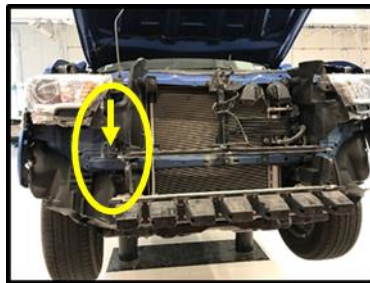
Location of Bolt top mounting surface and witness mark example

- After the bolt is removed, take a photo of the bolt witness mark on the body and note the direction of the offset. (see below for detail)
