# Technical Journal

**B&W speaker grill, noise**

<b>REF NO:</b> TJ 32777.1.0	<b>ISSUING DEPARTMENT:</b> Technical Service	<b>CAR MARKET:</b> United States and Canada	
<b>PARTNER:</b> 3 US 7510 Volvo Car USA		<b>ISSUE DATE:</b> 2017-10-23	<b>STATUS DATE:</b> 2017-11-15
<b>FUNC GROUP:</b> 8511	<b>FUNC DESC:</b> Door upholstery	Page 1 of 11

<b>Title</b>	Decor panel	<b>Page</b>	1 ( 9 )
<b>Action</b>	Product fix	<b>Operation number:</b>	98693-2

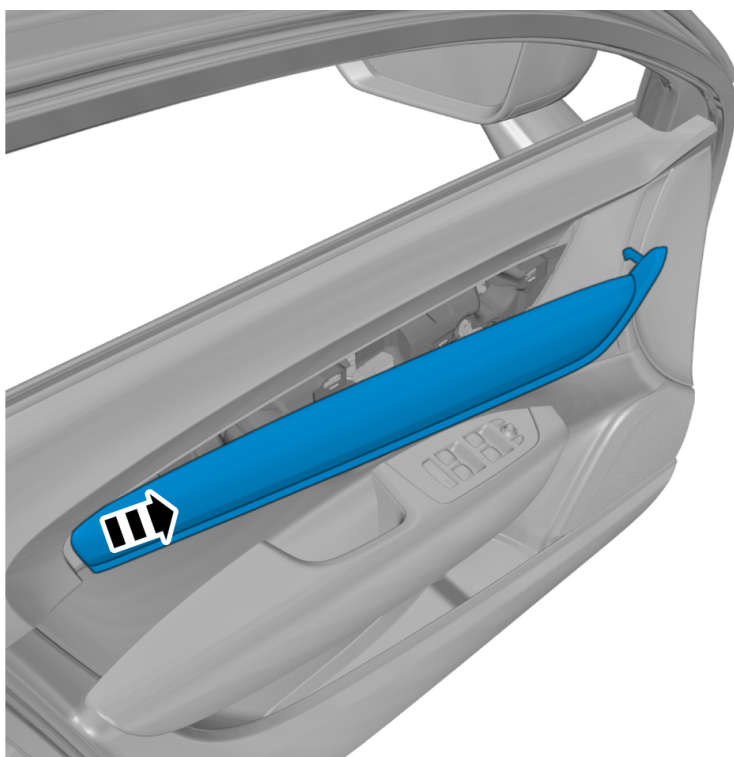
Remove the panel.

Disconnect the connector, if applicable.

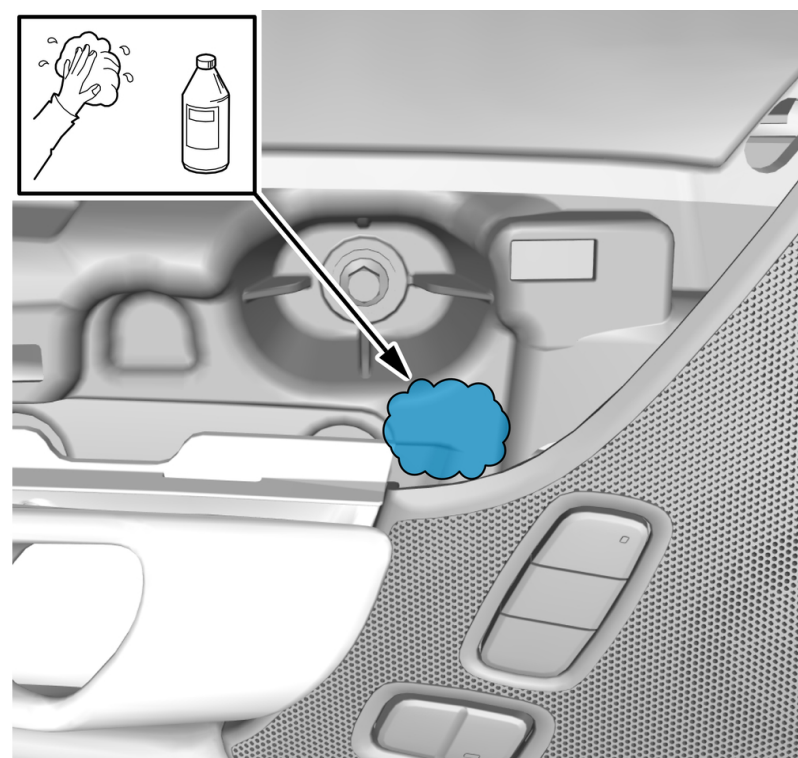
Clean the marked area.

**Use:** Isopropanol ,

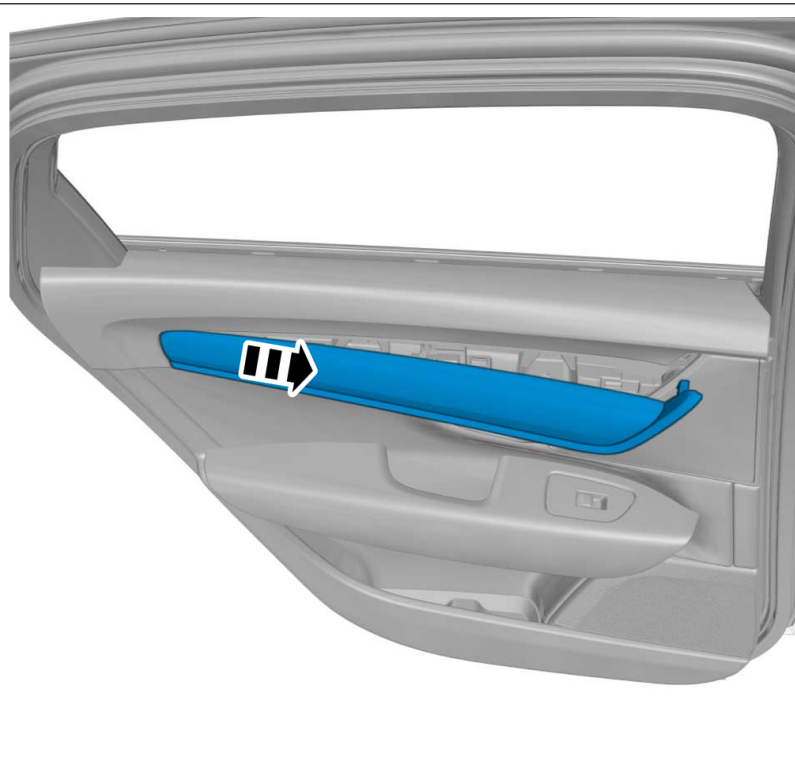
Remove the panel.

Disconnect the connector, if applicable.

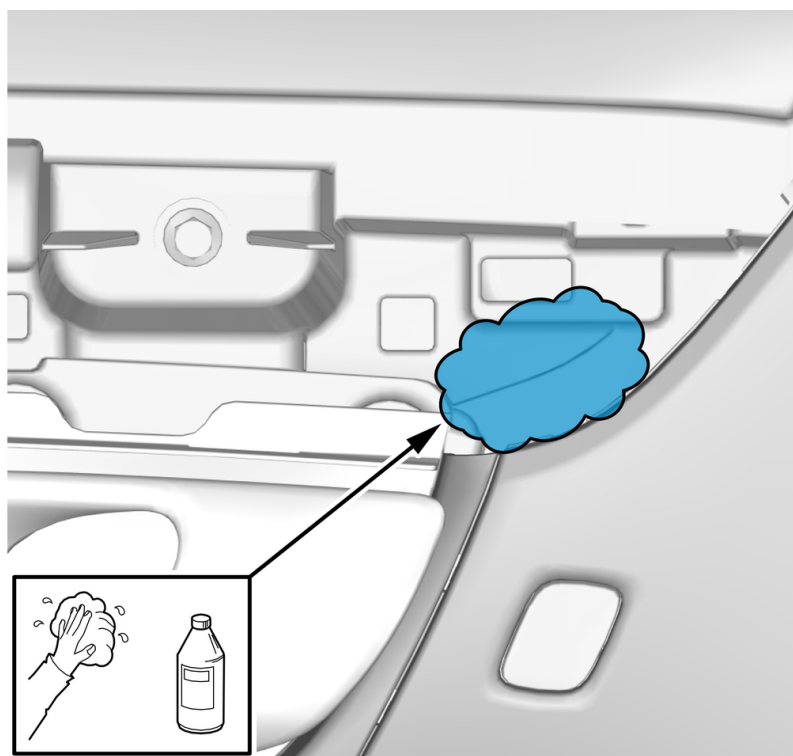
Clean the marked area.

**Use:** Isopropanol ,

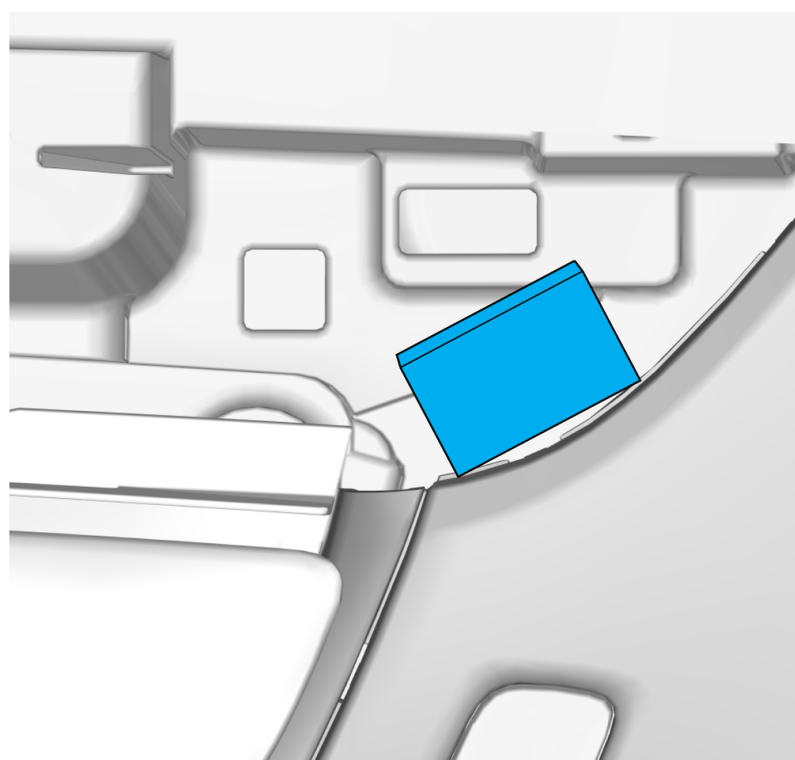
Remove the protective film.  
Install the marked component.

Reinstall the removed parts in reverse order.
