US 62067656-01

Navigator V (5) does not link up via the cradle

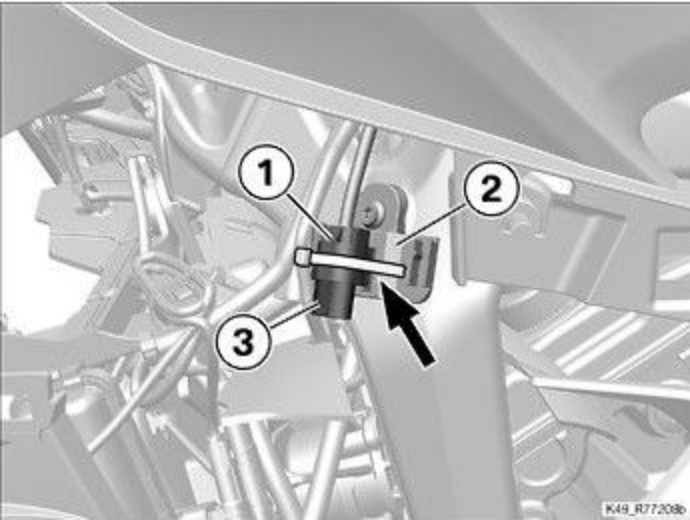
The Navigator V (5) does not link with the motorcycle when mounted in the cradle.

Cradle harness is plugged into the wrong connector.

The OA connector for the cradle is located on the left side of the vehicle.

See Workshop installation instructions 77 52 008 in the latest RSD.
