Volvo Models

Volvo Model Conventional

Title Volvo Chassis - HVAC Recirculation Door Whistle - **US17+OBD2016 Emissions, Model Year 2018 (Common Rail Fuel System ONLY)**

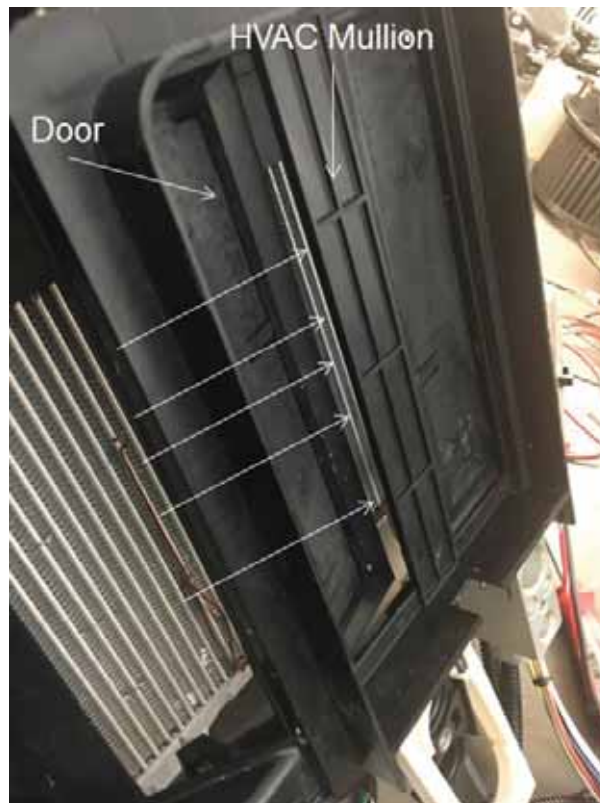
Cause HVAC Recirculation Door air gap causing a whistle at speeds over 50 mph.

Solution Over 50 mph+ conditions with the HVAC module in recirculation mode, low or medium blower speed whistle is heard in the cab of the vehicle. This believed to be caused by the air gap between the recirculation door center HVAC mullion.

The gap shown in the picture is enlarged for clarity.

Note: The evaporator core can be seen through the gap.

Remove air intake from vehicle to gain access to the recirculation door area from outside of the vehicle.

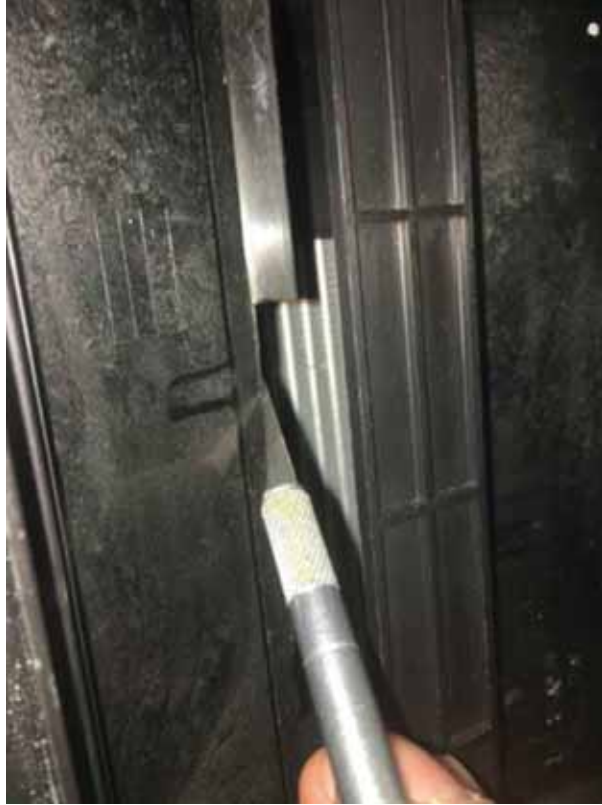
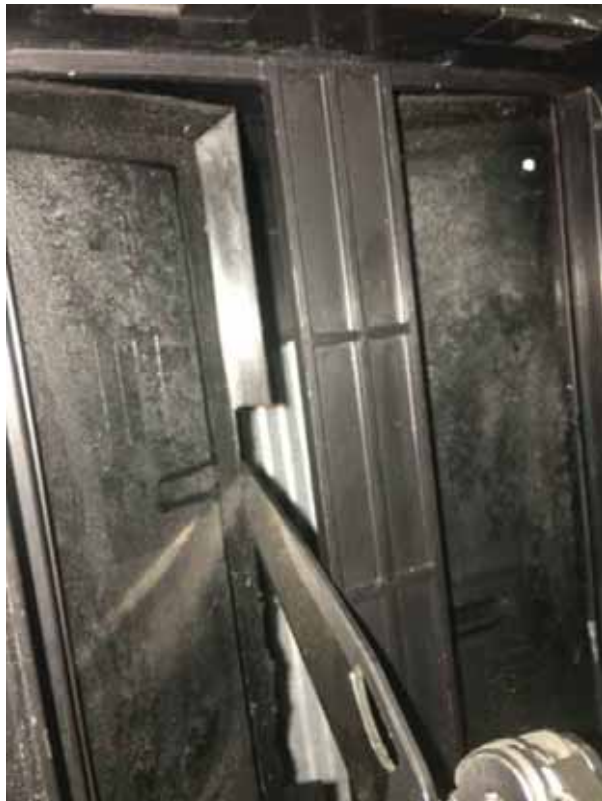
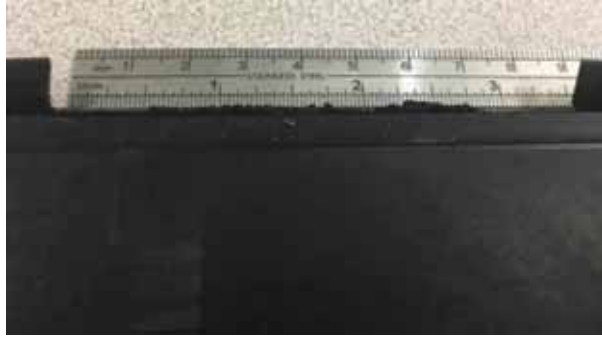
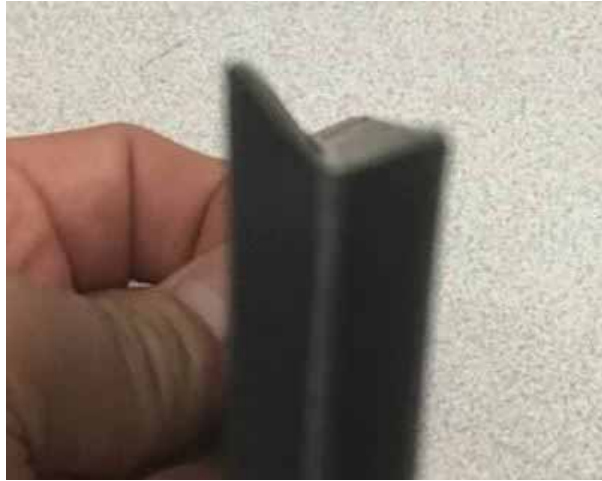
- Once access is complete carefully remove a section of the sealing surface of the door. Remove only the section that seals when the door is in recirculation
- **NOTE:** the seal is a “V” shape so you can remove only one side of the seal see picture.

- A sharp knife or exacto knife can be used for this operation

Both doors CAN have the overmold seal cut back as shown. However one should be sufficient.

Reinstall the air intake
