SI B63 03 15
Lights

Halogen Headlight Side Bulbs Fail

F30 (3 Series Sedan)

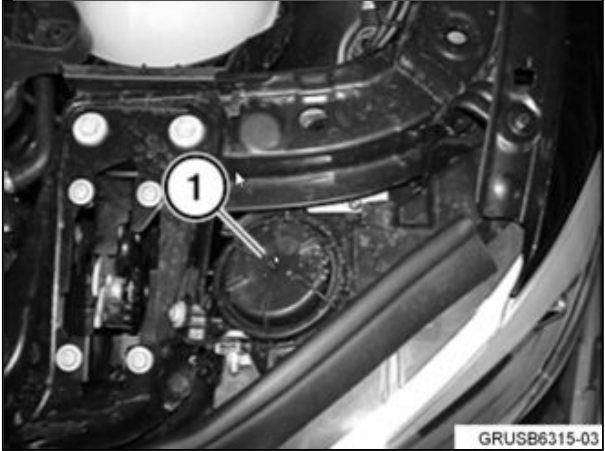
| | <p>Turn the protective cap (1) counterclockwise and remove.</p> <p>Installation note: To avoid a water leak, check that the seal in the protective cap is installed properly (1). Turn the protective cap (1) clockwise to the limit.</p> |

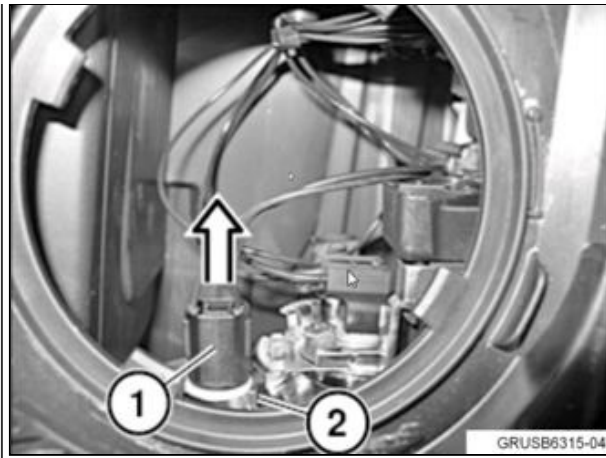
| | <p>Turn the bulb holder (1) left and then pull it up out of the headlight in the direction of the arrow.</p> <p>Installation note: Make sure the bulb holder (1) is seated</p> |

exactly in the headlight.

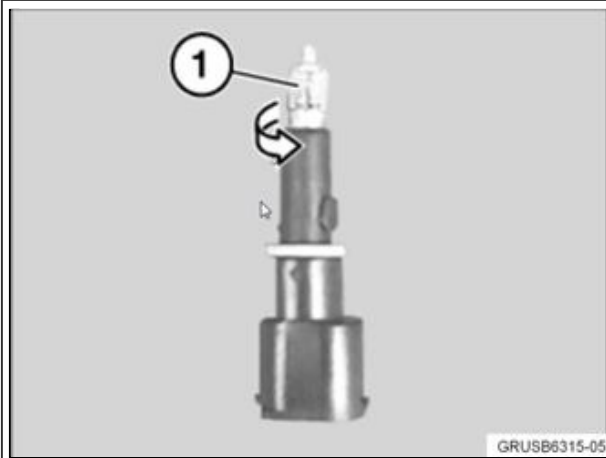
Turn the side light bulb (1) in the direction of the arrow and then pull it out of the bulb holder.

12V 6W halogen long-life bulb

Do not touch glass bulbs with bare hands, as even the smallest amount of contamination will burn in and reduce the bulb's service life.

Only touch light bulbs with clean gloves or a clean cloth.
