SUBJECT

External Engine Oil Leaks and Repairs

MODEL

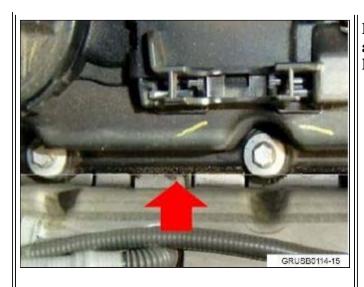
The purpose of this bulletin is to provide your workshop with information and a procedure that will help in identifying engine oils leaks that do and do not require a repair.
PROCEDURE A. No repair is necessary.
Light external engine oil accumulation: Due to sweating – this is not an "active" oil leak, and no repair is necessary.
Example: A-One Cylinder Head Cover Gasket

Light external engine oil accumulation No repair is necessary.

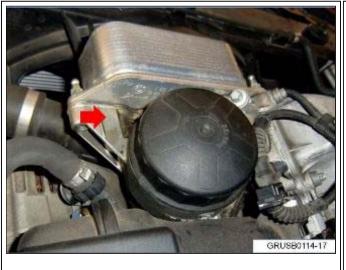
Example: A-Two
Oil Filter Housing and Heat Exchanger
Light external engine oil
accumulation
No repair is necessary.

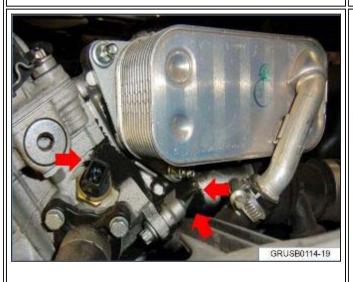
Example: A-Three Heat Exchanger **Light external engine oil accumulation No repair is necessary.**

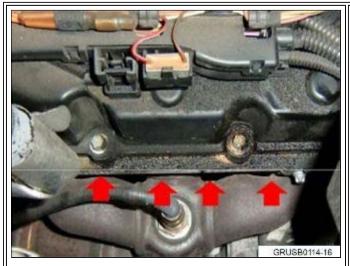
Medium to large external engine oil accumulation: Together with pooling, dripping and spotting – this is an active engine oil leak, and a repair is necessary.

Example: B-One Cylinder Head Cover Gasket **Medium to large external engine oil accumulation**

A repair is necessary.

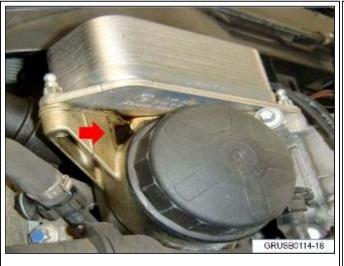
Example: B-Two
Oil Filter Housing and Heat Exchanger
Medium to large external engine oil
accumulation
A repair is necessary.

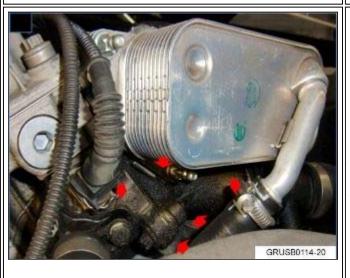
Example: B-Three
Heat Exchanger
Medium to large external engine oil
accumulation
A repair is necessary.
