SUBJECT
Band Clamp for Exhaust Front Pipe Is Loose
MODEL

F30 (3 Series Sedan)

F25 (X3)

With the N47T diesel engine

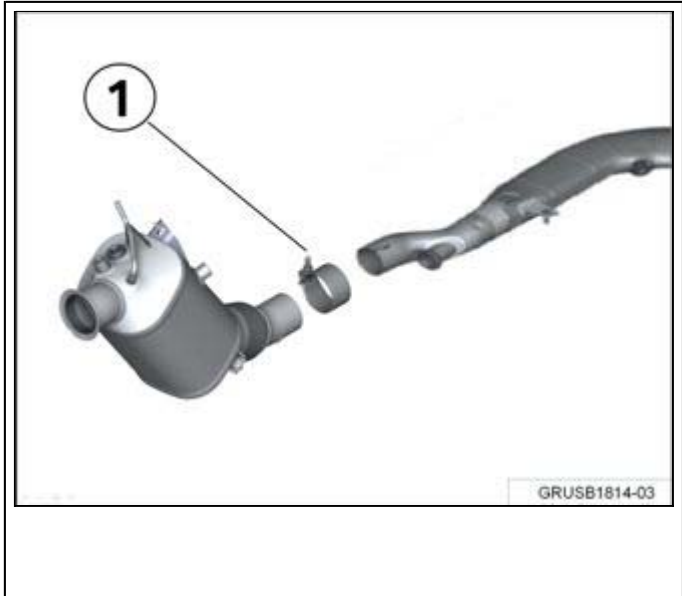
<p>The band clamp (1) is a one-time use only part. It must be replaced after any work performed that requires removal of the exhaust. The clamp will not hold its tightening torque when re-used.</p>
---	--

The band clamp holding the exhaust front pipe to the DPF has come loose.
