**SUBJECT****Diagnosis of Compound Brake System Complaints in M Vehicles****MODEL**

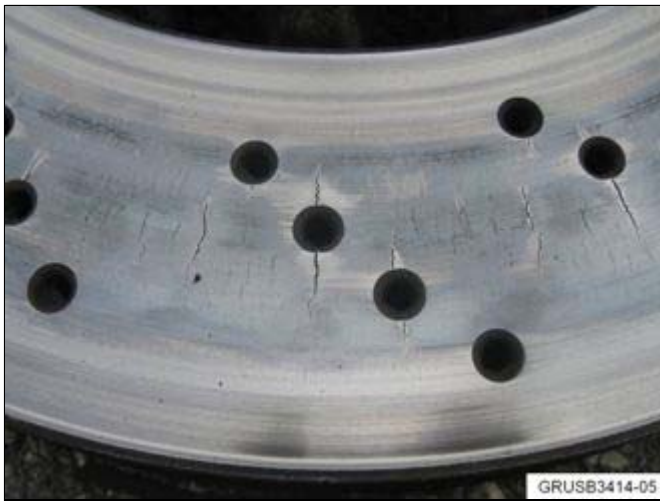
1. Visible cracks are caused by high thermal stresses during rapid heating and cooling of the brake discs. Braking from high speed with cold brake components (less than 212 degrees F) increases the likelihood of cracks to form. These surface hairline cracks are usually spread over the entire brake disc friction area, and have no negative influence on the durability or braking performance. The rotors should not be replaced only for their appearance reasons.

When performing routine service on the brake system (pad replacement due to wear), the brake discs should be replaced if surface cracks are found to be greater than 13 mm, or if the brake disc thickness is below the minimum thickness.

Always replace brake discs in pairs (per axle). Install new brake pads when replacing discs. By doing this, the service life of the friction pad surface is increased, and an even material loss is ensured.

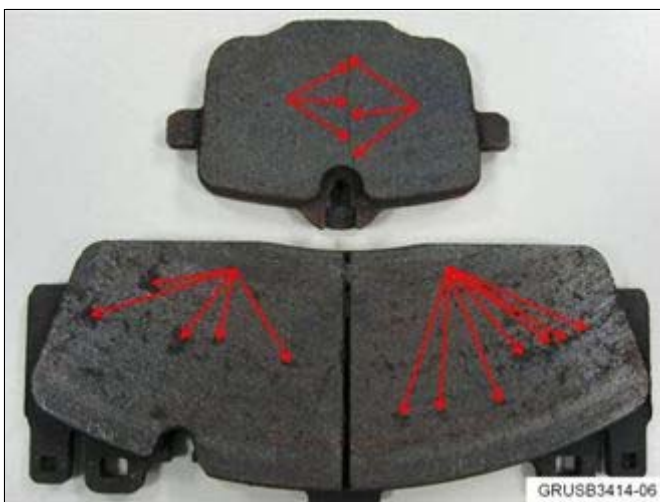
3. After high brake loads, running noises can be heard when applying the brakes, and may also be heard to a limited extent after the brakes are released. (See the note in the Owner's Manual).

These noises are reduced during normal everyday operation, due to further erosion of the brake pad friction lining.

Visible surface cracks or crater-like recesses on the brake pad surface are caused by a minor difference in the material of the pad lining, which will decrease with further operation and should not be replaced due to their appearance.
