NUMBER: 23-020-15

Replace Missing Manual Release Cover For The Electric Fuel Door

Jeep Renegade (Latin America Vehicles Only)

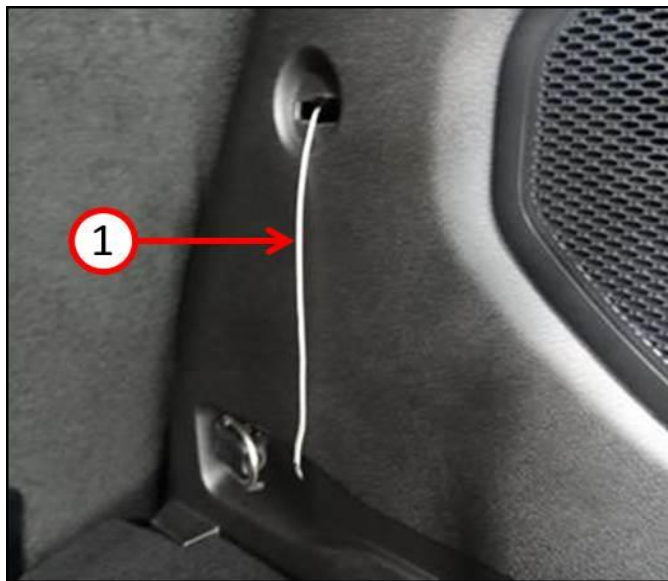
Fig. 2 Loose Cable

2. If cover is not present and cable (1) is hanging perform the repair (Fig. 2).

1 - Cable

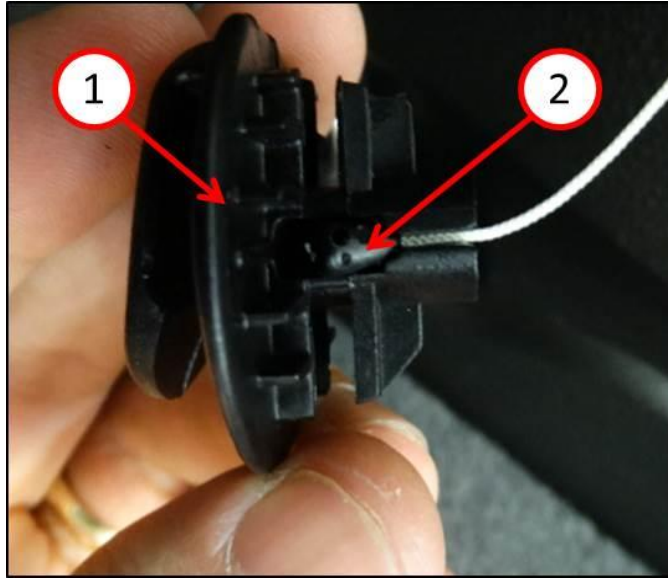
Fig. 3 Cable Insertion

- 1 - Cover
- 2 - Cable

3. Install the cable (2) onto the new cover (1) (Fig. 3).

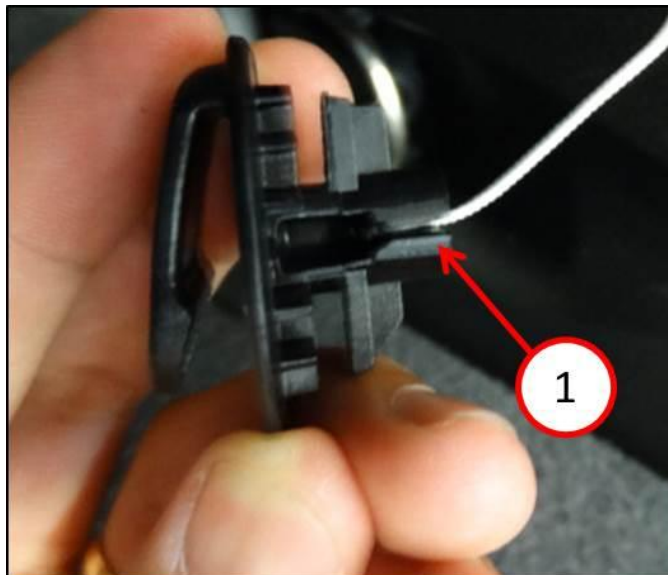
Fig. 4 Cable Fully Inserted Into Cover

- 1 - Cover
-

-
4. Make sure the cable is fully inserted into the cover (1) as shown (Fig. 4).

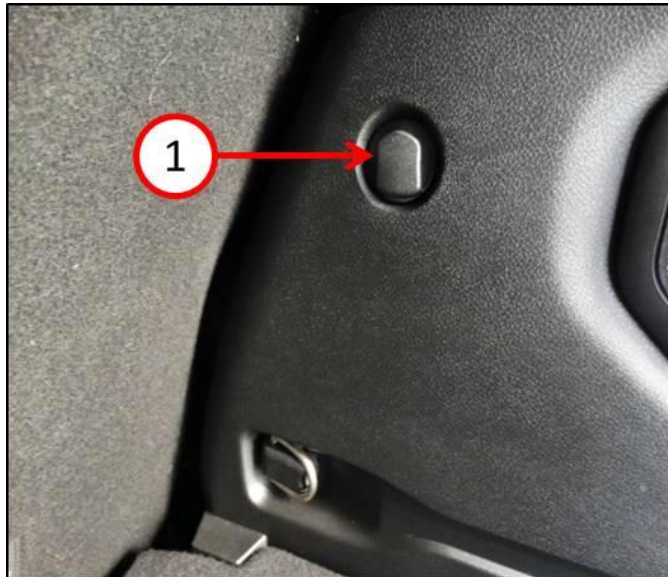
Fig. 6 Cover Installed

1 - Cover

6. Make sure the cover (1) is flush and installed properly (Fig. 6).
