NUMBER: 07-005-15 REV. B

GROUP: Cooling

Intermittent Coolant Weepage From Upper Radiator Hose Or Radiator

This bulletin involves installing an additional clamp on the upper radiator hose along with replacing the radiator assembly.

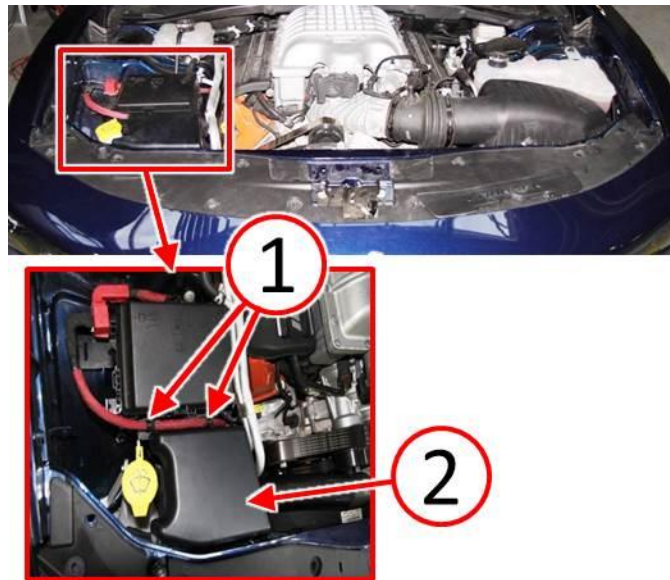
Fig. 1 Remove ABS Module Cover

1 - Battery Cable Push Pin Connectors

2 - ABS Module Cover

1. Disconnect and isolate the negative battery cable at the Intelligent Battery Sensor (IBS). Refer to the detailed service procedures available in DealerCONNECT> TechCONNECT under: Service Info> 08 - Electrical> 8F - Engine Systems> Battery System.
2. Raise the hood.
3. Remove two push pin connectors (1) that wrap around battery cable and capture tabs on ABS Module cover (Fig. 1).
4. Remove the ABS Module cover (2) (Fig. 1).

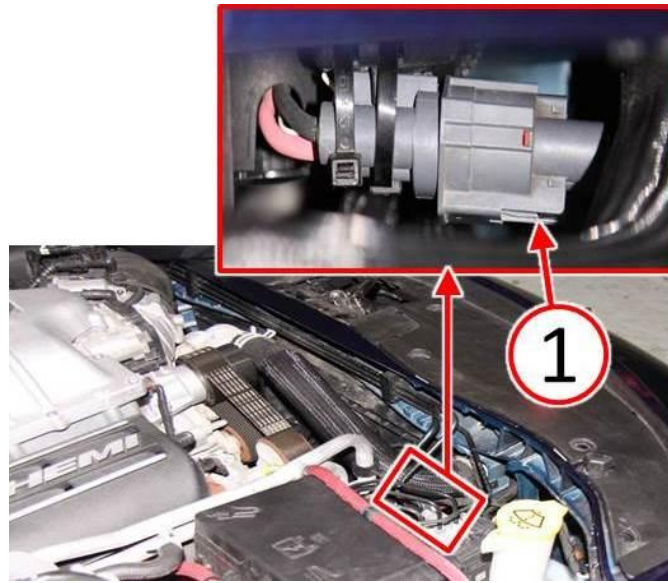
Fig. 2 Disconnect Fan Electrical Connector

1 - Cooling Fan Electrical Connector Locking Tab

-
5. Depress locking tab (1) then pull to disconnect the cooling fan electrical connector (Fig. 2).

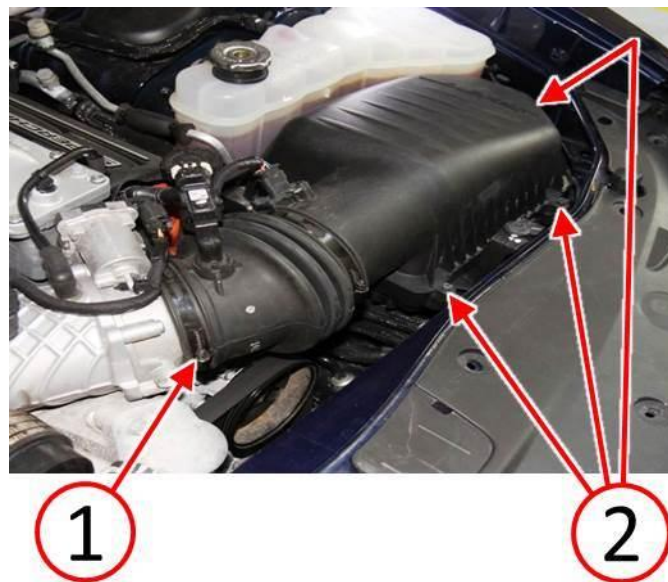
Fig. 3 Air Inlet

1 - Air Inlet Duct Clamp
2 - Air Cleaner Housing Cover

6. Remove three screws (2) securing the air cleaner housing cover (Fig. 3).
7. Loosen the air inlet duct clamp (1) then rotate the air inlet assembly up to provide access (Fig. 3). It is not necessary to disconnect electrical connectors or fully remove the air inlet from the vehicle.

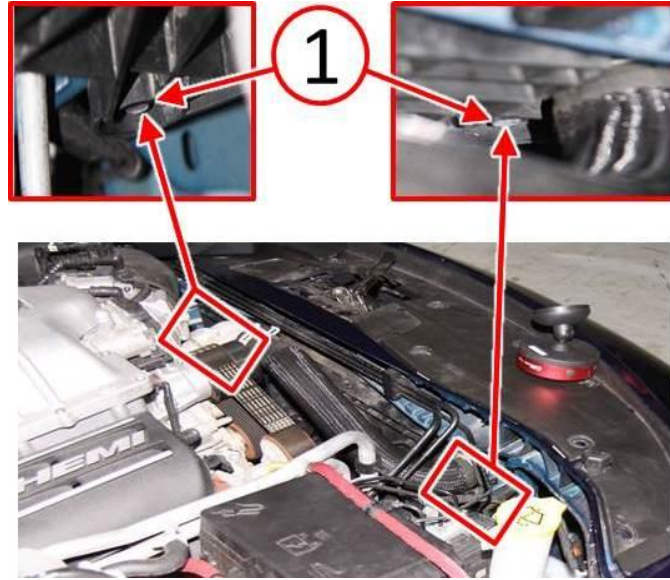
Fig. 4 Remove Cooling Fan Mounting Bolts

1 - Radiator Fan Mounting Bolts

8. Remove the radiator fan mounting bolts (1) (Fig. 4).

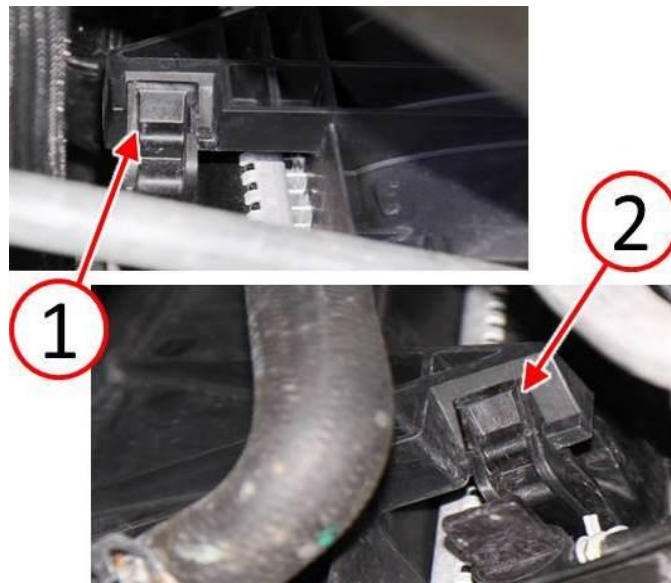
Fig. 5 Release Lower Fan Shroud Clips

- 1 - Left Fan Shroud Clip
- 2 - Right Fan Shroud Clip

NOTE: Belly pan removal is not required for releasing the lower fan shroud clips. (Fig. 5) bottom views are provided for information only.

9. Lift the fan assembly to release the lower fan shroud clips (1 and 2) (Fig. 5).

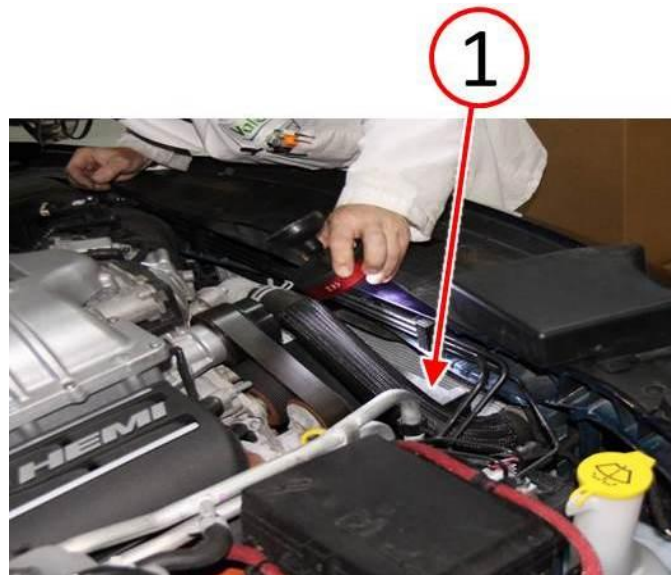
Fig. 6 Reposition Fan Assembly For Radiator Tank Crimp Access

- 1 - Fan Shroud
-

10. Repositioned the fan shroud (1) leftward and rearward to gain access to the right side radiator tank crimp tabs (Fig. 6).

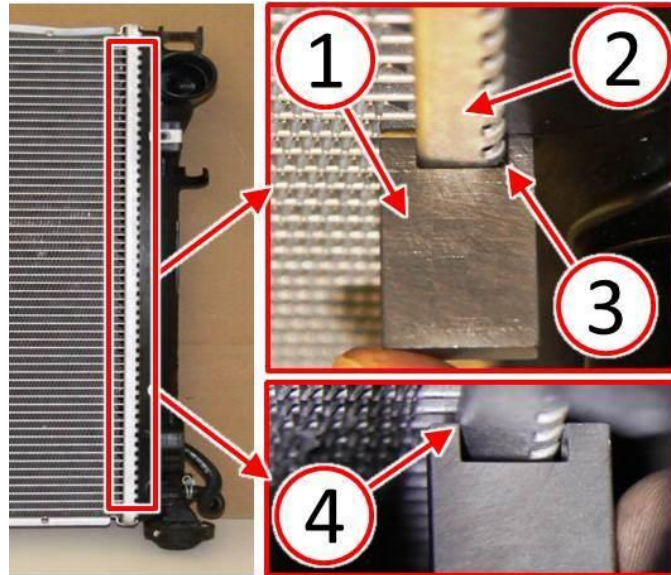
Fig. 7 Inspect Crimp Height Using Gage

- 1 - Inspection Tool
- 2 - Radiator Crimp Flange
- 3 - Inspection Tool Clearance
- 4 - Inspection Tool Interference

11. Insert the radiator crimp inspection tool (1) over the crimp flange (2) checking for tool clearance or interference along as much of the radiator tank crimp flange as is accessible. The inspection tool should fit freely around the crimp flange without interference (3). If the inspection tool interferes with the crimp flange (4) not fitting freely over the flange, at any location along the entire length of the crimp flange, the radiator will require replacement.

-
12. Was any interference between the inspection tool and the crimp flange found at any location along the entire length of the crimp flange?
- a. YES>>> Continue with [Step #13](#).
 - b. NO>>> Proceed to [Step #49](#)

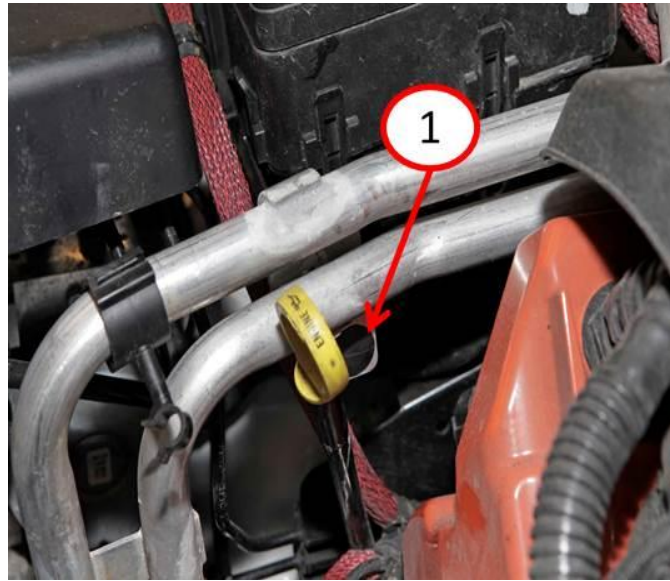
Fig. 8 Push Pin for Tubes

1 - Push Pin

19. If equipped with supercharger, disconnect the push pin (1) securing the coolant tubes by the Power Distribution Center (PDC) (Fig. 8).

40. Install the lower radiator hose.
41. Install the upper radiator hose.
42. Install the push pin for the coolant tubes next to the PDC if equipped with supercharger (Fig. 8).

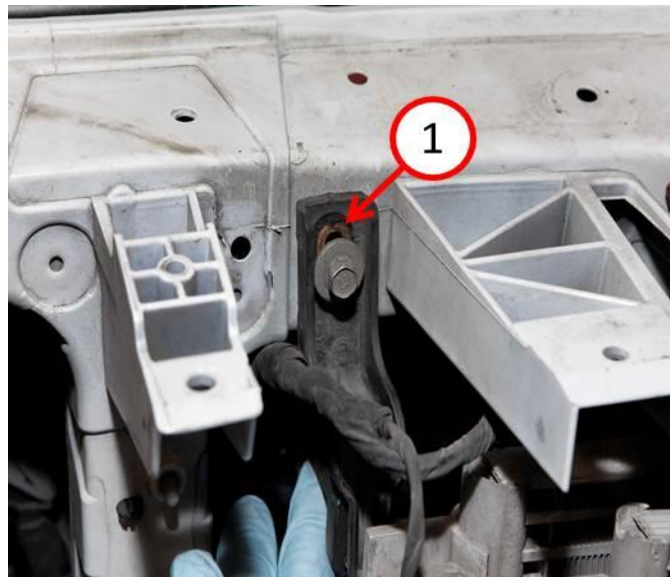
Fig. 9 Upper Radiator Support Bracket

1 - Upper Radiator Support

20. Remove the bolts and the upper radiator support bracket (1) (Fig. 9).

38. Install the radiator close out panels (Fig. 10).
39. Install the bolts and the upper radiator support brackets (Fig. 9). Tighten the bolts to 12 N·m (106 in. lbs.).

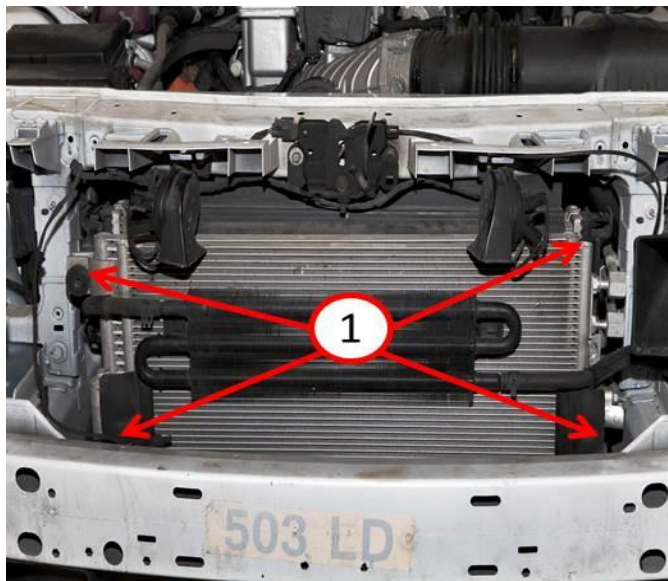
Fig. 11 Bolts securing the AC Condensor

1 - Bolt Location

22. Remove the 4 bolts (1) for the A/C condenser to the radiator and the Low Temperature Radiator (LTR) cooling system cooler if equipped with supercharger (Fig. 11). Secure the A/C condenser and LTR as an assembly to prevent stress on the lines/hoses.

36. Remove the tie strap securing the upper fan shroud (Fig. 12).
37. Install the 4 bolts securing the LTR cooler if equipped with supercharger and A/C condenser to the radiator. Tighten the bolts to 9 N·m (80 in. lbs.) (Fig. 11).

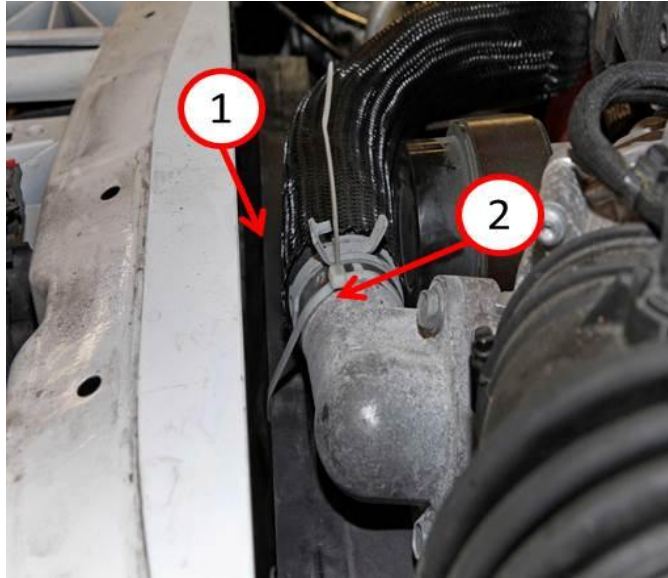
Fig. 12 Fan Shroud Tied Back

1 - Fan Shroud

2 - Tie Strap

23. Tie strap (2) the upper fan shroud (1) out of the way as shown (Fig. 12).

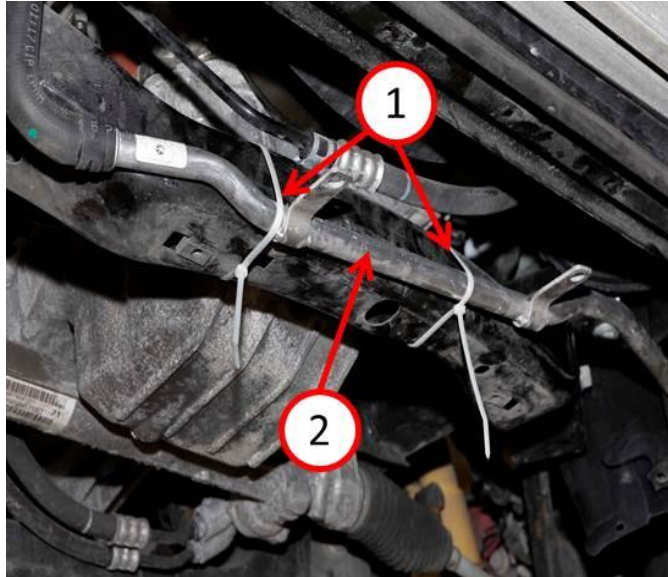
Fig. 13 LTR Tube Tied Back

- 1 - Tie Strap
2 - LTR System Tube
-

24. Remove the push pins from the lower radiator support to the electric water pump for the LTR system tube (2) if equipped with supercharger. Tie strap (1) the tube back against the front cradle for clearance of the radiator (Fig. 13).

34. Install the lower radiator close out panels (Fig. 14).
35. Remove the tie straps securing the LTR tube and install the push pins to the lower radiator support if equipped (Fig. 13).

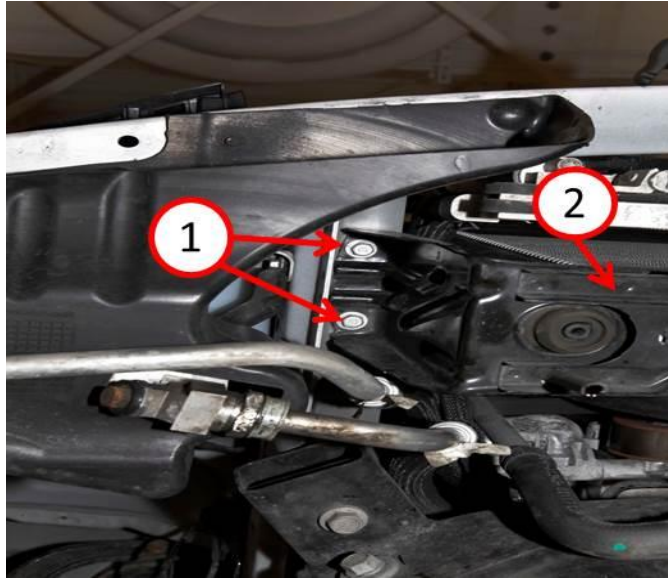
Fig. 15 Lower Radiator Support Bolts

1 - Lower Support Bolts

2 - Lower Support

27. Remove the 4 bolts (1) for the lower radiator support (2) (Fig. 15).

31. Install the radiator from the bottom of the vehicle (Fig. 17).
32. Install the lower radiator support bracket (Fig. 16).
33. Install the 4 bolts securing the lower radiator support (Fig. 15). Tighten the bolts to 16 N·m (141 in. lbs.).

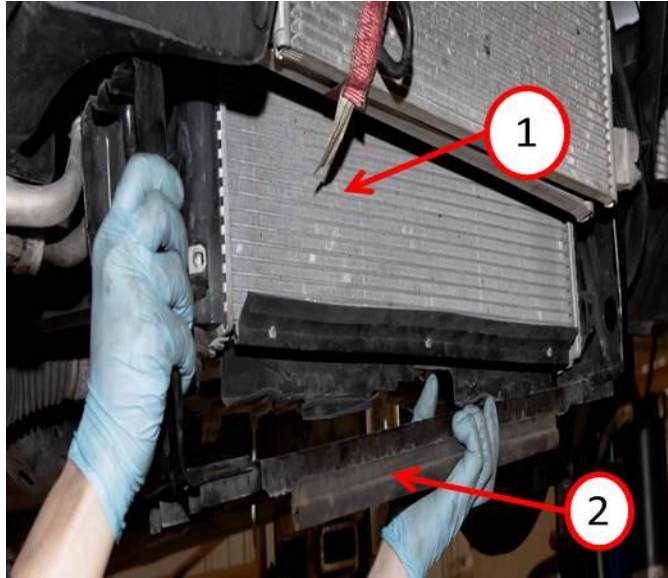
Fig. 16 Radiator Lower Support

1 - Radiator

2 - Lower Support Bracket

28. Remove the lower support bracket (2) from the radiator (1) (Fig. 16).

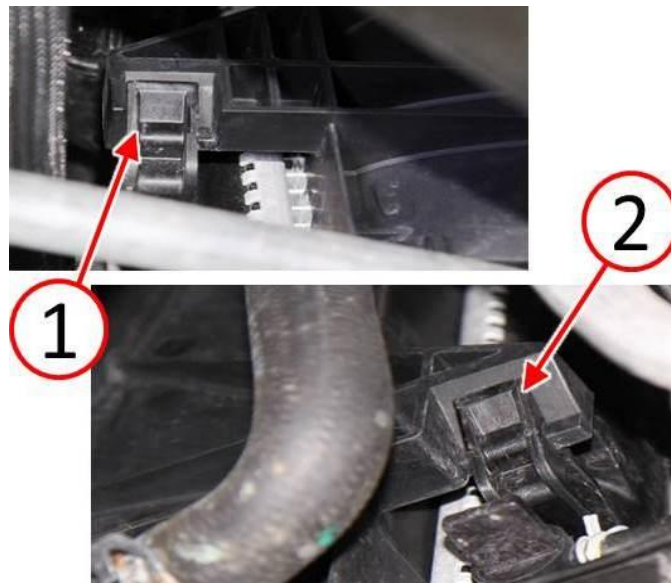
Fig. 18 Latch Lower Fan Shroud Clips

- 1 - Left Fan Shroud Clip
- 2 - Right Fan Shroud Clip

48. Lower the vehicle.
49. Insert the fan assembly into the lower fan shroud clips (1 and 2) (Fig. 18).

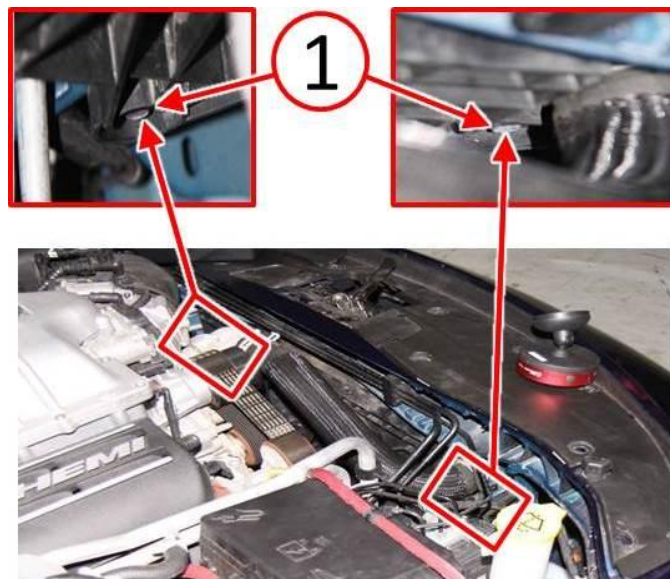
Fig. 19 Install Cooling Fan Mounting Bolts

- 1 - Radiator Fan Mounting Bolts
-

50. Install the fan bolts securing it to the radiator. Tighten the bolts (4) to 9 N·m 80 in. lbs.) (Fig. 19).

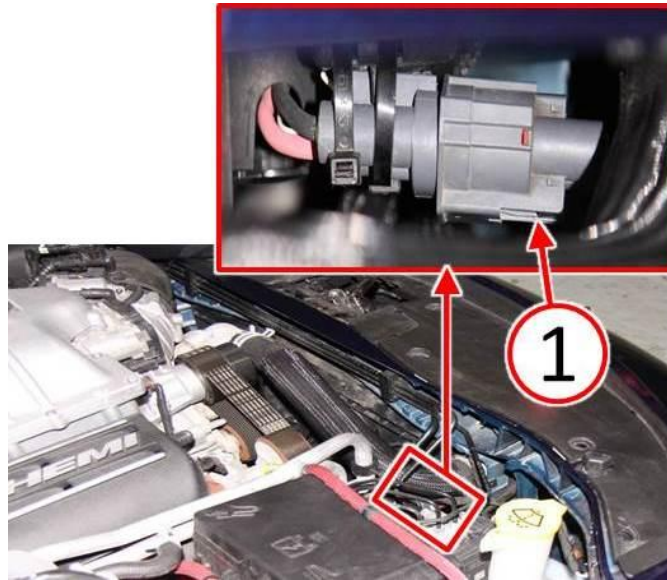
Fig. 20 Connect Fan Electrical Connector

1 - Cooling Fan Electrical Connector Locking Tab

51. Reconnect the electrical connectors to the fan ([Fig. 20](#)).

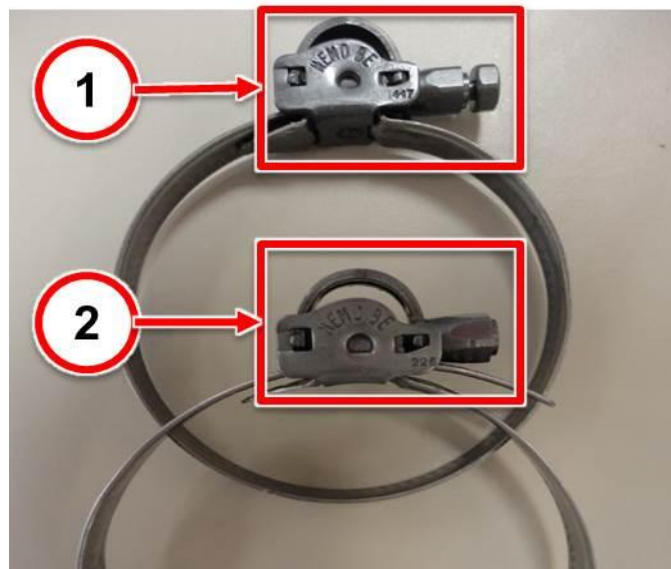
Fig. 22 Hose Clamp Torque Limiting Head

- 1 - Before tightening
- 2 - After tightening

NOTE: The new clamp will have a torque limiting head. The head will break free once proper torque of 3 N·m (26 in. lbs.) is achieved. Care must be taken to ensure the socket used only engages the head of the bolt to prevent over tightening the clamp.

55. Using a 7 mm shallow socket and swivel, tighten the new clamp until the torque limiting head breaks free as shown in (Fig. 22).

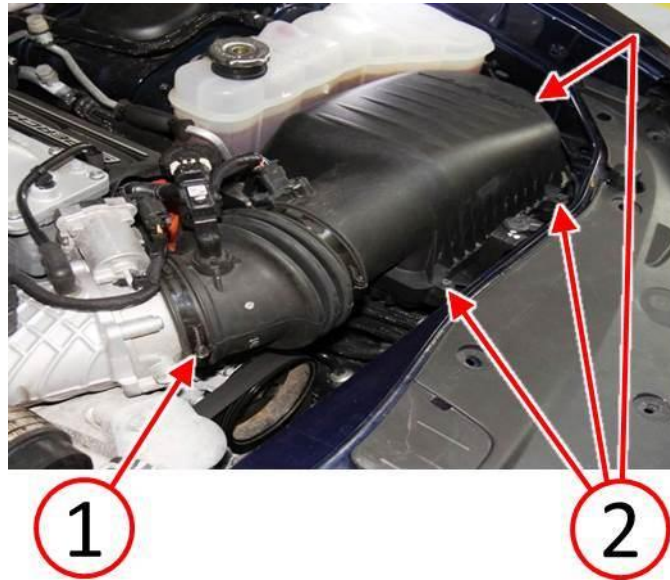
Fig. 23 Air Inlet

- 1 - Air Inlet Duct Clamp
- 2 - Air Cleaner Housing Cover

56. air cleaner housing cover (Fig. 23).

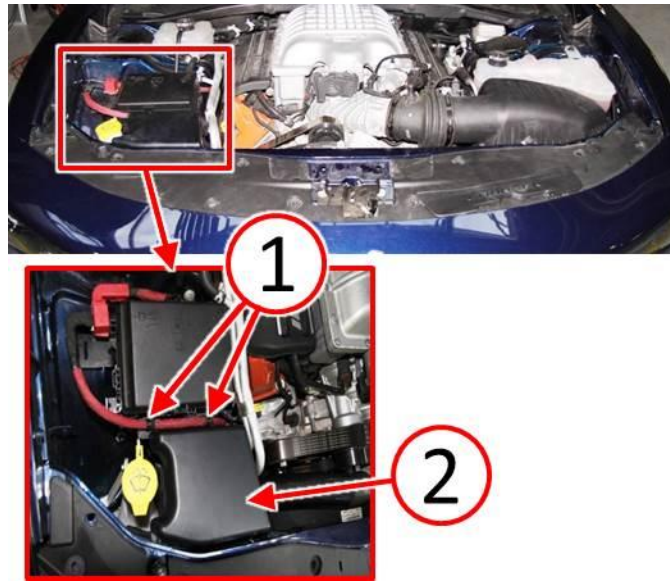
Fig. 24 Install ABS Module Cover

1 - Battery Cable Push Pin Connectors

2 - ABS Module Cover

57. Install the ABS Module cover (2) (Fig. 24).
58. Install the two push pin connectors (1) that wrap around battery cable and capture tabs on ABS Module cover (Fig. 24).
